Tracker Parameters Trending Monitor

GLAST I and T Workshop, Feb 27th, 2007 Tsunefumi Mizuno mizuno@hirax6.hepl.hiroshima-u.ac.jp

Purpose of the Monitoring Feb 28, 2006

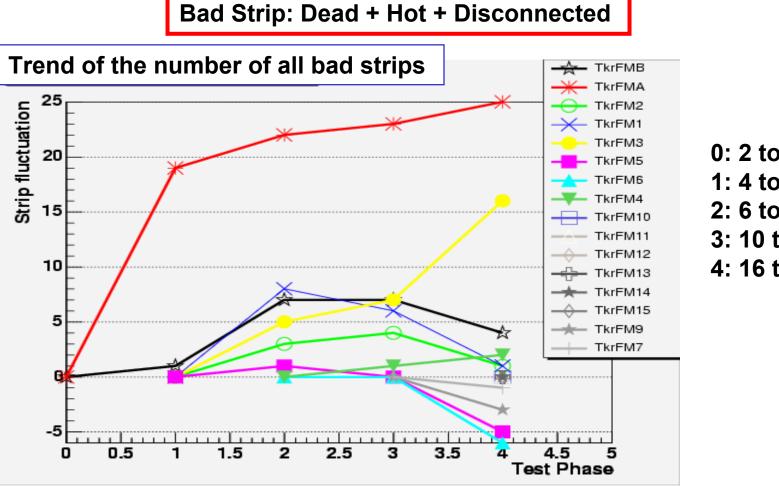
Bad Strip Monitor

Maximum increase of all bad strips is 25, less than 0.05% of strips in tower.

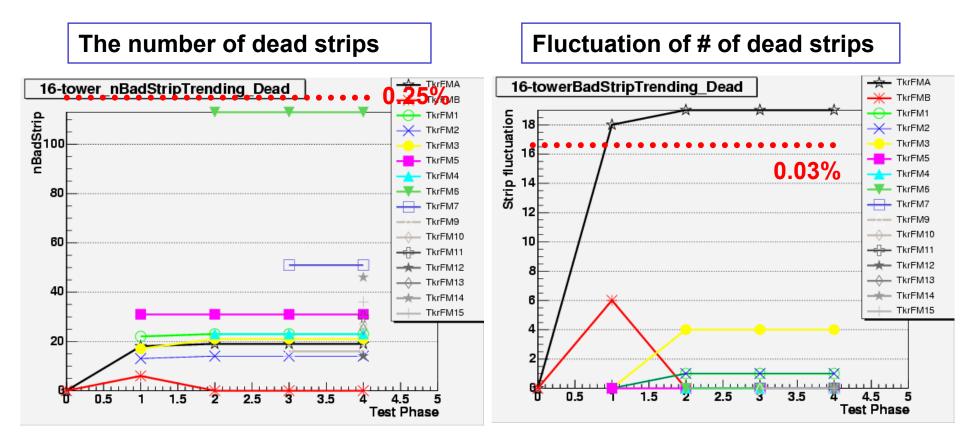
Instrument Analysis Meeting- Feb 28, 2006 Dead Strip Monitor

- Less than 0.25% for all 16 towers.
- The maximum increase of dead strip is 19 strips, only ~0.03% of strips in a tower -> no degradation of read-out electronics.

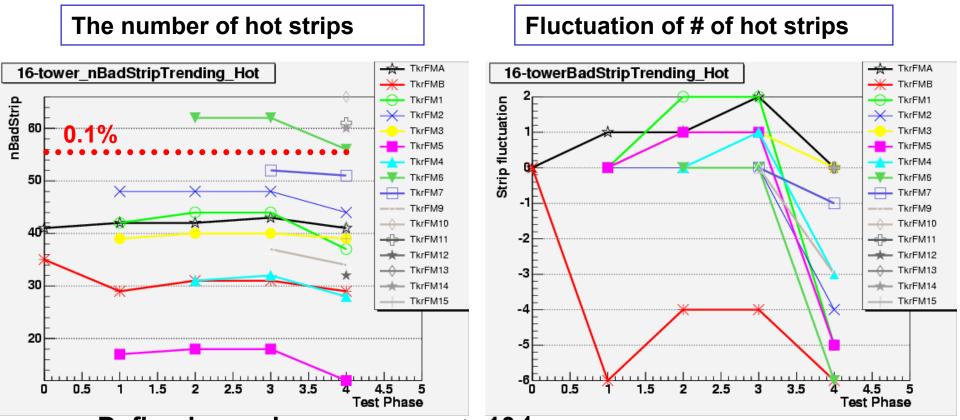
Instrument Analysis Meeting- Feb 28, 2006 Hot Strip Monitor

- Defined as noise occupancy > 10⁻⁴
- # of Hot strips of each tower is only ~0.1% or less of strips in a tower.
- The number decreased in most of towers (see next)

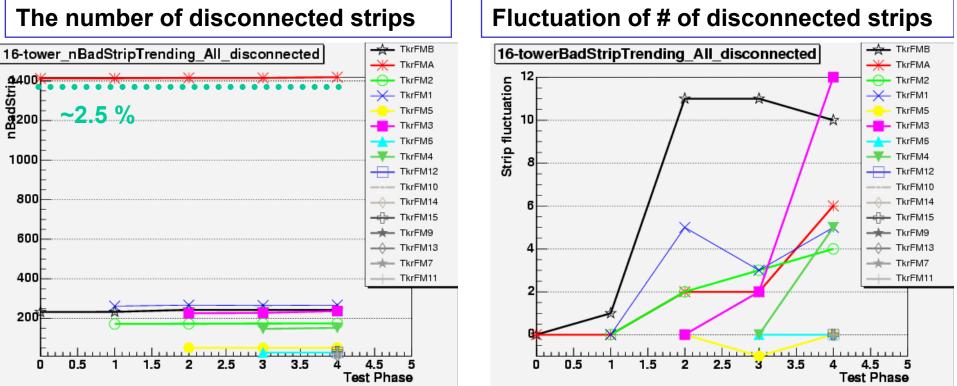
GLAST LAT Project Instrument Analysis Meeting- Feb 28, 2006
Disconnected Strip Monitor

- Disconnected strips are due to failure of wire bonding between two SSDs or SSDs and pitch adapter.
- ~1400(~2.5%) hot strips found at FMA.
 - Due to initial encapsulation process.
 - Process improved and the number of disconnected strips decreased down to ~200, less than 0.4% of strips in a tower
- Fluctuation well understood: most of "new" disconnected strips were originally classified as hot strips.
