GLAST Large Area Telescope:

**Mechanical Subsystem
Downspout & Top Flange CCHP
Reproof Pressure Test**

Scott Herzberg
herzberg@slac.stanford.edu

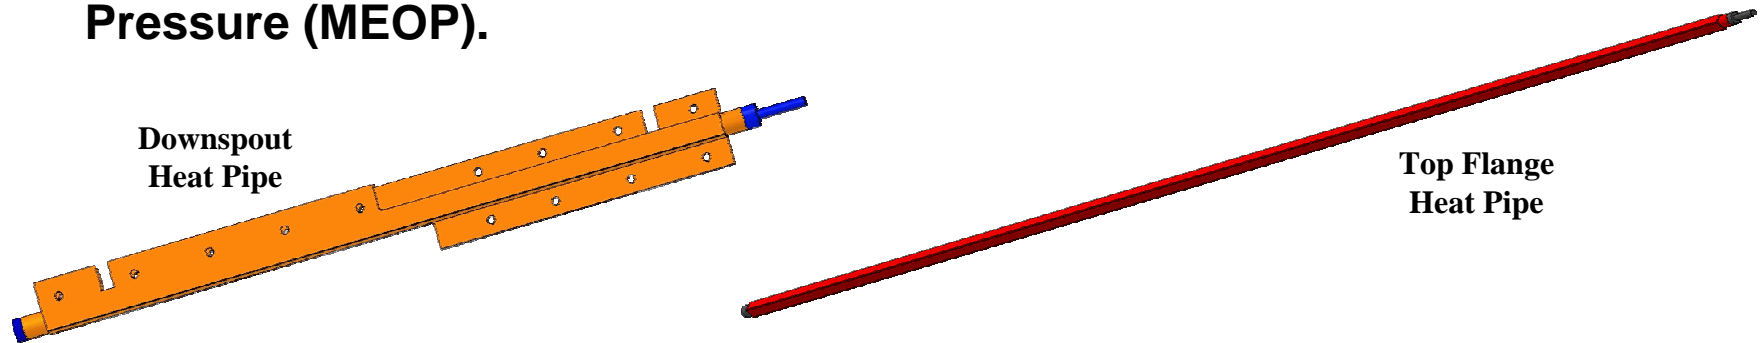
- Downspout & Top Flange Constant Conductance Heat Pipes (CCHP's) were poof pressure tested to 1.1 times Maximum Expected Operating Pressure (MEOP).

- CCHP's should have been tested to 1.5 times MEOP to be consistent with the pressurize system requirements per GLAST LAT Preliminary Hazard Analysis LAT-MD-00366, MIL-STD-1522, and EWR 127-1 safety requirements.
- CCHP Operating Pressure 490 PSI (MEOP)
 - 1.1xMEOP = 539 PSI Min
 - 1.5xMEOP = 735 PSI Min
