# GLAST Large Area Telescope:

## Tracker Subsystem WBS 4.1.4

## Tracker EM Vibration Test Status Engineering Meeting December 2, 2003

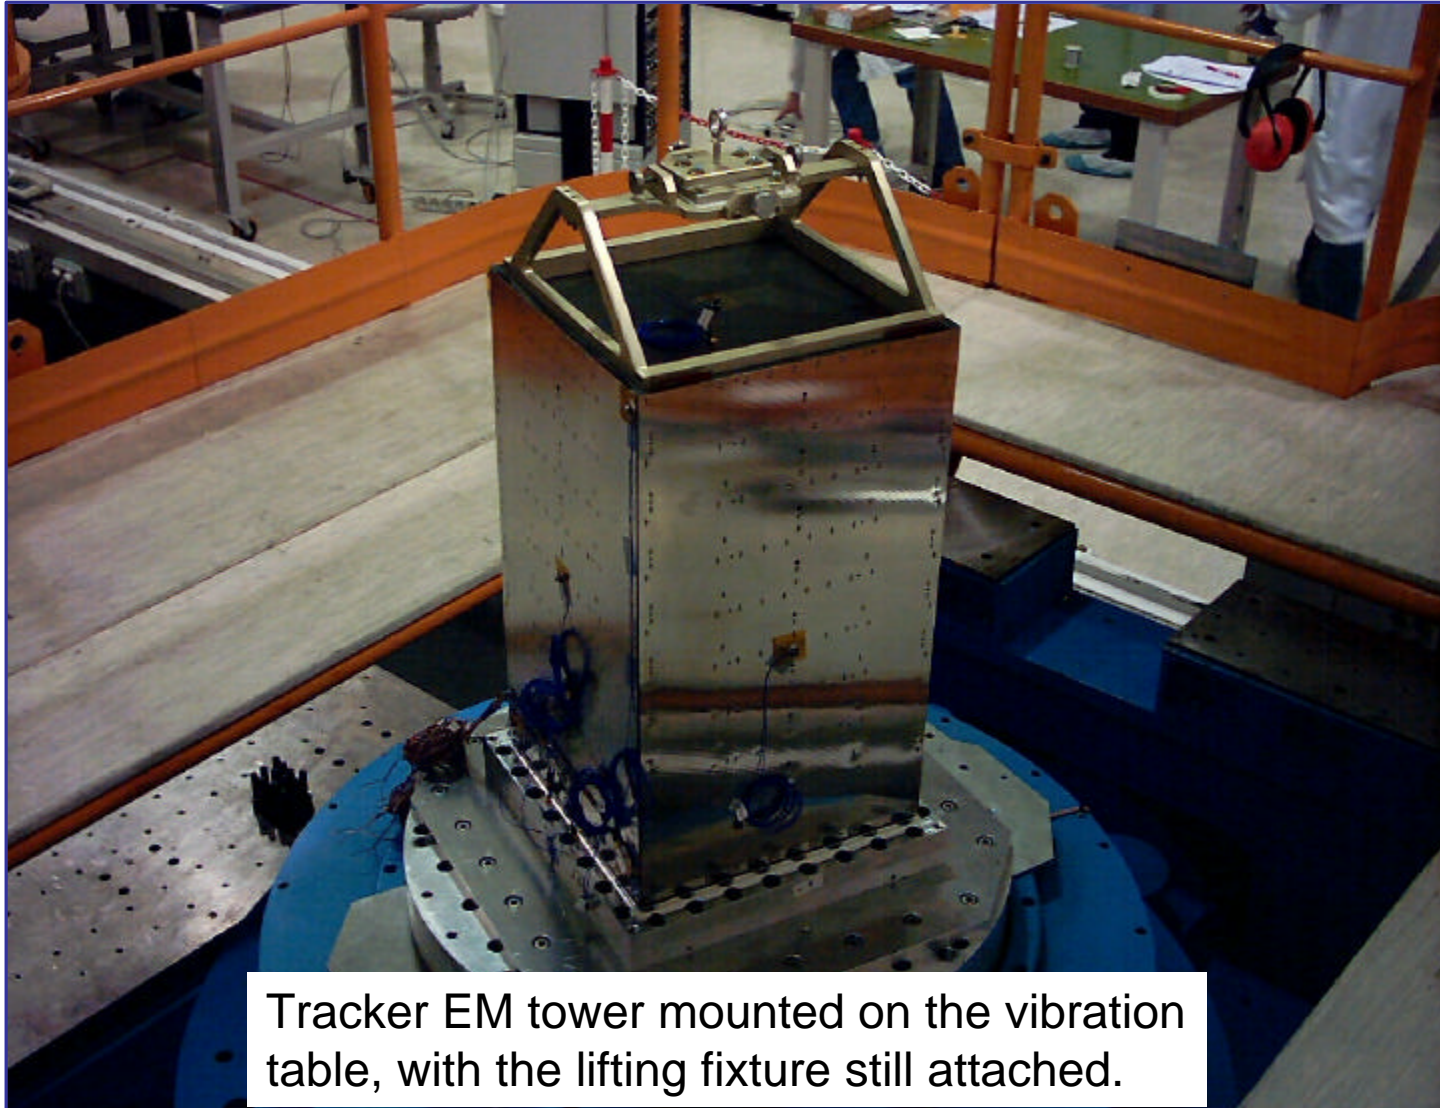
Tracker EM tower mounted on the vibration table, with the lifting fixture still attached.

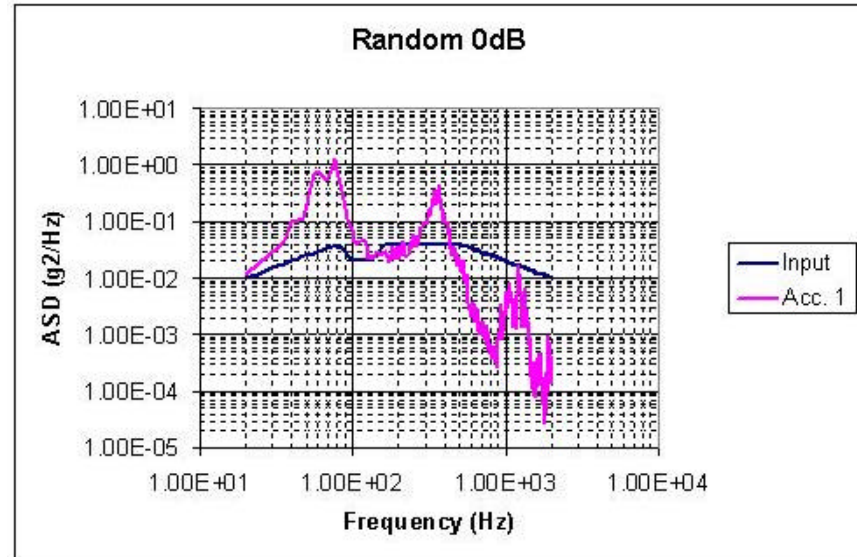
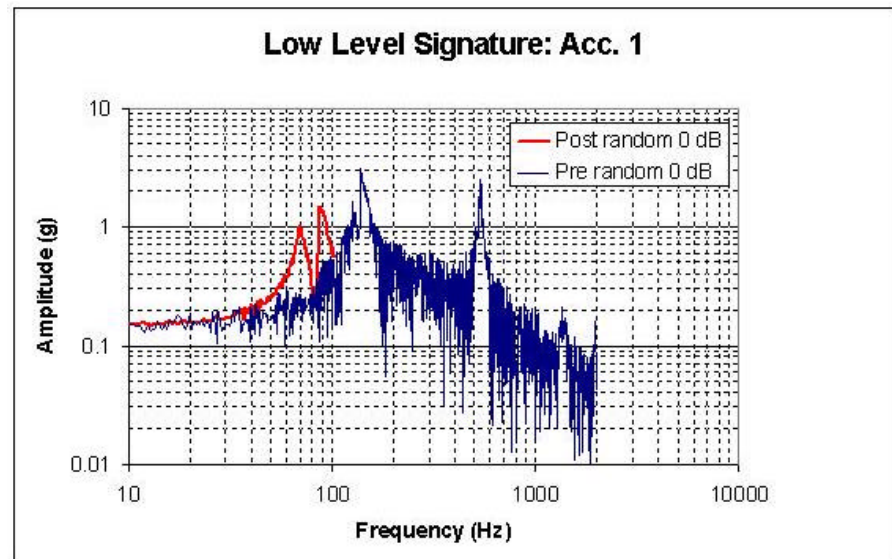
- Accelerometer data from the full-level random vibration in X.
- Accelerometer data from the sine sweeps before and after the 0dB random vibration in X. The post-random sweep was terminated just above 100 Hz.

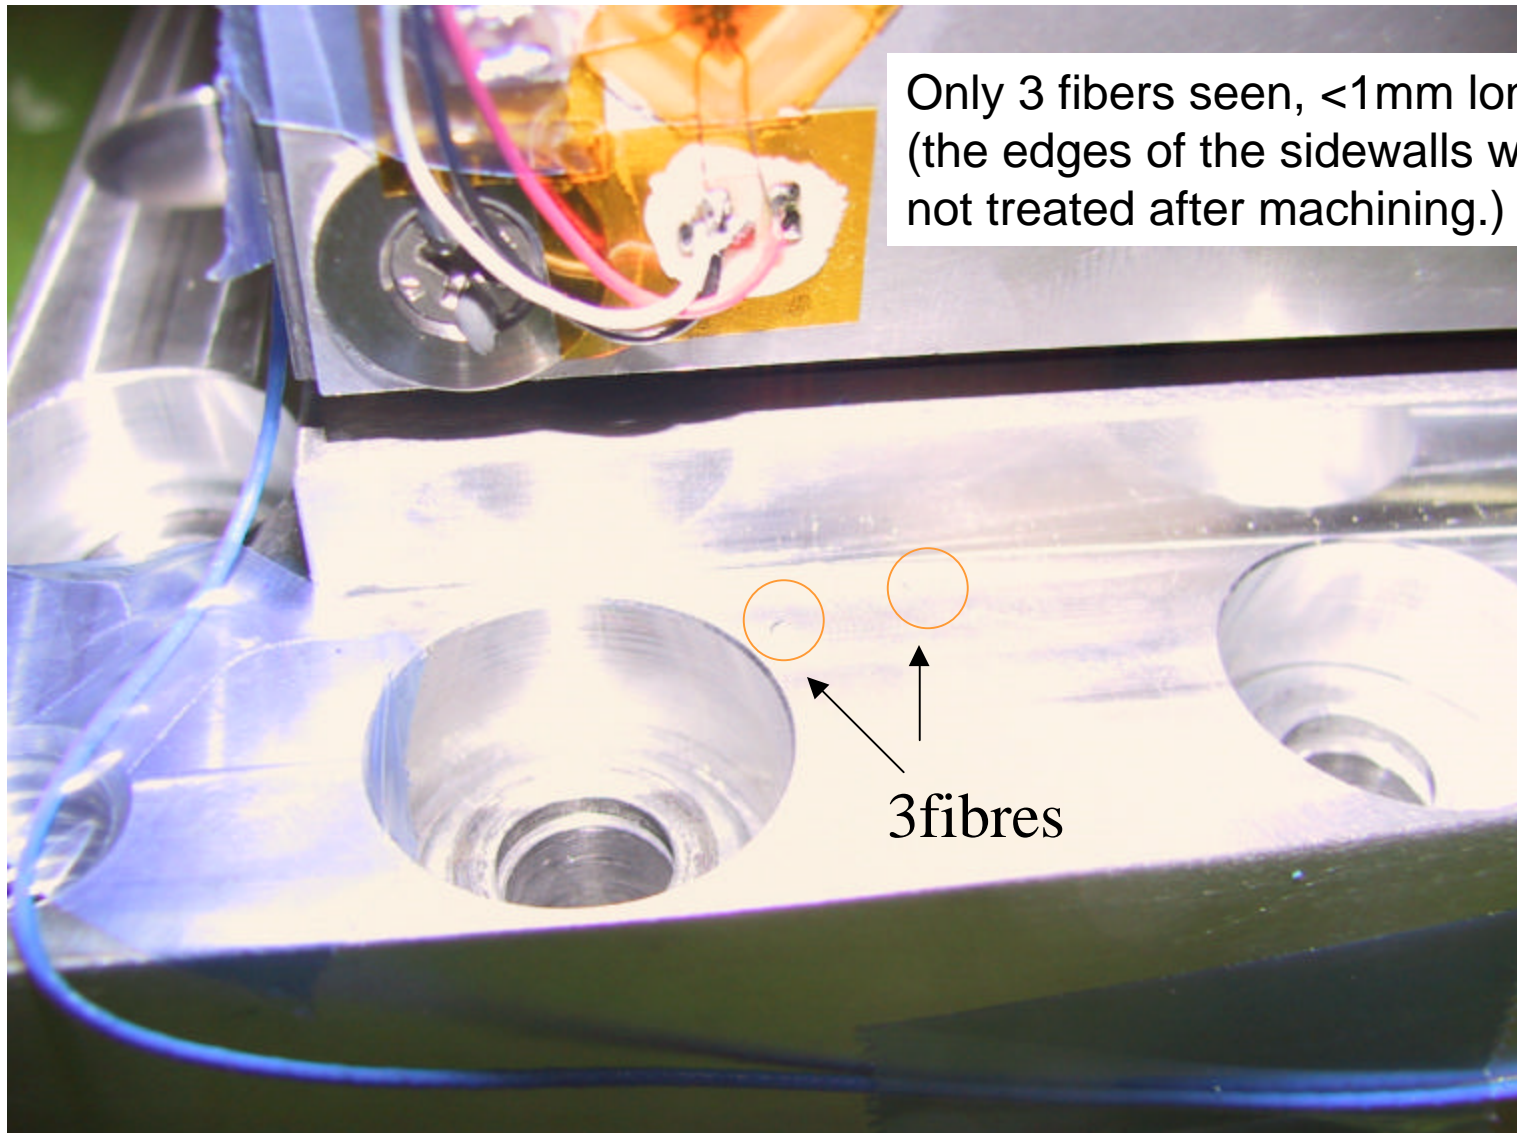
Only 3 fibers seen, <1mm long  
(the edges of the sidewalls were  
not treated after machining.)

3fibres

Damage observed in the corners of the grid.

Damage in the Al 1/4" alignment hole due to the shoulder of the steel screw.

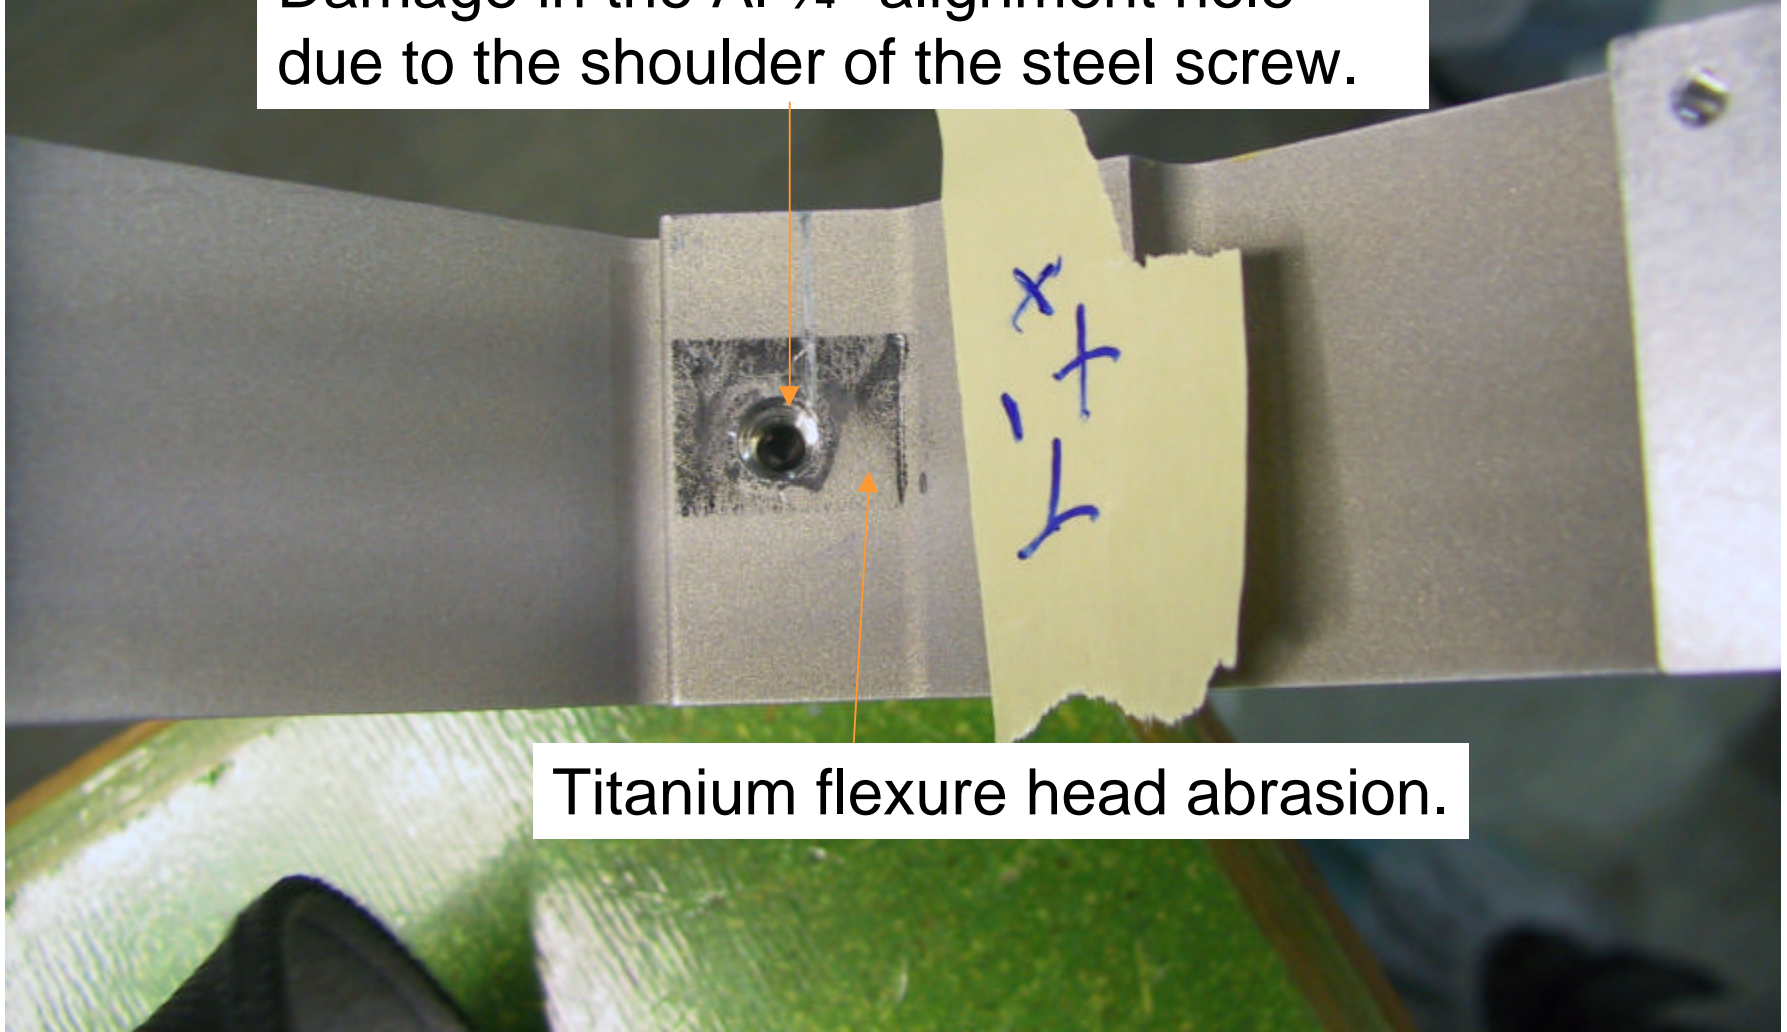
Titanium flexure head abrasion.
