GLAST Large Area Telescope:

Tracker Subsystem WBS 4.1.4

Persis S. Drell
Stanford Linear Accelerator Center
LAT Deputy Project Manager

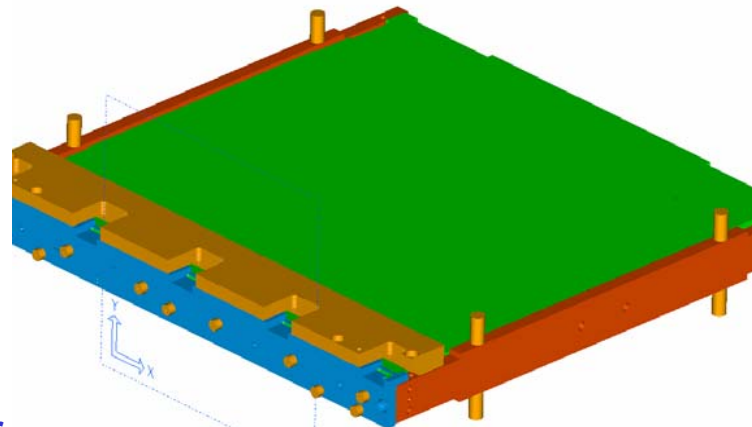
The tray with the TMCM assembly jig.

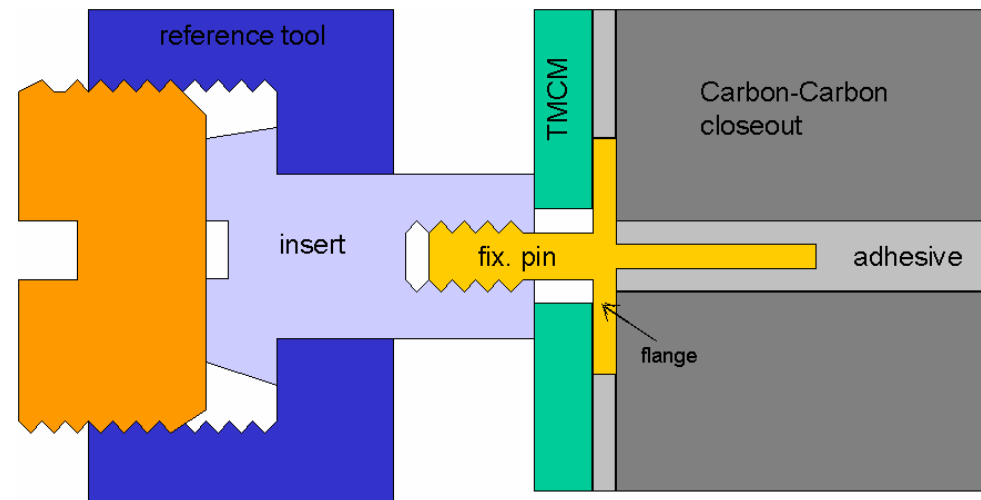
Fixation pin assembly scheme.

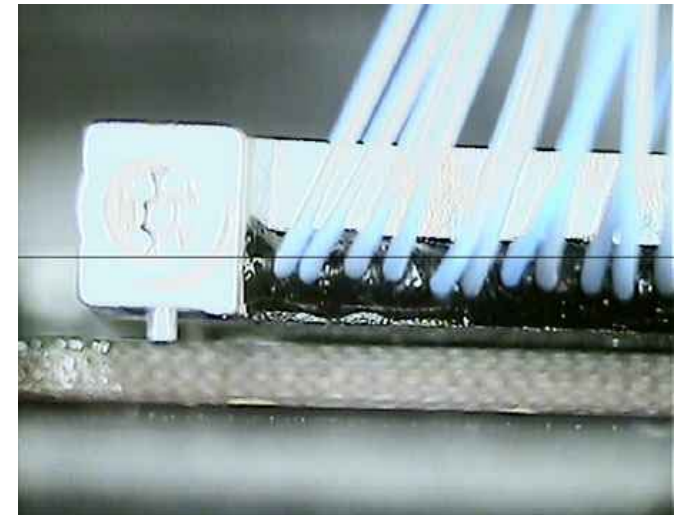
- Even with new bonding procedures continued difficulty meeting tolerance
- Root Causes:
 - (1) Most of the MCM connectors are not fully torqued, and some have a visible gap between the connector and PWB.
 - The clearance between MCM and Tracker sidewall is very small, such that we can tolerate only a 100-micron excess in thickness beyond the 3.81mm nominal
 - On most MCMs at SLAC we can turn the screws about $\frac{1}{4}$ turn before reaching 10 inch-oz. This pulls them to within the thickness spec.
 - (2) Pockets on Closeouts too shallow
 - Rework and process change at Plyform
- For the few extreme cases, where the MCM+Connector thickness is greater than 4.0mm, we have not tried to pull it snug, for fear of damaging the connector or solder pins. These will require rework.

This photo is an extreme example.

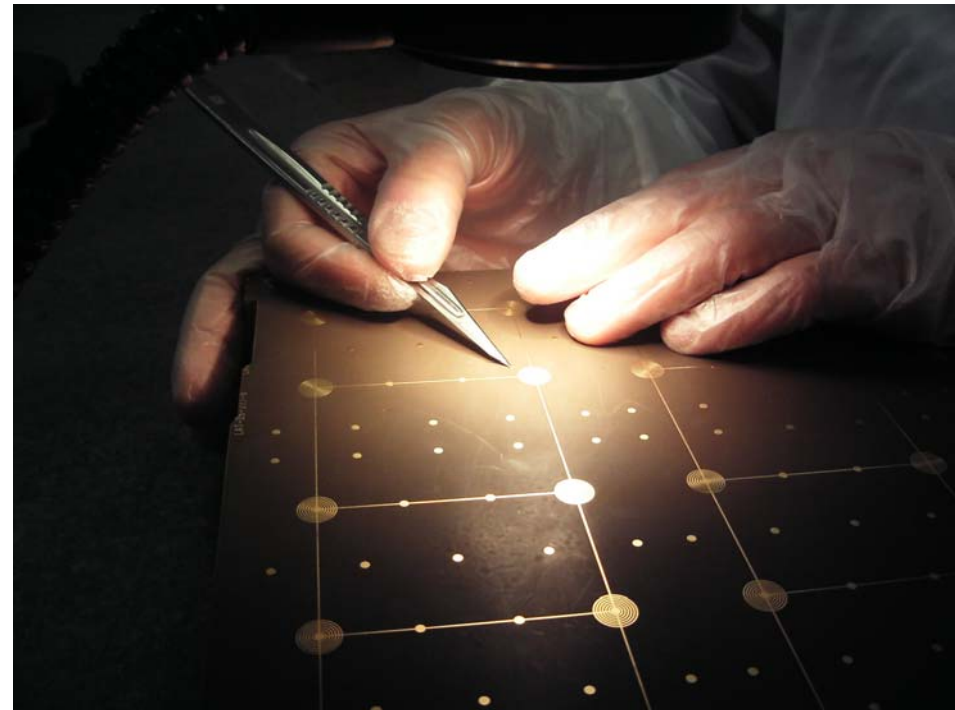
- **Process of laminating bias circuit traps air**
 - Preferentially at center of tray
 - Process improvements continue
 - MRB 11-12-04
 - Size of bubble limited (< 4 dots)
 - Disposition: For bubbles >~1.8cm
 - Small (<2mm) cut far from bias lines (>1mm) using an edged scalpel
 - Perform Insulation test with an ohm-meter between tray and shield plane
 - Affects ~30% of trays produced so far
 - Recent production shows significant improvement
- Procedure has never resulted in electrical short

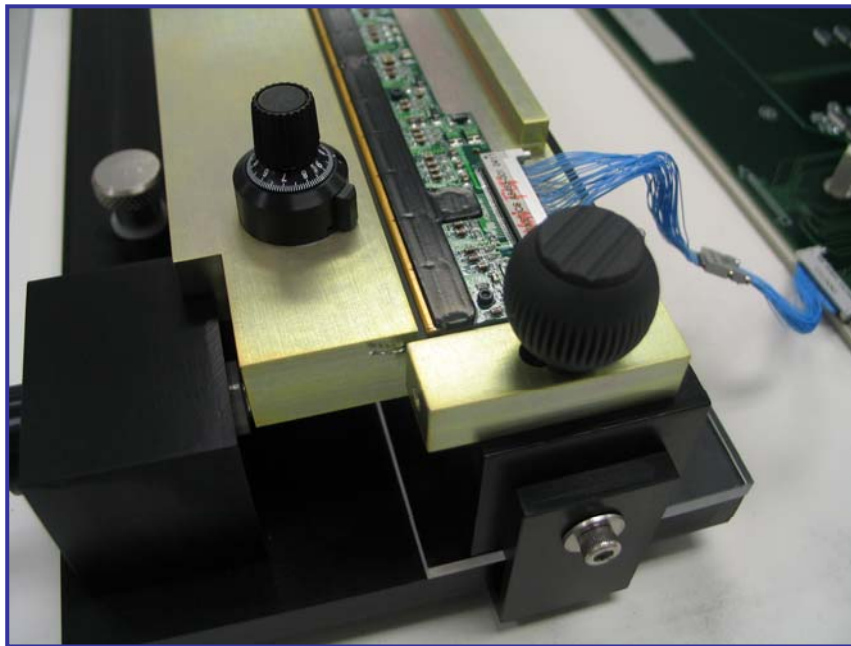
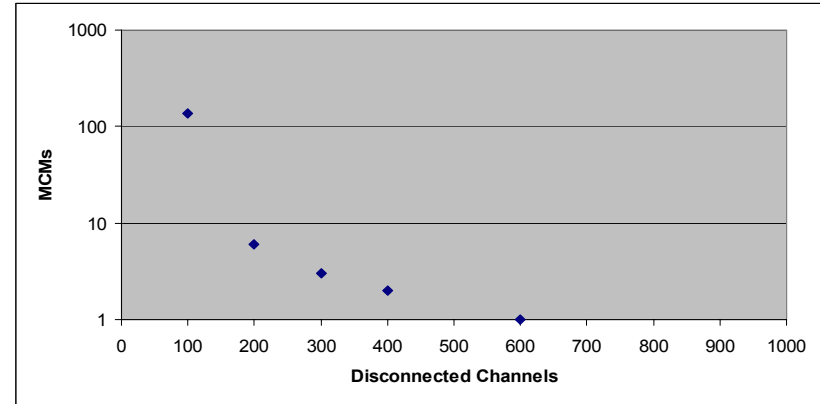
11% of the MCMs have >15 bad connections.
Average number of broken connections/MCM after rejecting those 11% is only 2.

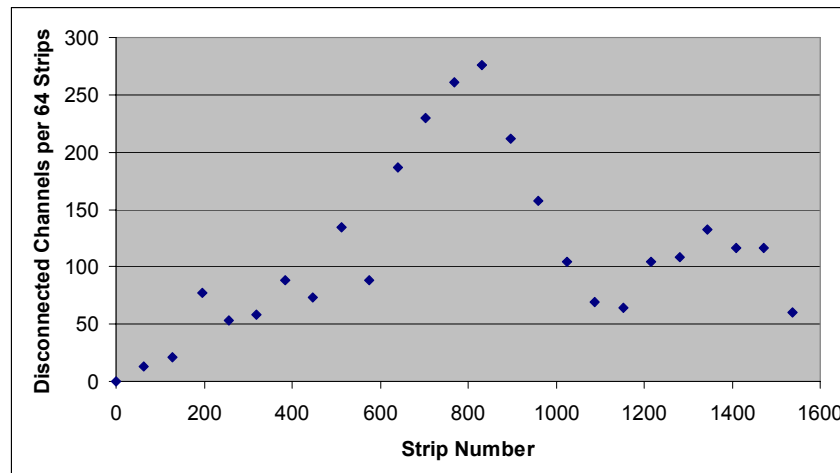
- Open channels can be intermittent and sensitive to pressure indicating that the break occurred after curing of the encapsulation, and the two pieces are still very close to each other.
- We do not see any broken bonds on the PWB side of the ASICs indicating the break is almost certainly at the pitch-adaptor end of the wire bond
- The highest probability of breakage is toward the center of the MCM.

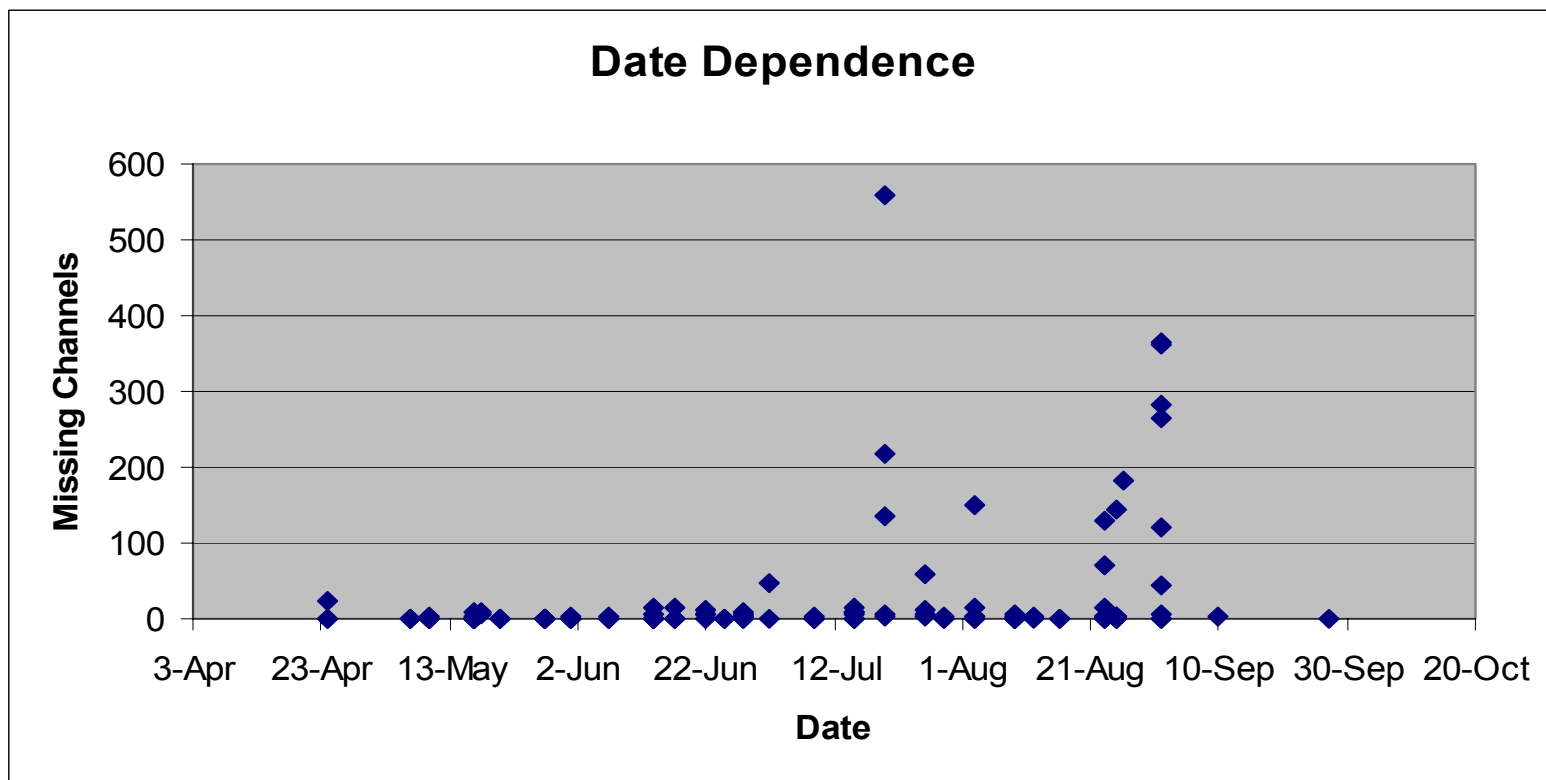
- The problem seems to have started in July and gotten worse in August and September.
- These data are incomplete, however, as we are continuing with testing of the existing MCM stock.

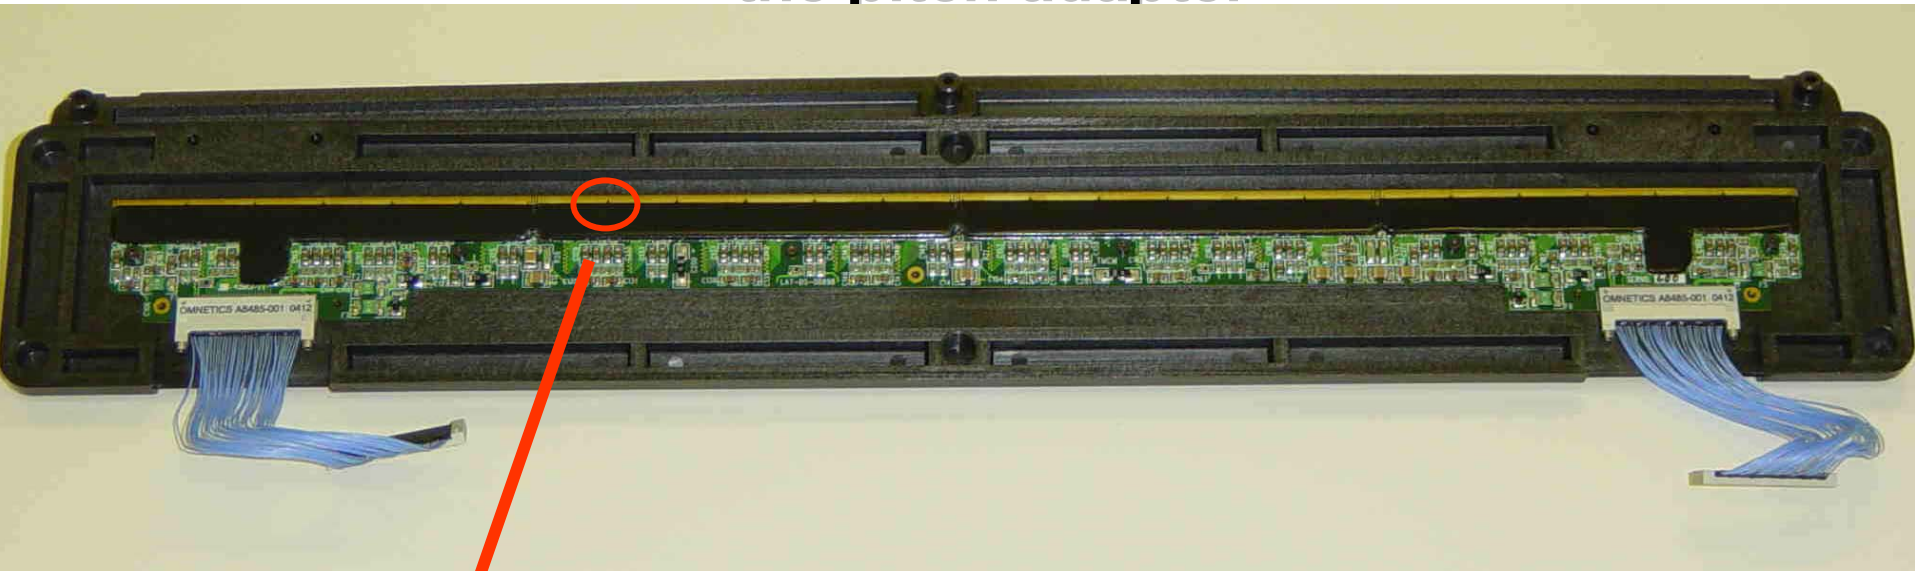
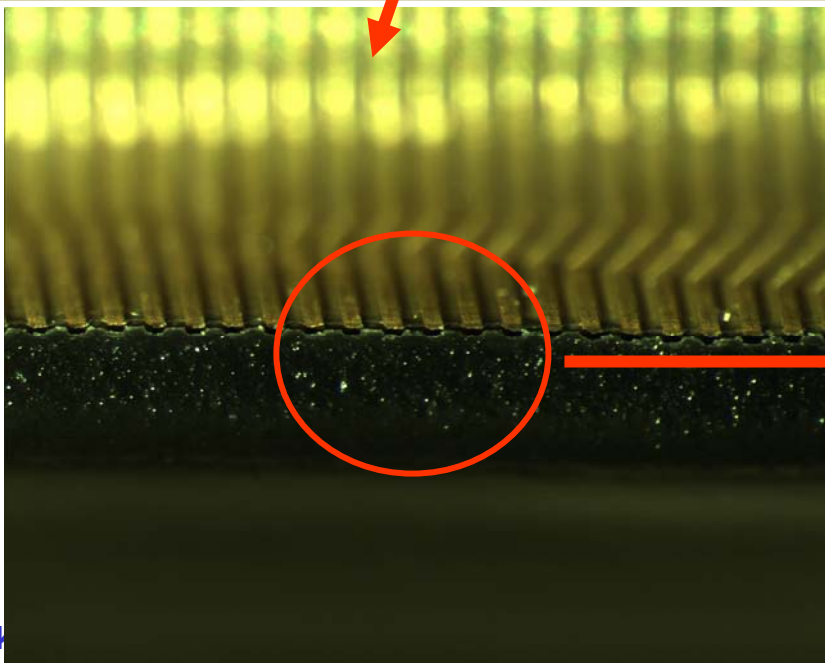
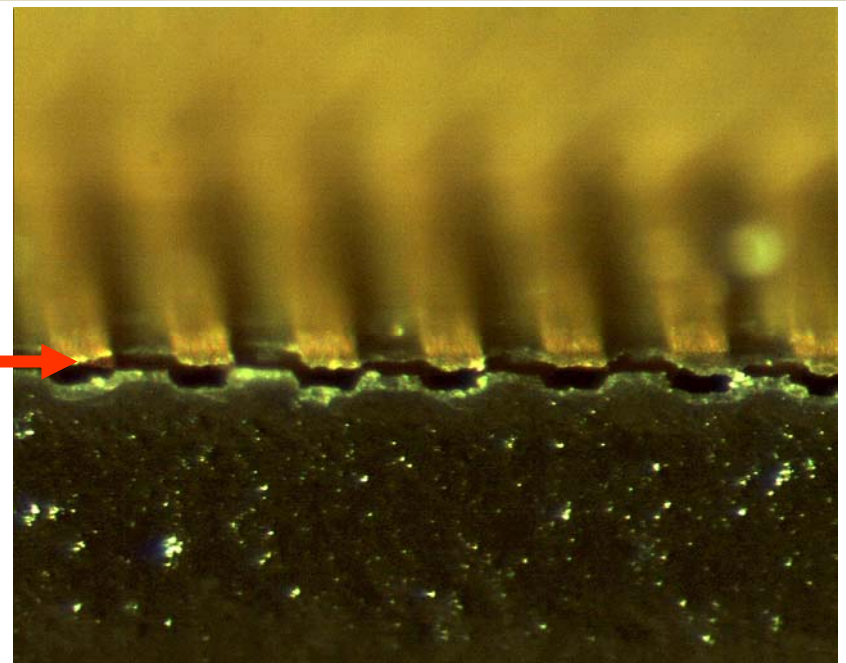
Failure of the wire bonds where they connect to the pitch adapter

- **The results verify that the wire bonds are broken at the pitch-adapter end, at the “ankle”.**
- **The results also indicate debonding of the encapsulant from the substrates in the affected regions.**

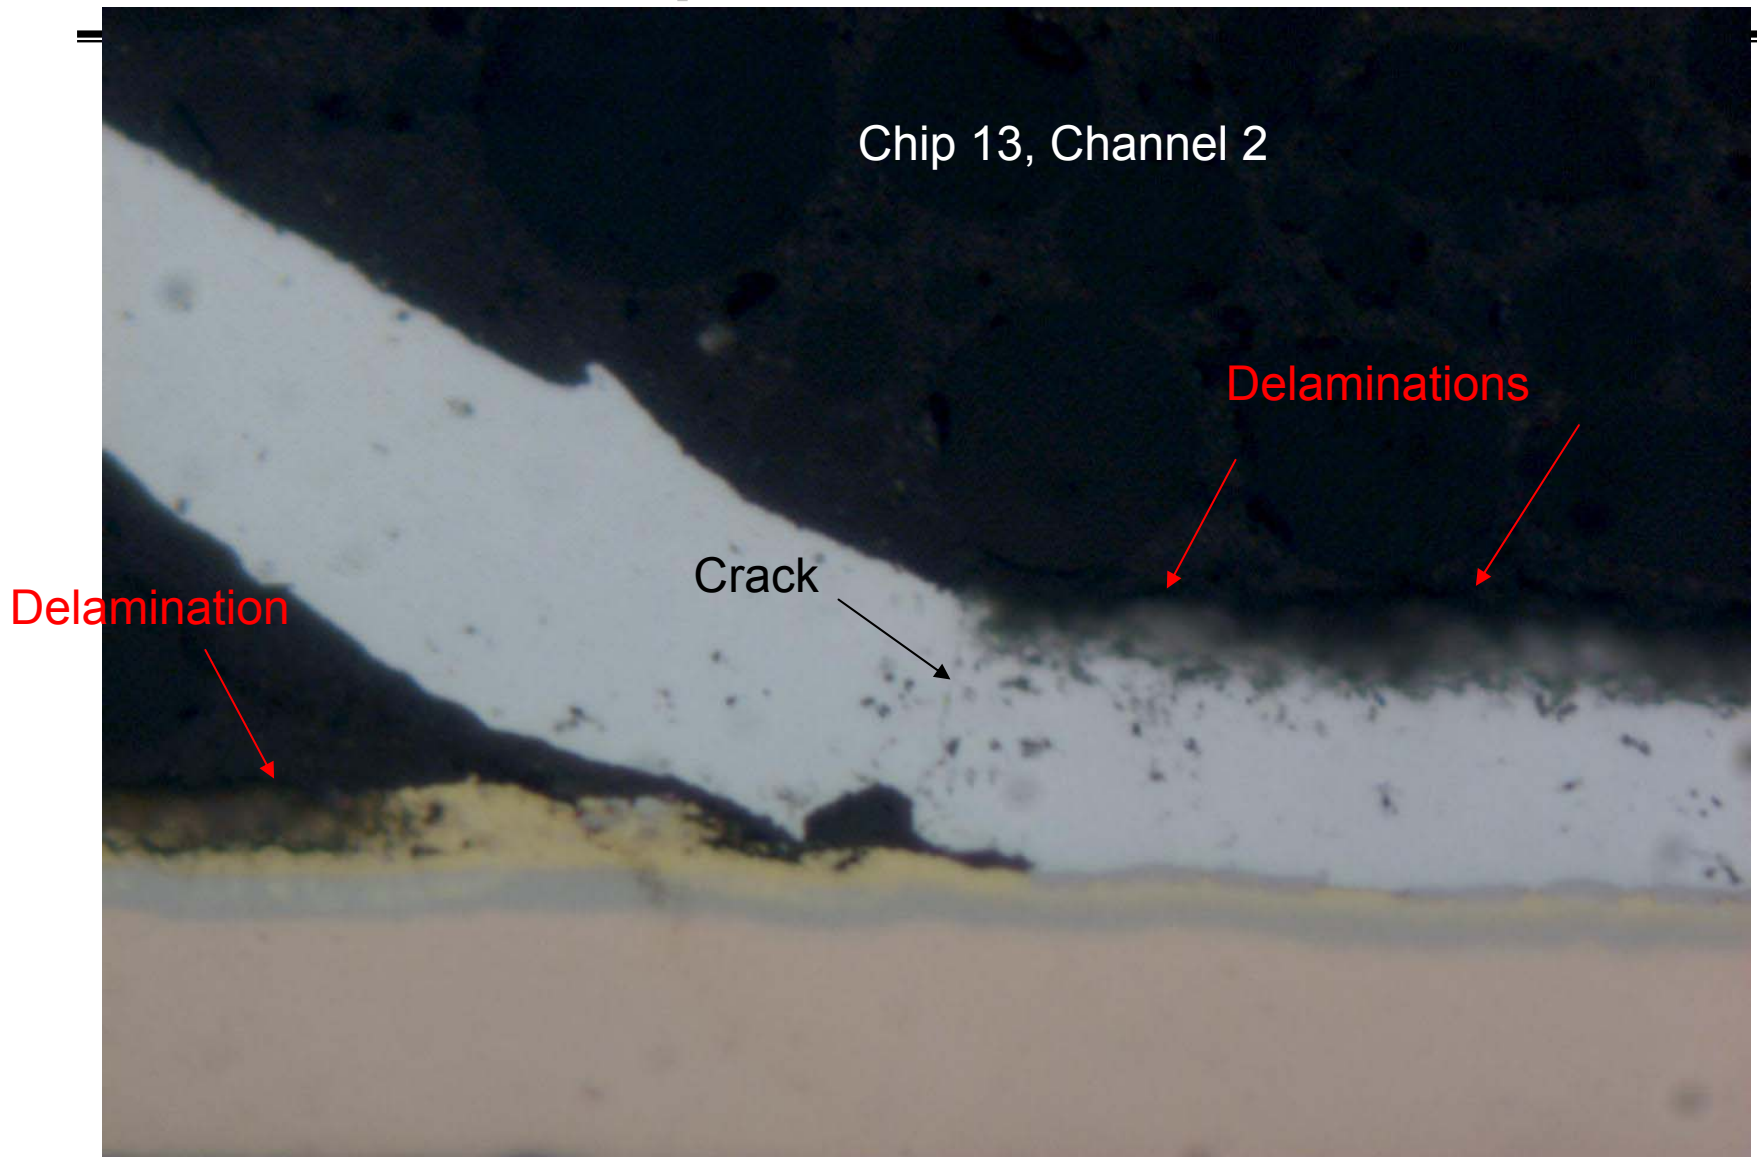
Example Wire Bond Crack

- **Source of the disconnected channels**
 - **Small numbers are from the cracked traces, verified by visual scans**
 - **Most are from broken wire bonds.**
- **The cause of the broken wire bonds is movement of the encapsulant relative to the pitch adapter.**
 - **This motion would not occur if the encapsulant remained well adhered.**
 - **This problem never occurs on the PWB side of the ASICs.**
- **The root cause of the encapsulation debonding needs to be better understood. Note that it does *not* happen on *all* MCMs.**
 - **Surface contamination?**
 - **Inadequate surface preparation?**
 - **Too much temperature range (+125C cure vs 30C test)?**

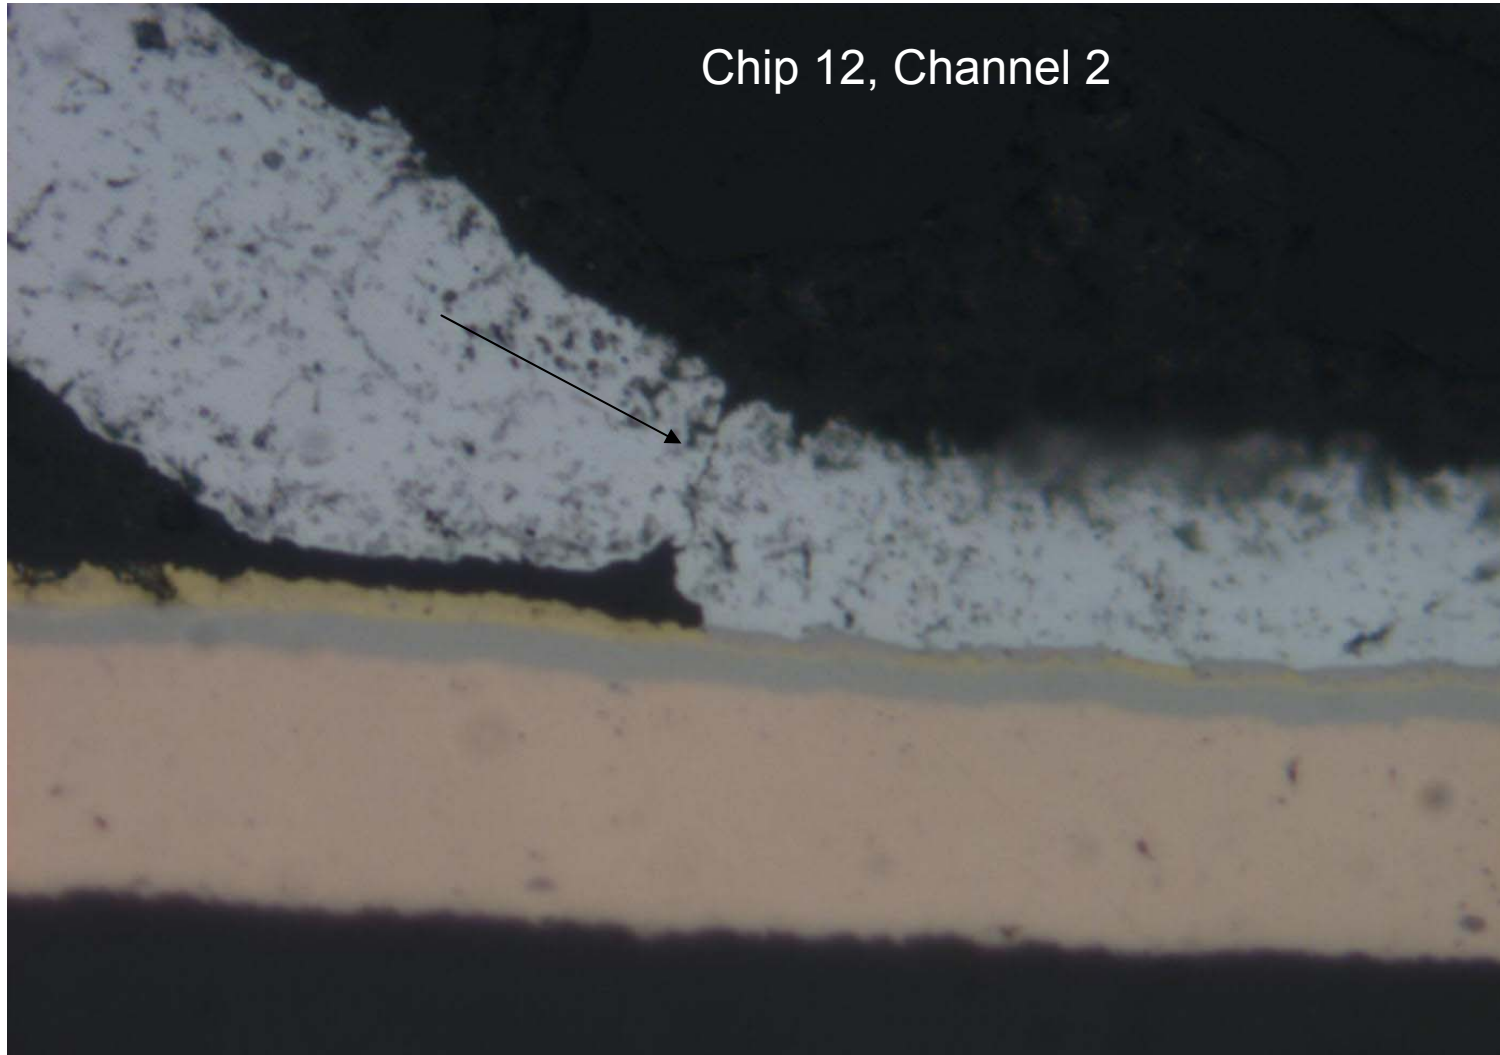
Chip 12, Channel 2

Another Example Crack

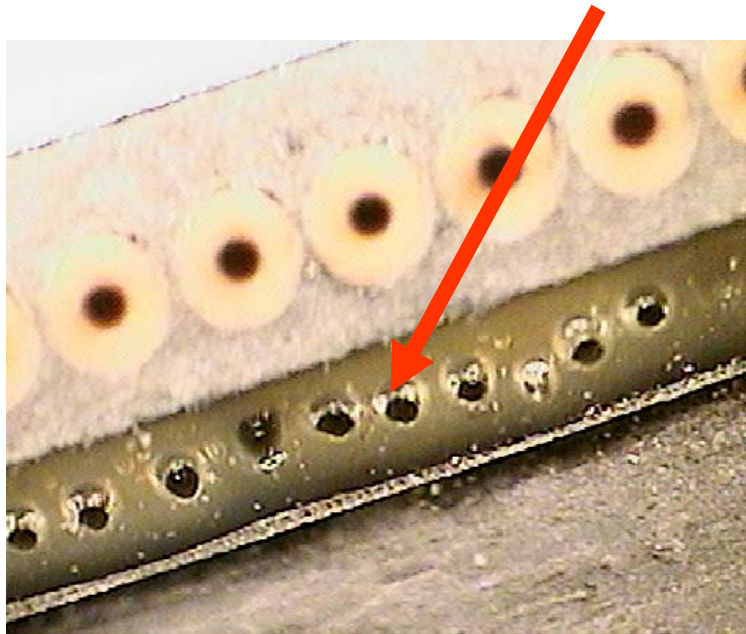
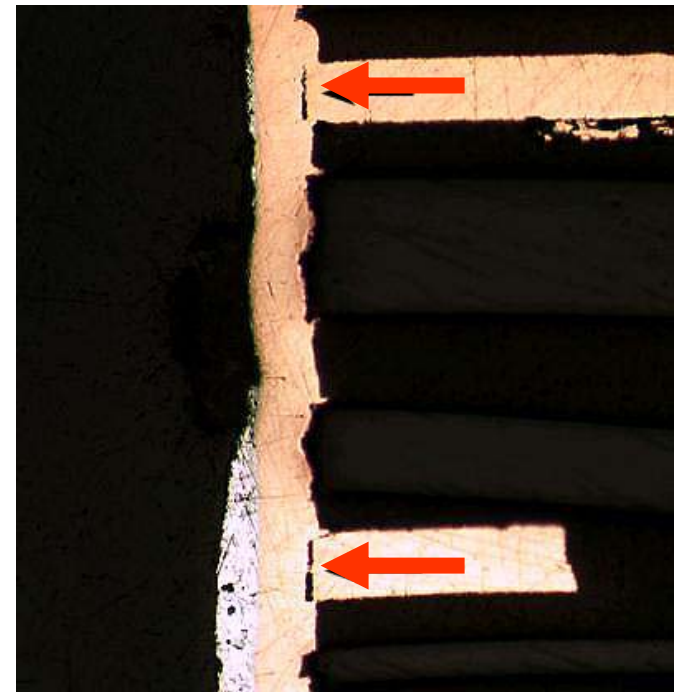
- **Two technical issues identified:**
 - **Bad coupon tests indicating separations between barrel plating and internal layers.**
 - **Bubbles in adhesive holding connector to cable**

- **Parlex**
 - **CAP developed for assembly process**
 - **Bubbles not a problem**
 - **Assembly is going forward**
 - **Production of new flex circuits still stopped**
 - **Root cause of bad coupons still not understood**
 - **Delivery schedule continues to be unreliable**
 - **Daily telecons**
 - **Biweekly visits from QA and tracker personnel**
 - **GSFC team to visit Parlex next week**
- **Currently installing cables in hand (with original plating process) to stay on schedule for Tower A assembly**
 - **Tower A will have lien to be resolved at a later time**
 - **Plan to also do for Tower B and beyond**
