GLAST Large Area Telescope

Systems Engineering

NCRs and Waivers Verification Status

Stanford Linear Accelerator Center

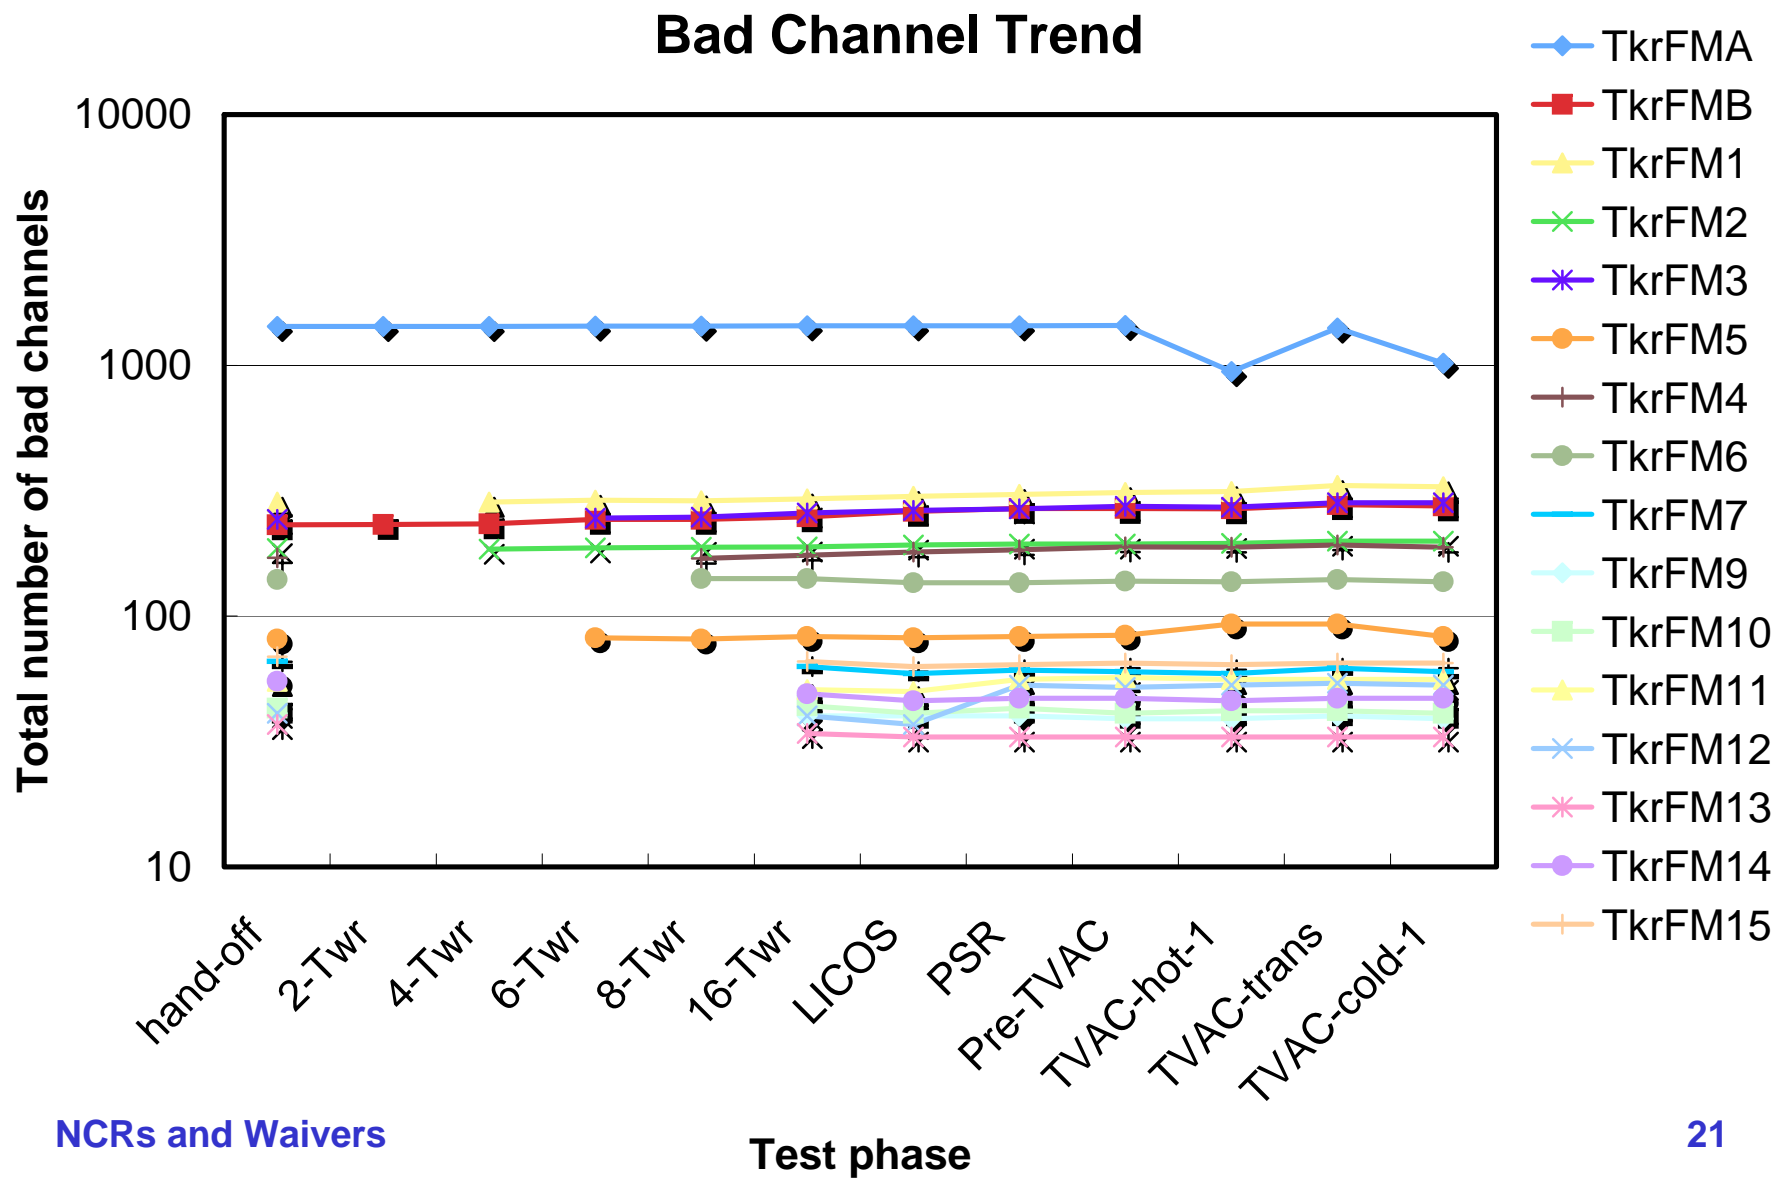
TKR Bad Strips - SLAC Trending, All Towers

- Three major categories:
 1. Hot strips:
 - Historically anything $>10^{-4}$ occupancy, but strips well above this level can still be useful and should not be masked unnecessarily!
 - Small numbers, with no trending issues.
 2. Dead strips: do not respond to internal charge injection.
 - Either a dead amplifier or a broken SSD strip connected to the amplifier (usually the latter).
 - Very small numbers, with no trending issues.
 3. Disconnected strips: broken wire bond or trace
 - between ladder and amplifier, mostly due to MCM encapsulation debonding from silicone contamination.
 - or between SSDs within a ladder, due to Nusil encapsulation debonding in thermal cycles.
 - The majority of the bad strips are in early towers, and the delamination definitely propagates somewhat with time.

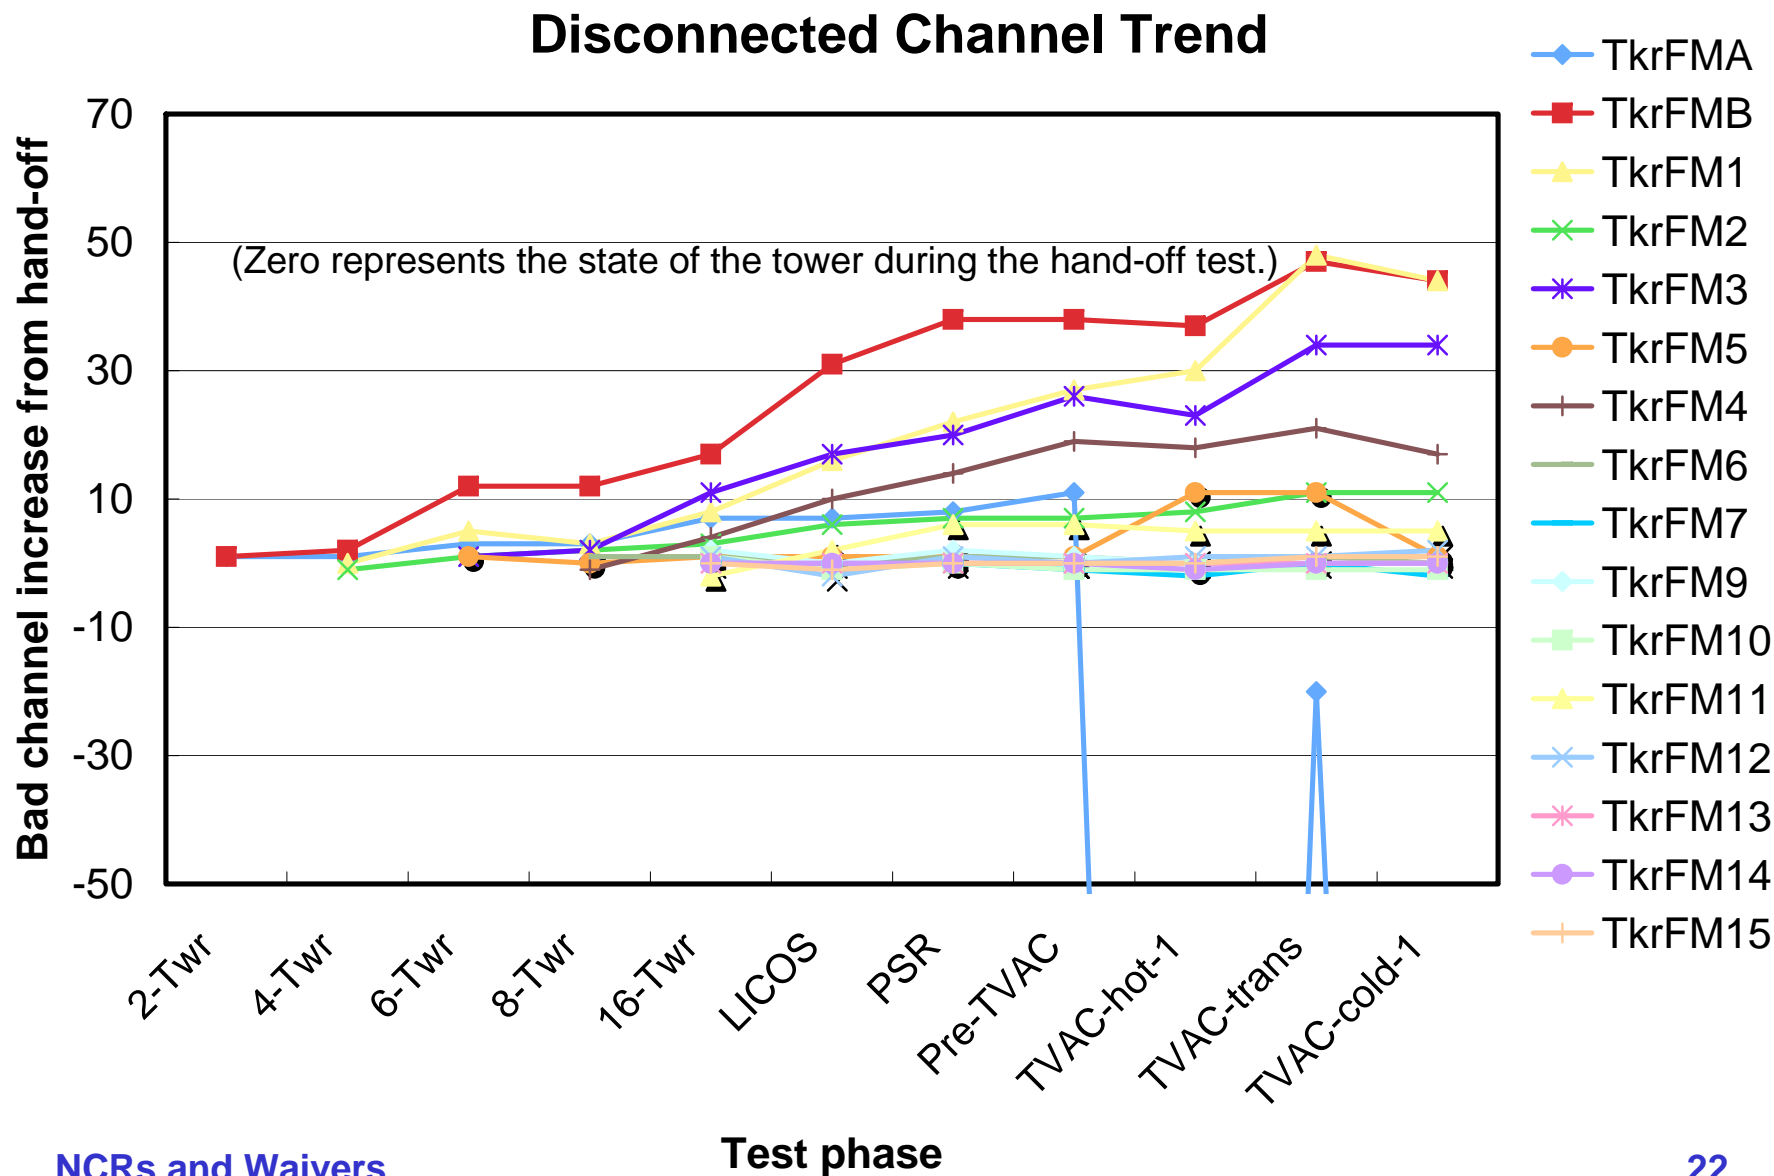
TKR Bad Strips - SLAC Trending

- The problem of encapsulation delamination has been well known and discussed for a long time, including the increase during Tracker T/V testing, but the project elected to use the affected MCMs as-is because of

- Nothing is different today:
 - There is some evidence that the problem areas have expanded very slightly during LAT integration, but
 - It is impossible to be sure at any time what channels are really disconnected, because the wires in delamination regions often make electrical contact even when the mechanical bond is gone. Many channels of the channels that appeared to be new disconnects at SLAC, were observed to be disconnected during TKR TV testing.

- No disconnected channels have appeared in previously unaffected regions of MCMs.
 - We can expect that the problem regions will expand during LAT environmental testing, but if comparable to the Tracker environmental testing, the degradation will not be significant with respect to science performance.
