# SEM Exam of Parlex Drilled Hole Samples for GLAST LAT Tracker Flex Cables

Dr. Len Wang/541

December 1, 2004

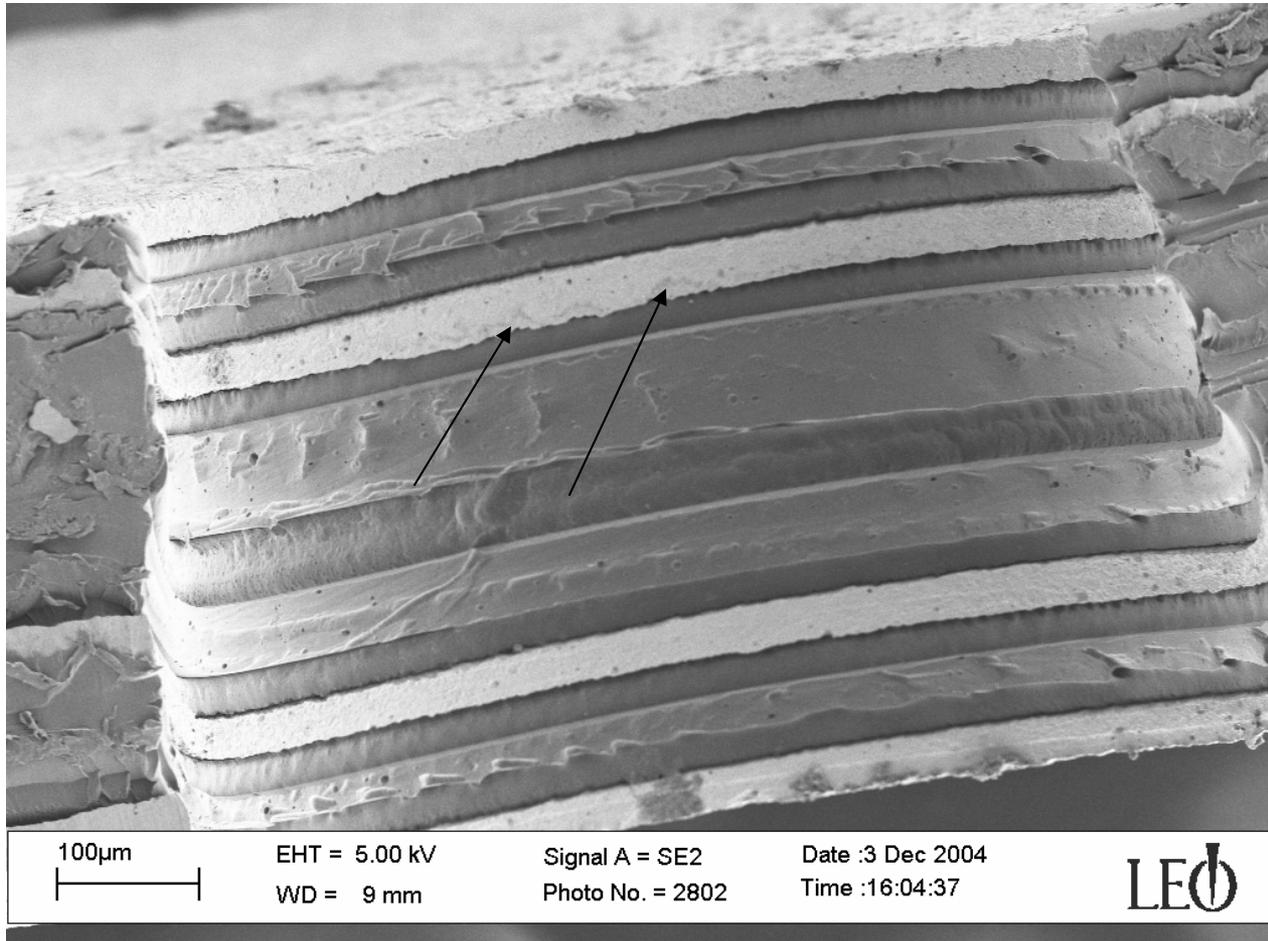
# SEM Image Sample #3M with Oxide

- Samples after microetch process (i.e. plasma etched then microetched) displayed oxide rich particles (see slide 9) on sample holes which had not been 'water blasted'—sample holes identified as '3M'. One of the six '3M' holes examined in the SEM contained oxide rich regions which were covering considerable areas on the internal foils (see slides 6-8).
- Samples after microetching with water blasting process, i.e. '2M', added were not found to contain oxide rich regions or particles following SEM exam of 6 holes (both halves of hole examined for all of these). Slide 10 illustrates one such sample area

Arrows indicate oxidized regions on inner foils, see slides 7 & 8 for magnified images

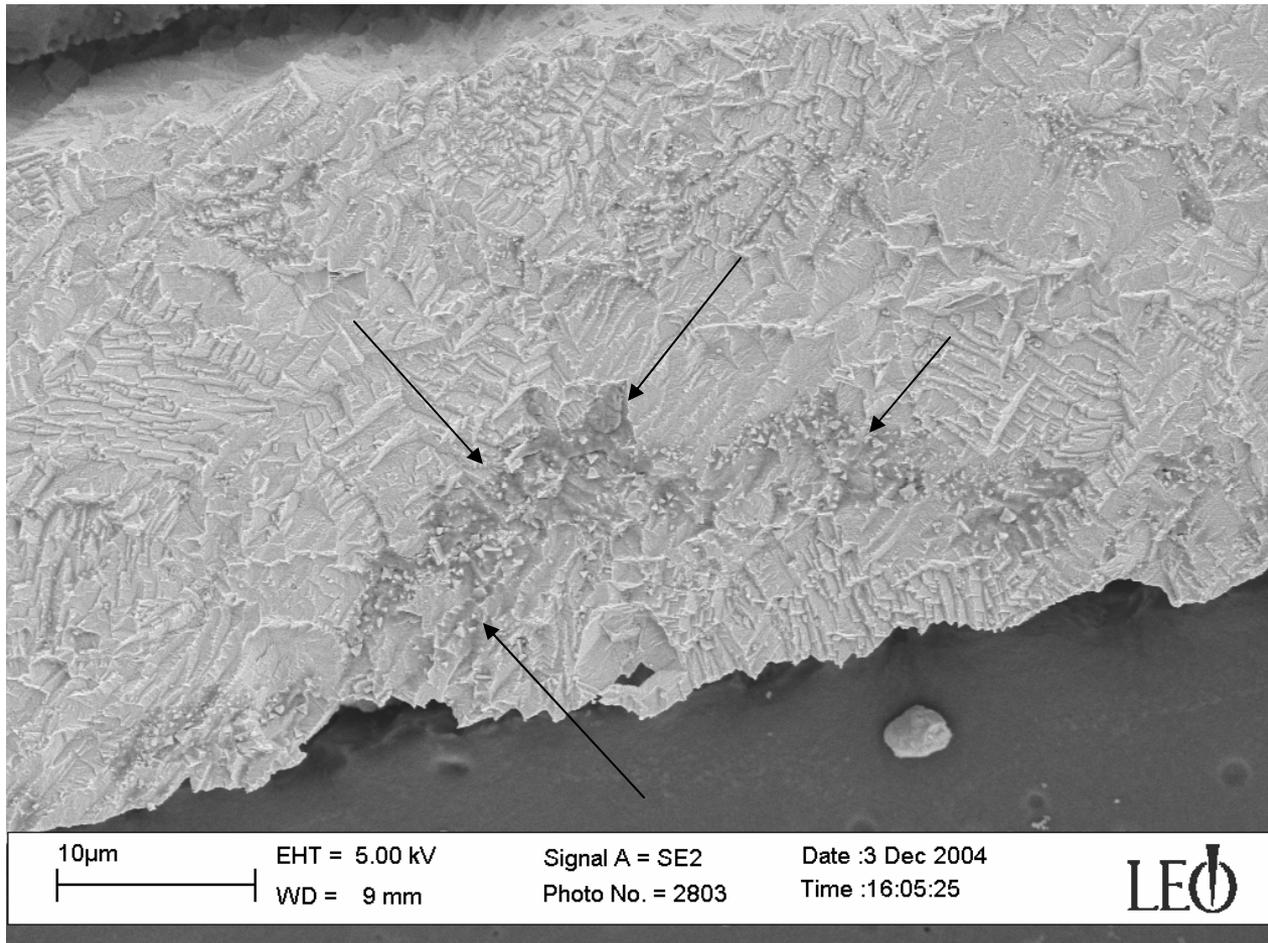
# SEM Image Sample #3M with Oxide

Arrows indicate oxide deposits on inner foils

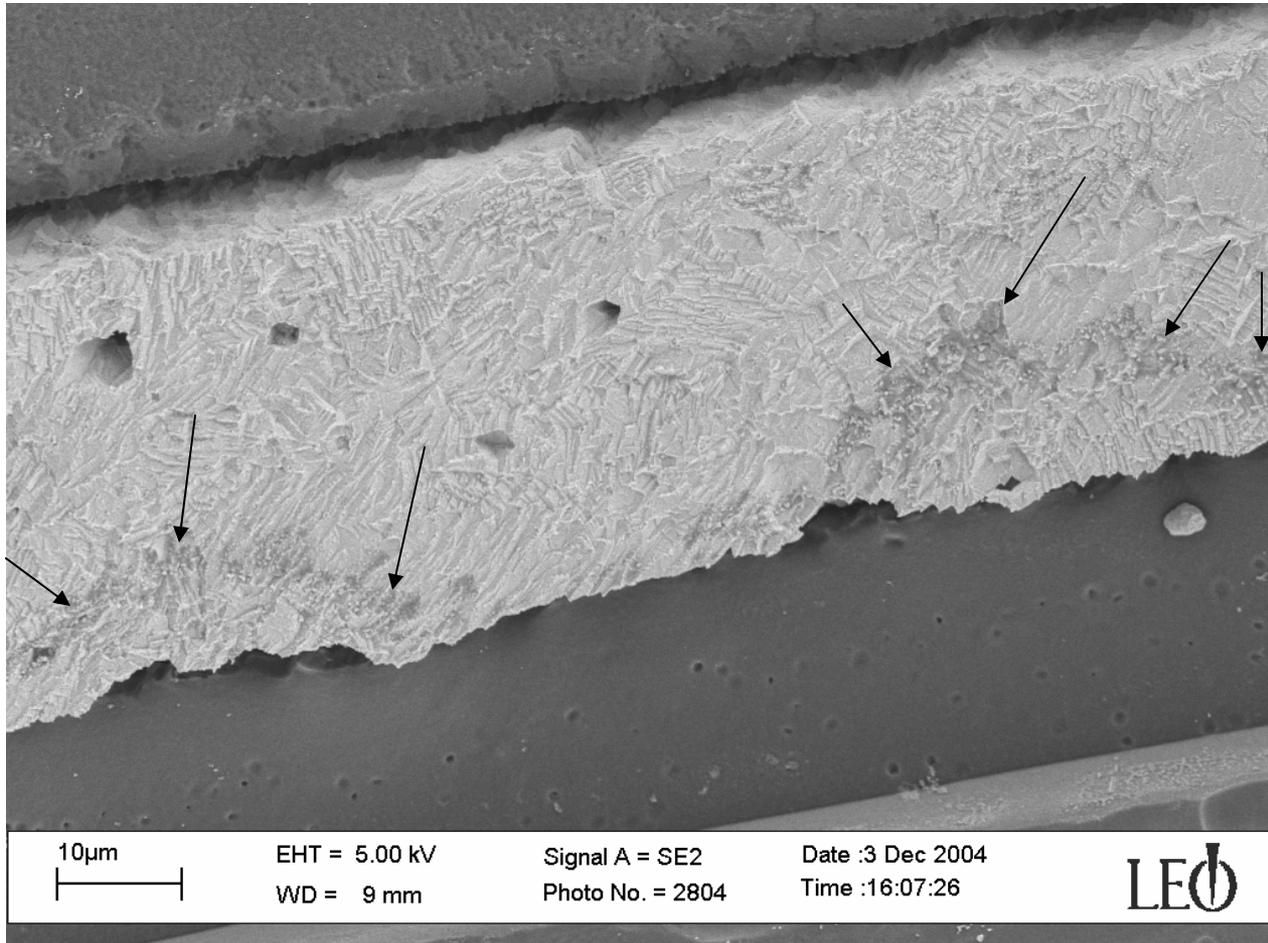
# SEM Image Sample #3M with Oxide

Arrows indicate oxide deposits on inner foils

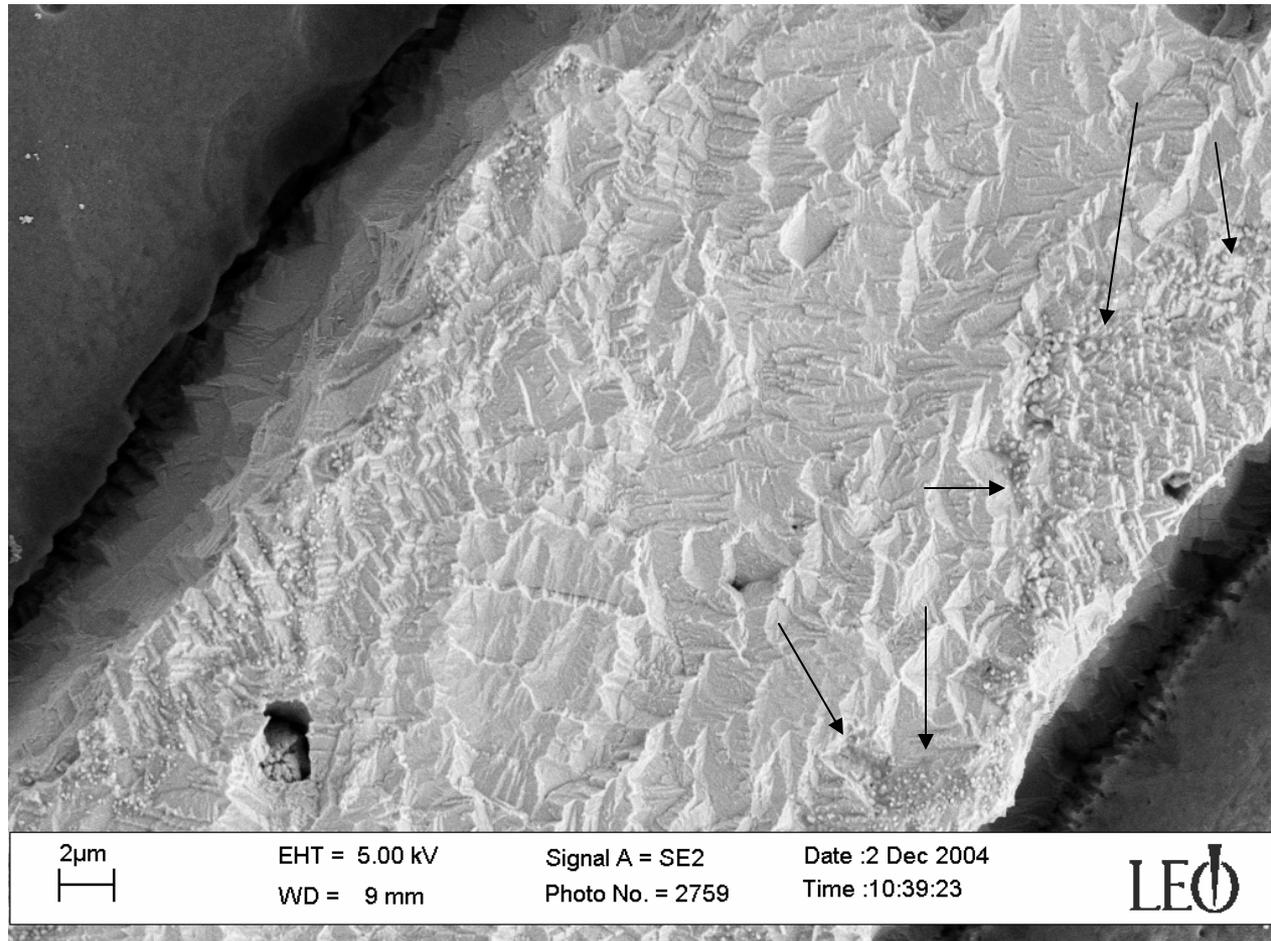
# SEM Image of Sample # 3M

Arrows indicate regions of oxide particles on inner foils after microetching

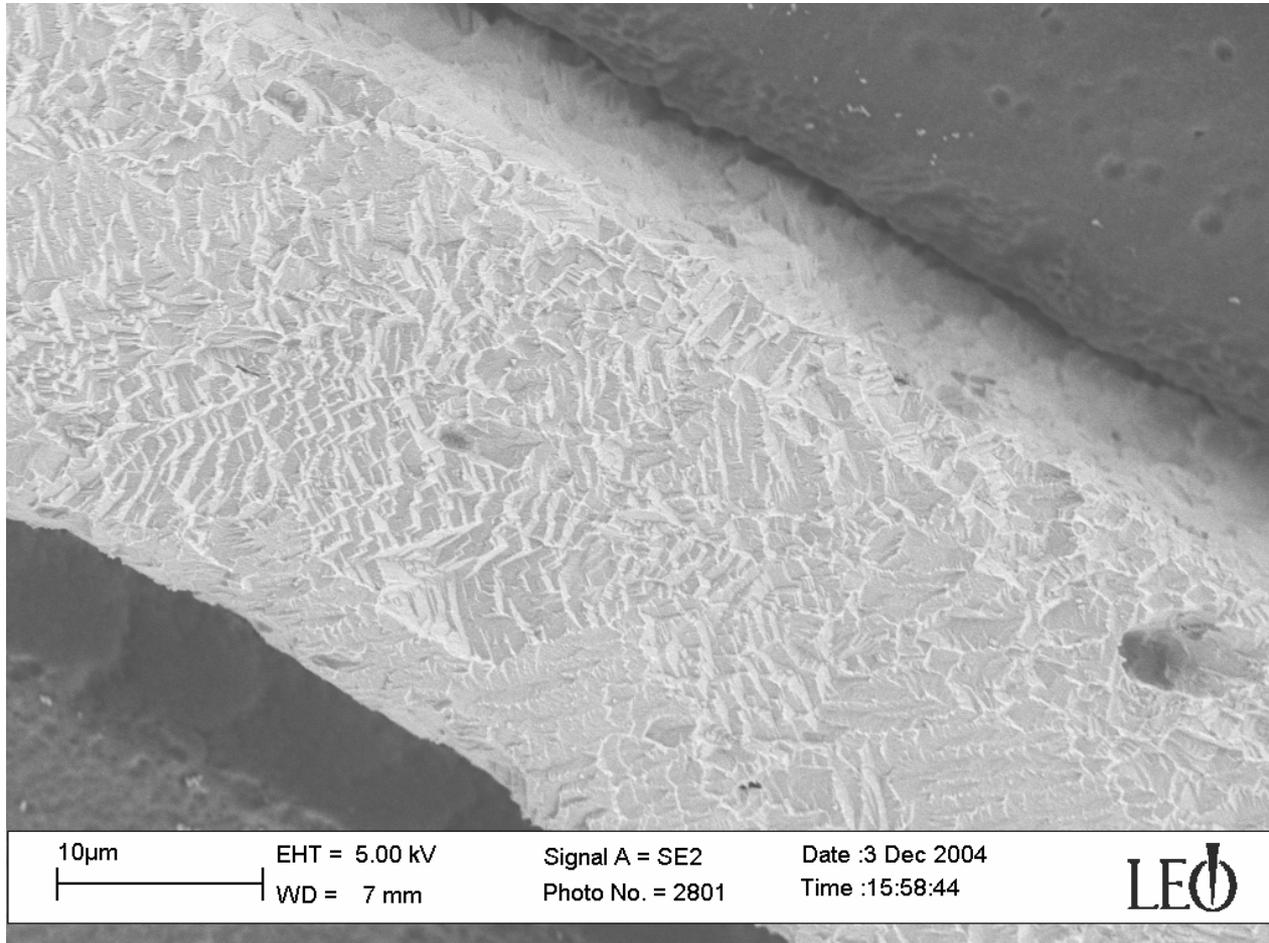
# SEM Image Sample #2M—No Oxides

Water blasted inner foils show no oxide contamination after microetching

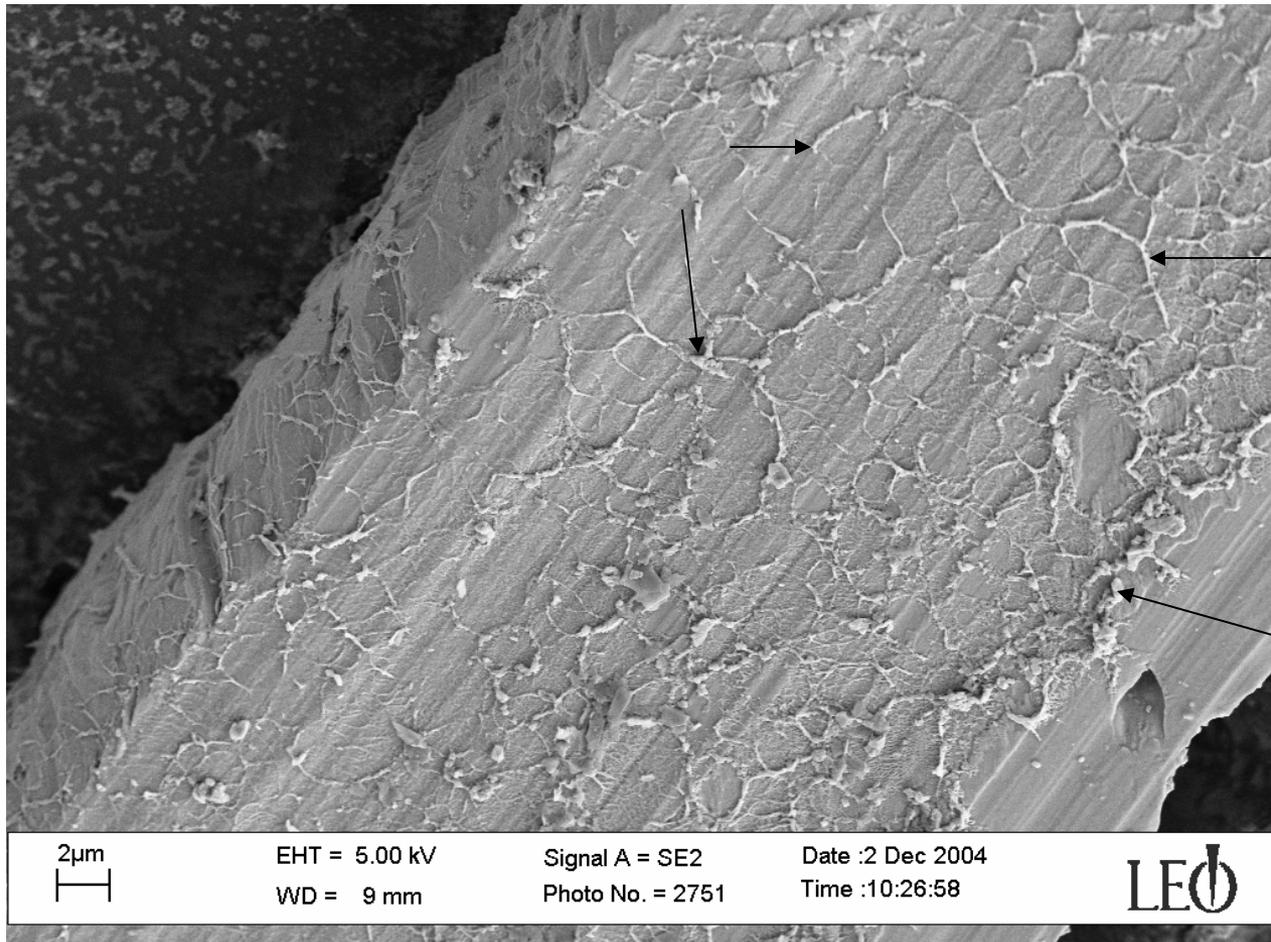
# SEM Image Sample # 2P—teflon deposits

- Plasma etched sample holes both with- and without-water blast process displayed a fibrous network of debris with high Fluorine content (Teflon-like material) see slide 11. Water-blasting process appeared to disperse but not remove these. None of these deposits were present after microetching so it appears the microetch was successful in removing these
- Outermost region of outer foils were found to contain considerable contaminants (see slides 12-13), but this was likely handling and only occurred on those foils at edges of the board surfaces. This finding was discounted as the cause for the failures since the separations observed in the microsections were on the internal foils.

Surface deposit on inner foils, EDS analysis indicated high F content

Note: Microetching appears to have removed this contaminant

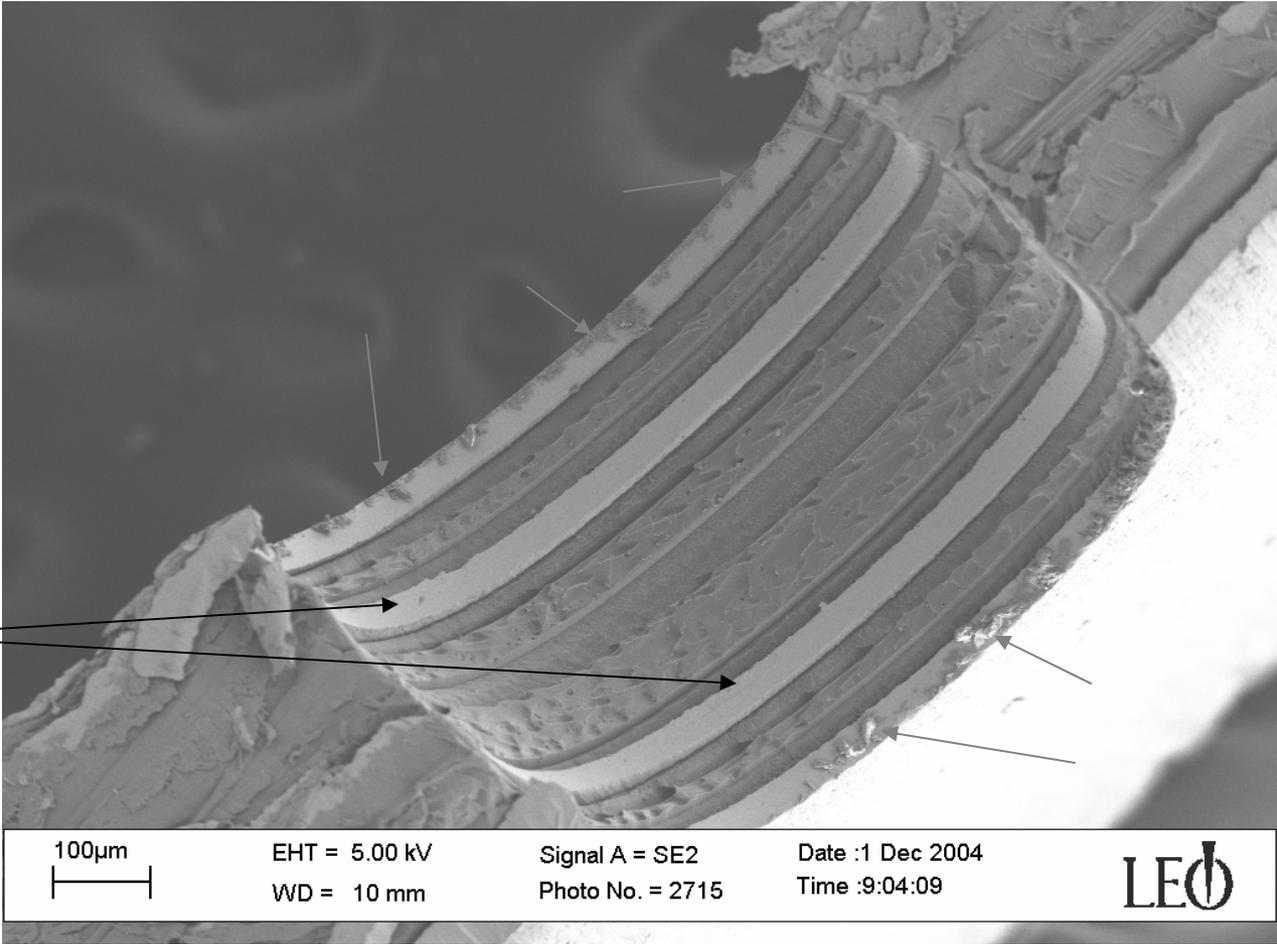
# SEM Image of drilled hole Sample #3P

Contamination on outer foils indicated with white arrows, note absence of material on inner foils

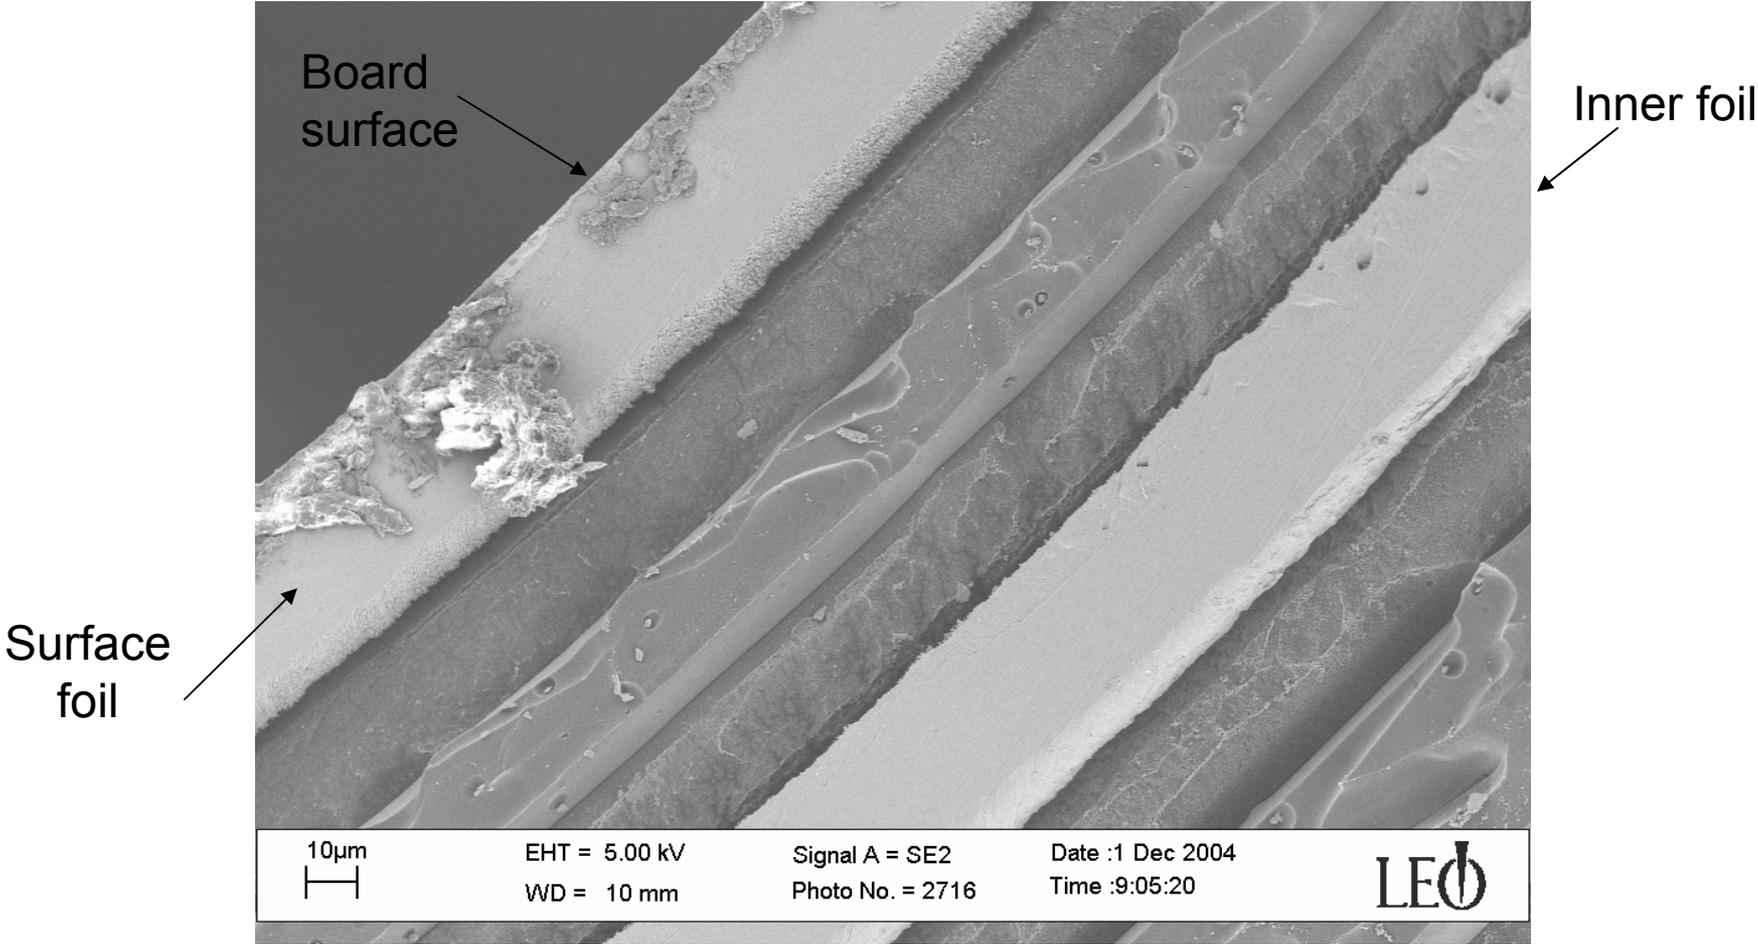
# SEM Image of drilled hole Sample #3P

Note smooth foil surface on typical processed foils, contamination of outer foils at board surface
