Open Issues

Tower Zero Assembly Activities

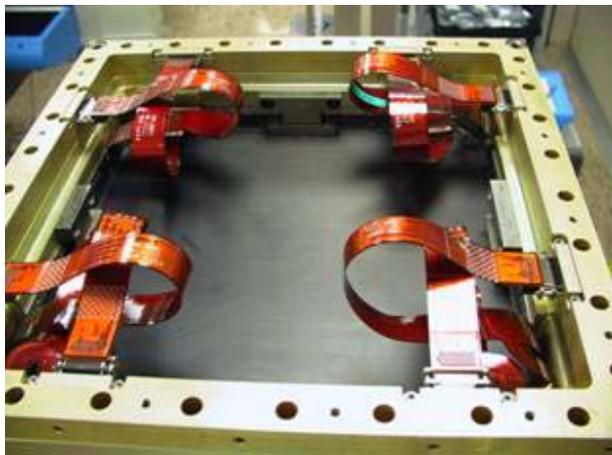
Figure 1

1. Cables on Cable Holding Plate are twisted (figures 1 and 2). Concerns about this configuration during vibe tests.
2. Modification of Cactus Arm bending tool required.

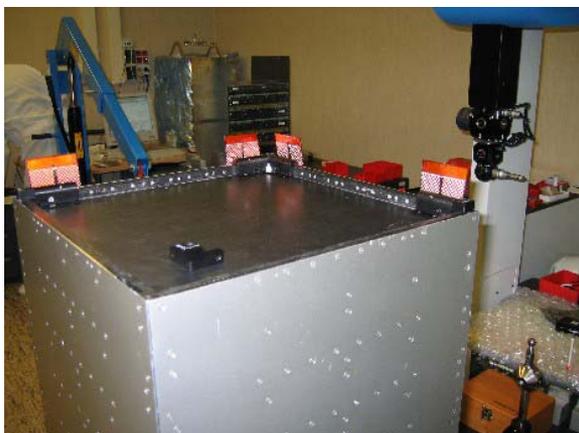
Figure 3

5. Improve assembling of Top Bracket and Cables Top Bending (figures 3 and 4):
 - Tape needs to be placed over the gaps between the closeouts on the top tray and the sidewalls to prevent object falling.

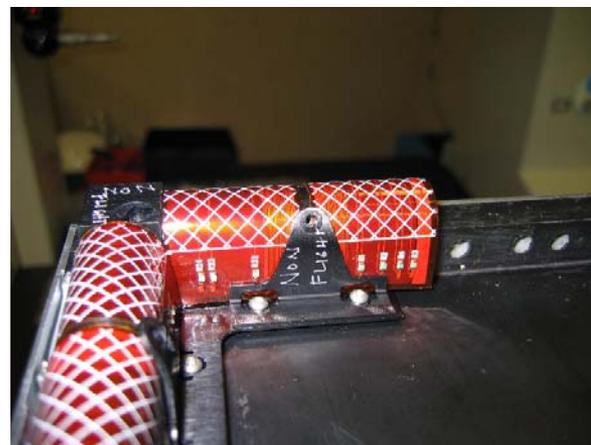
Figure 4

- Care needs to be taken to push the cables all the way against the clip when placing the mid screw.
 - After pushing the cable down there was no more interference and the third screw could be installed (figure 4).
