## TMCM stick out problem

A.Brez

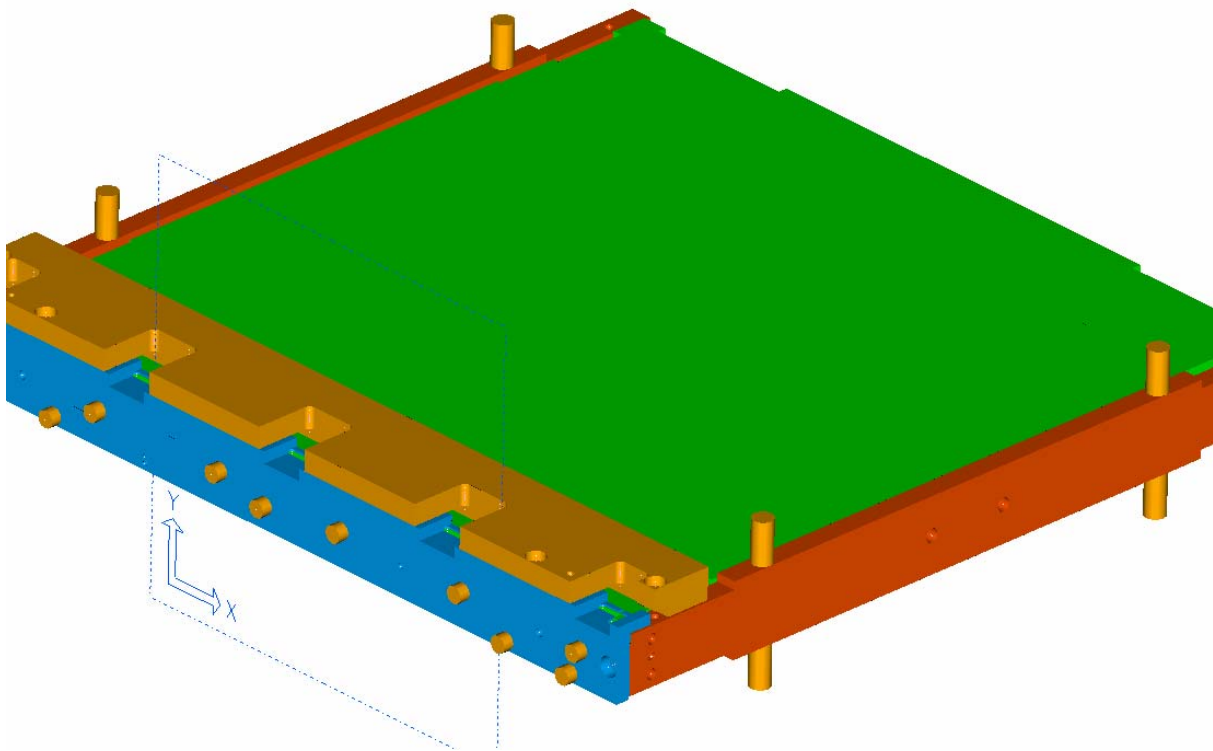
fig. 1. The tray with the TMCM assembly jig.

1. the way the tool was used, caused a frequent block of the horizontal bar (gold bar in fig. 1) against the bias circuit surface
2. the adhesive used to glue the fixation pin could overflow between the flange and the tray surface.
3. the bond line was inspected only from the top side. The inspection could not identify the connectors sticking out.
4. the flange thickness was 0.3mm, reducing the stay clear to 0.1mm
5. the thermal boss thickness was  $4.2\text{mm} \pm 0.1\text{mm}$ . The stick out of the connectors does not depend on this tolerance

Changes in the G&A Engineering procedure have been discussed to avoid the tool blockage against the bias circuit and to guarantee no adhesive between the fixation pin flange and the closeout wall. The LAT-PS-01801 procedure and the G&A Engineering internal procedure will consider a CMM check of the position of the connectors to guarantee that the connectors do not stick out from external closeout surface.

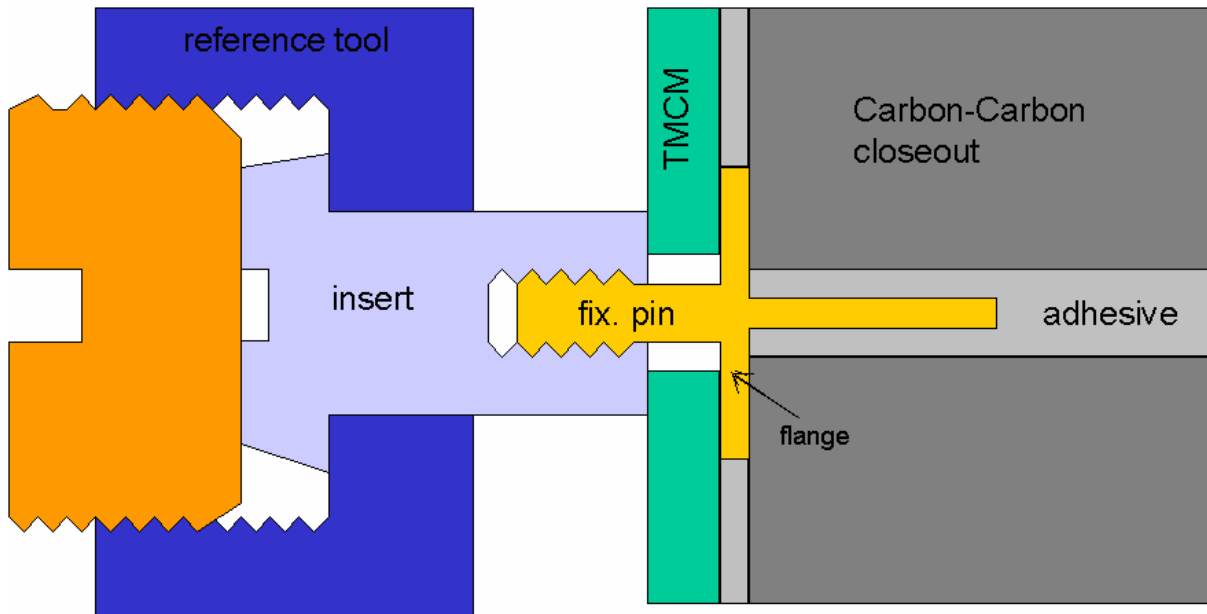
**fig.2 Fixation pin assembly scheme.**

A new set of fixation pins with 0.2mm flange will be produced.

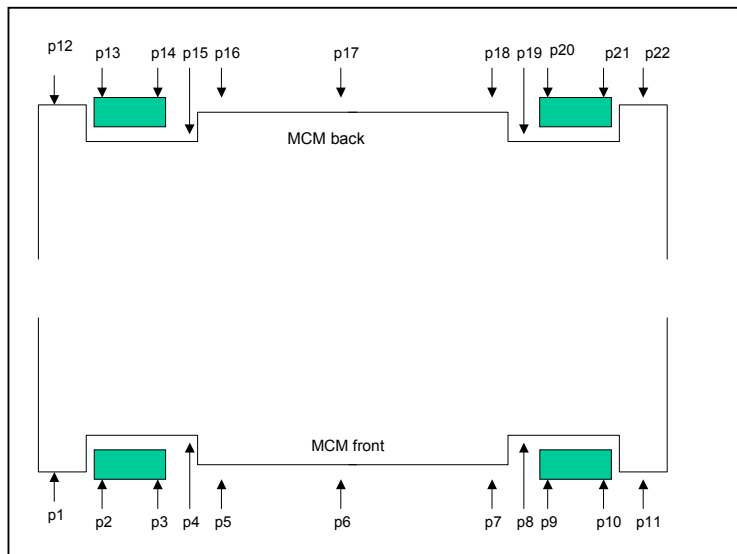
A first group of trays have been measured with a CMM following the scheme in fig.3

**Fig.3 measured points**

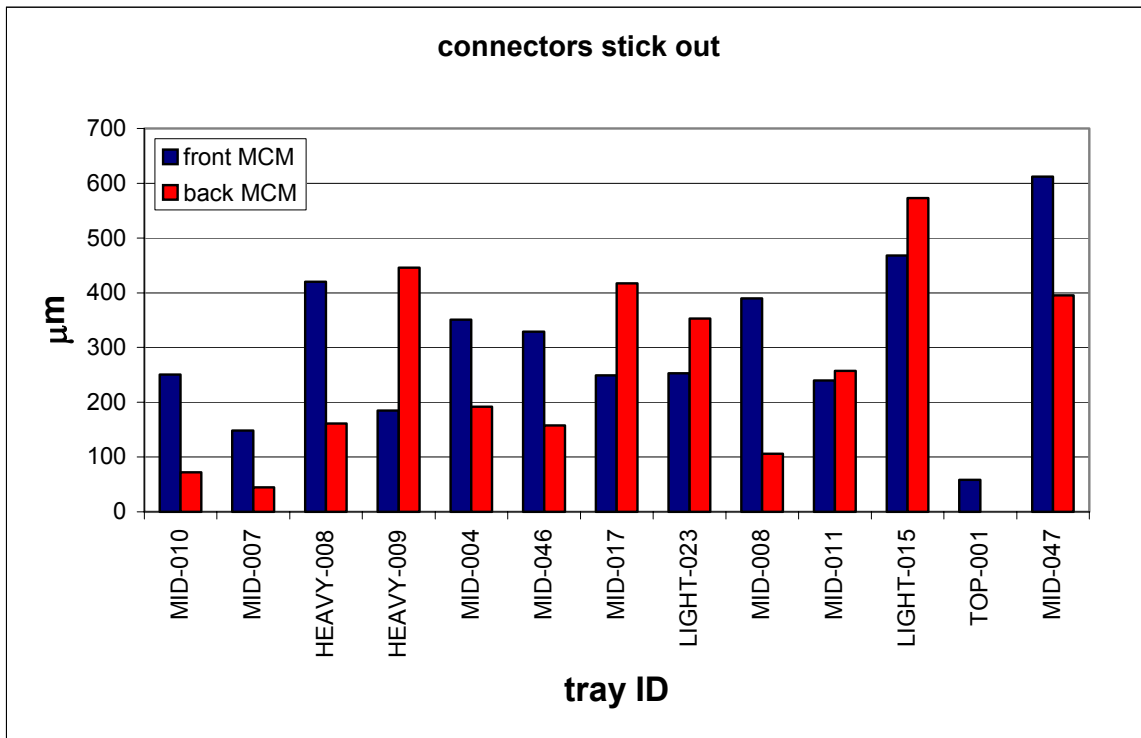
The max stick out of the connectors on both sides of a first set of trays has been measured and plotted in fig.4

fig. 4 the max stick out of the connectors on front and back side of the trays
