# **MRB on MCM Leakage Current Problem**

**Tom Himel**

**SLAC**

**February 4, 2005**

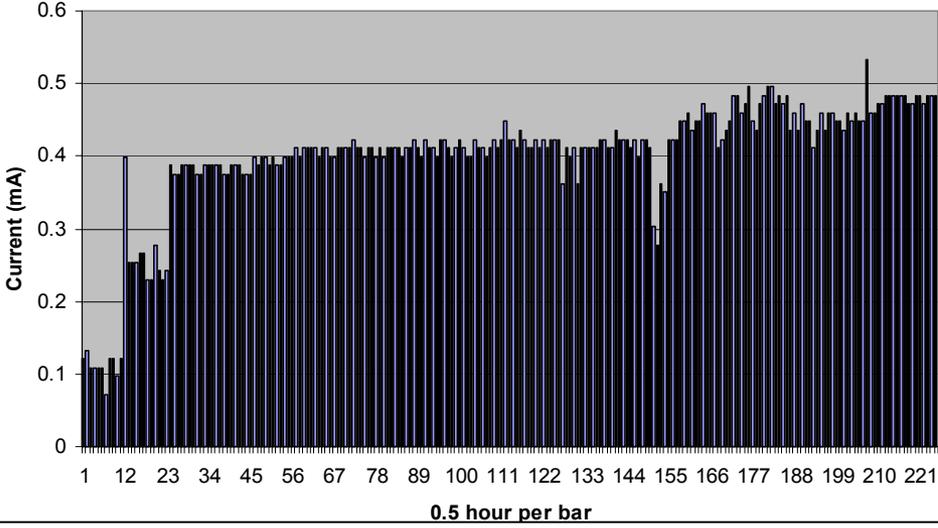
**Burn in of 6/21/04 with SN 644**

- ✦ The burn-in is done for 7 days at 85° C with 120 V between layers 7 and 8.
- ✦ 36 boards are done in parallel. The total bias current of the 36 boards is recorded.
- ✦ Batches with failed board(s) show a current increase after 2, 3.5, 4, 6, 10, 20, and 75 hours of the 168 hour burn-in.

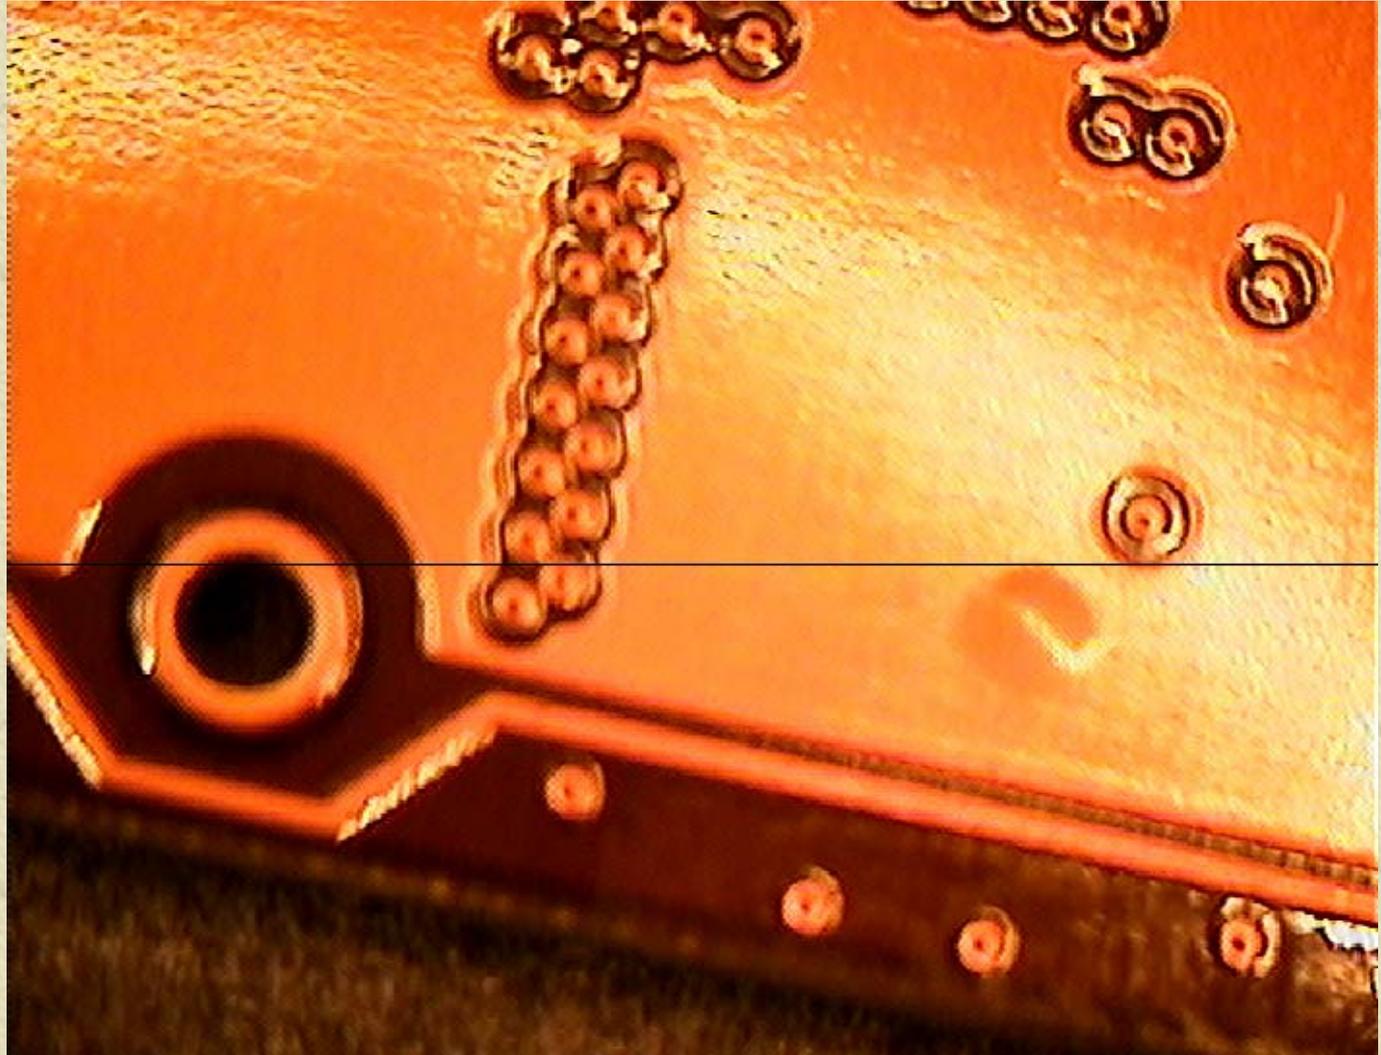
# DPA – blister in SN 688 after amps passed through it

- ✦ 6 of the 8 boards had the problem site located by putting several amps of current through them (bypassing the 270k resistor).
- ✦ This showed the problems were in random places, not by vias.
- ✦ One of these was sectioned, but the damage seen is properly attributed to the heating from the large current.

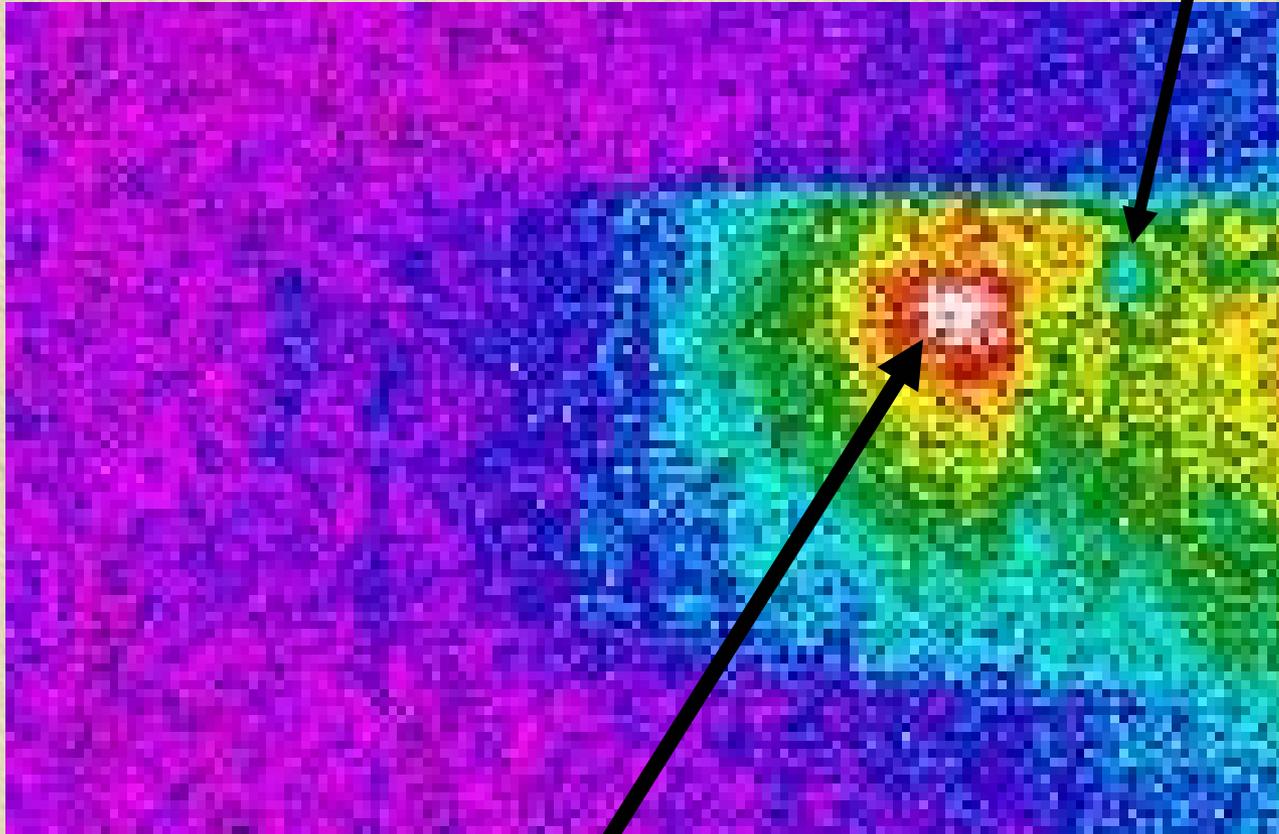
Hot Spot 1.2°C

Infra-Red image of SN 612 short provided by Jack Shue/563 from IR test results.

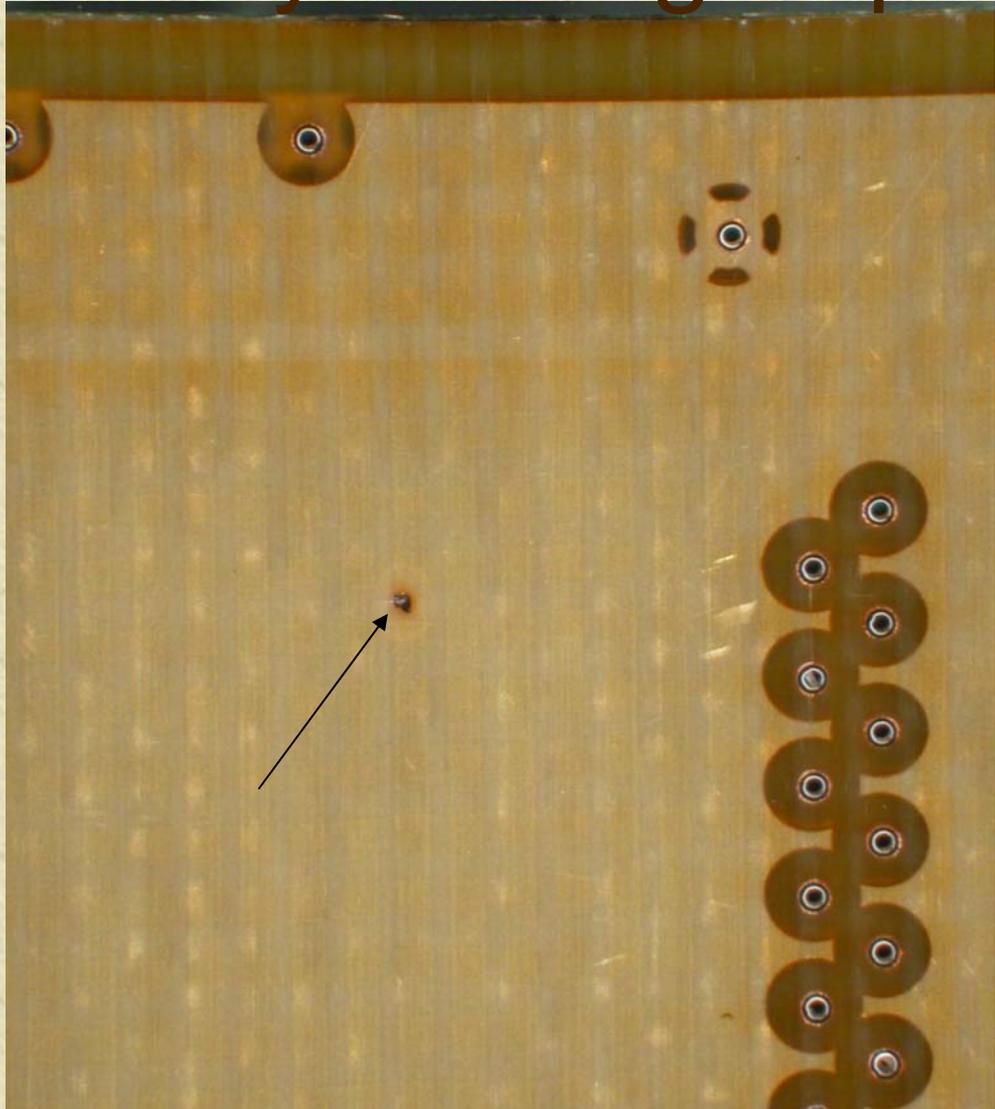
The copper of layer 8  
was polished off.

Low magnification image of particle within laminate between layers 7 & 8 for  
SN 612

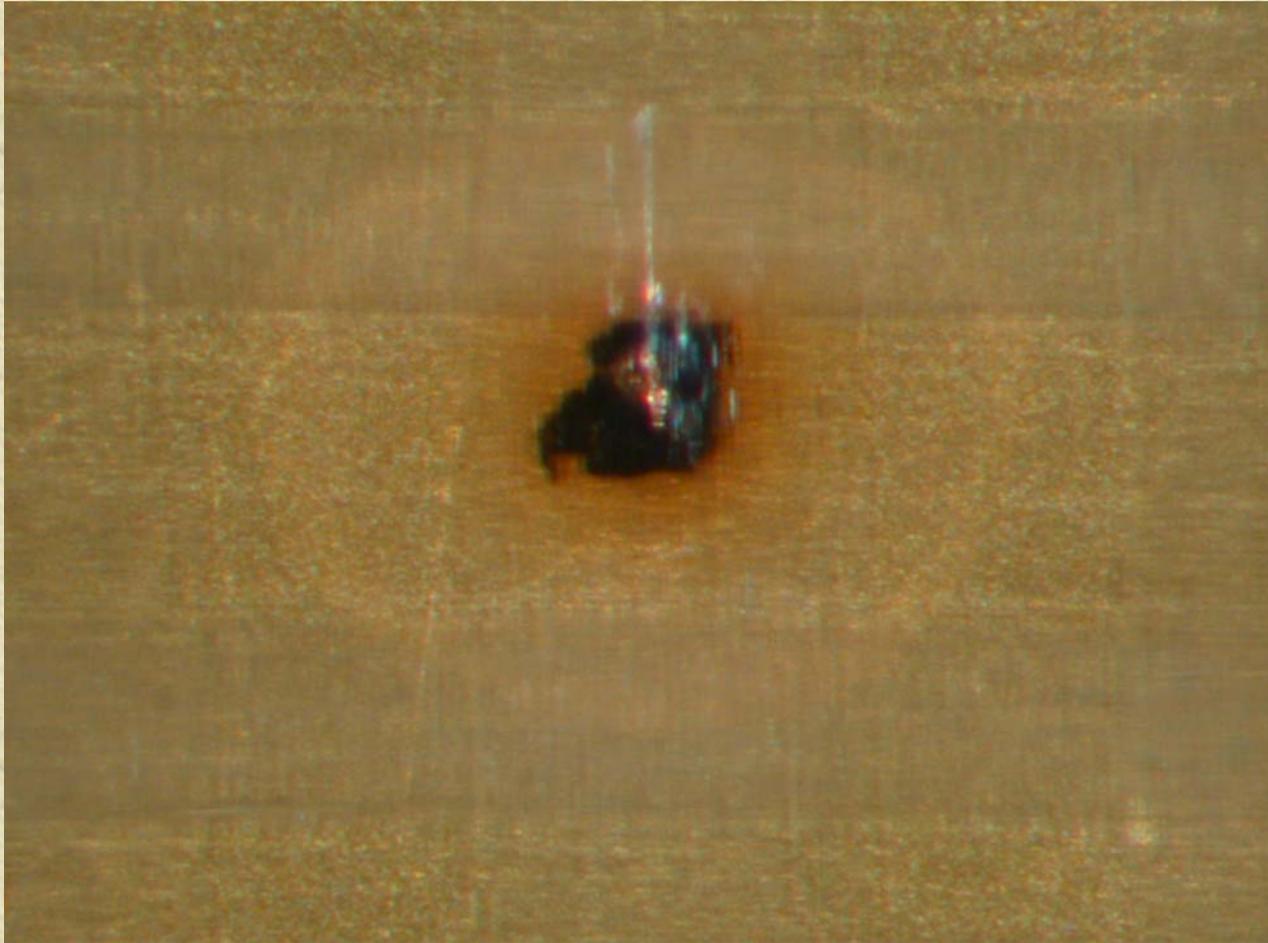
Magnified image of particle between layers 7 & 8, note copper color

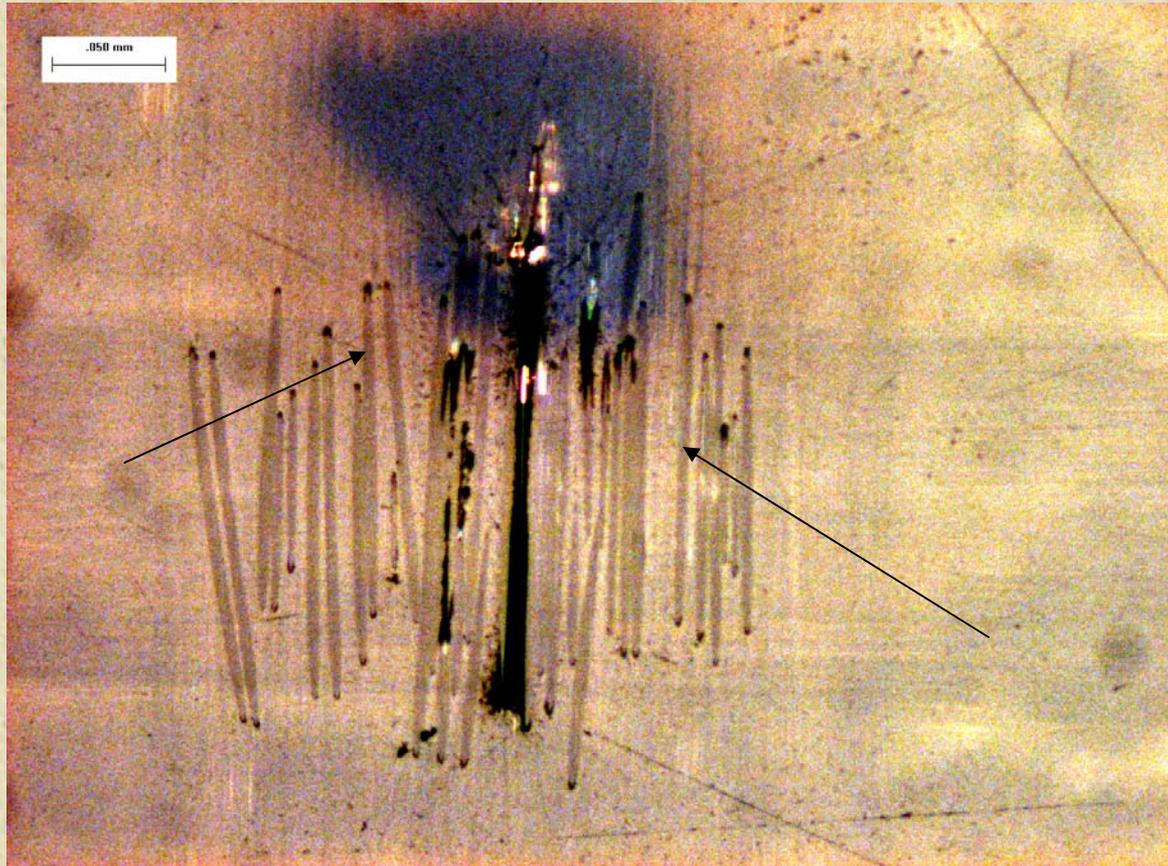
Optical surface image showing copper particle protrusion through polished surface just below layer 8. Arrows indicate shadow of subsurface particle shown in previous slides. Linear pattern in vertical direction are exposed laminate fibers

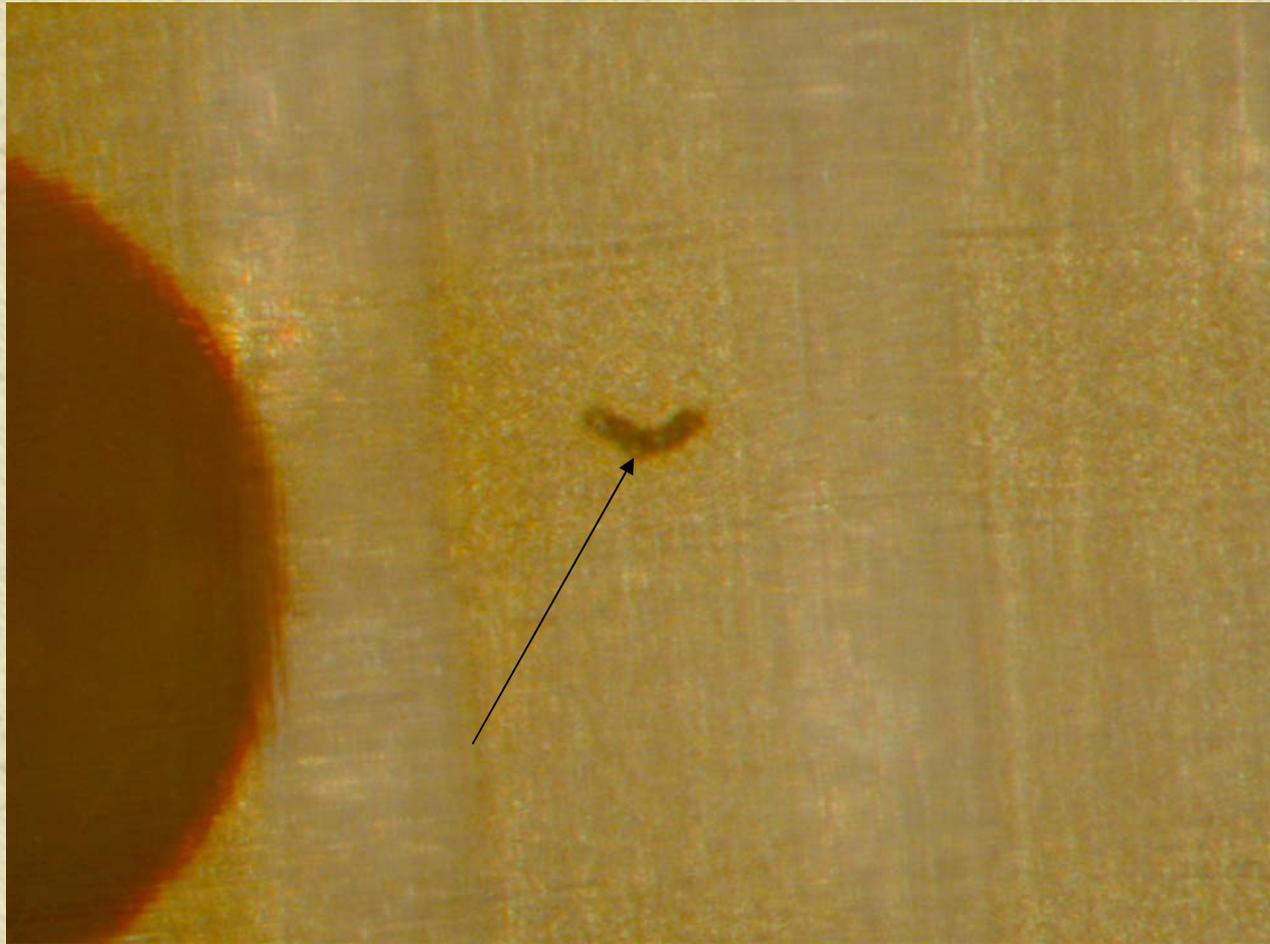
Arrow indicates additional particle in SN 612 section laminate.

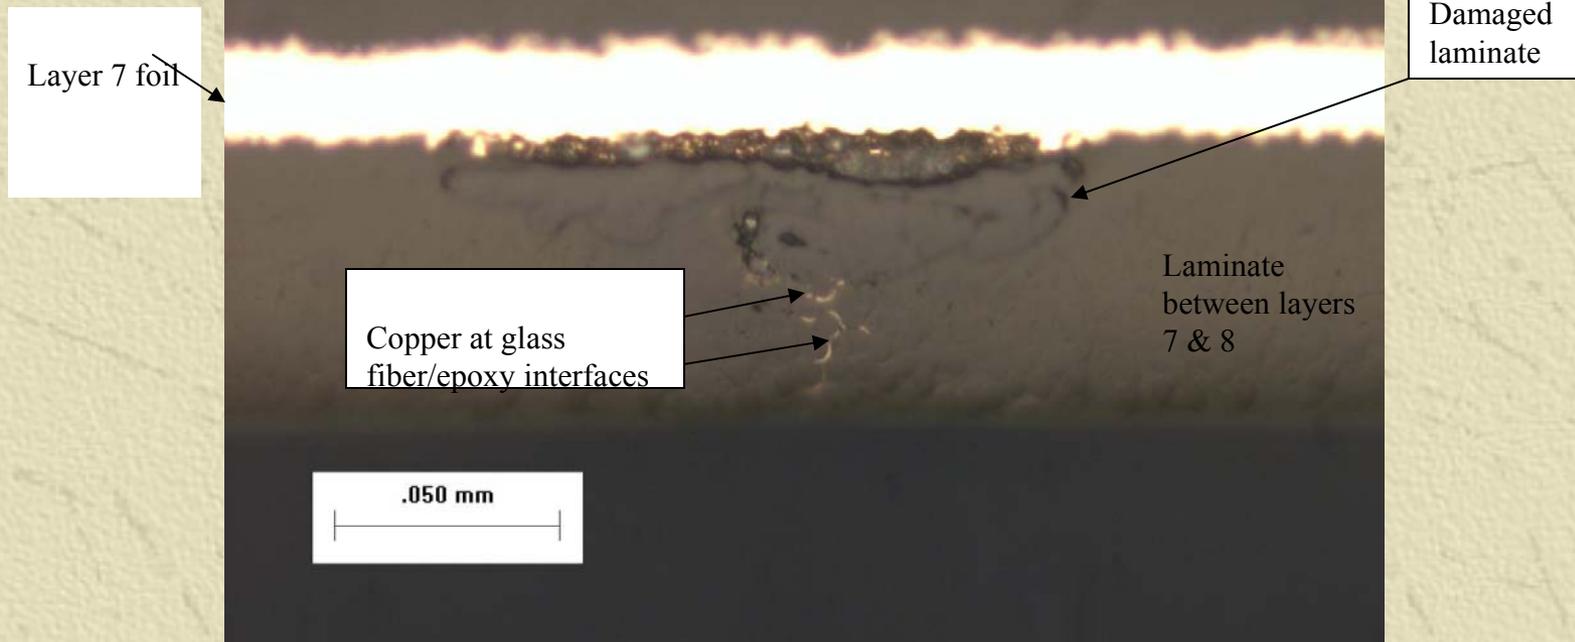
The side section (profile of the copper particle) shows considerable laminate damage adjacent to the central area which has copper deposited among the glass fibers of the board section. I will be checking with Henning's friend at CALCE to determine whether this is CAF, but I think the copper deposit is too thick to be that mechanism. May have been deposited by the same occurrence which heated the adjacent laminate.

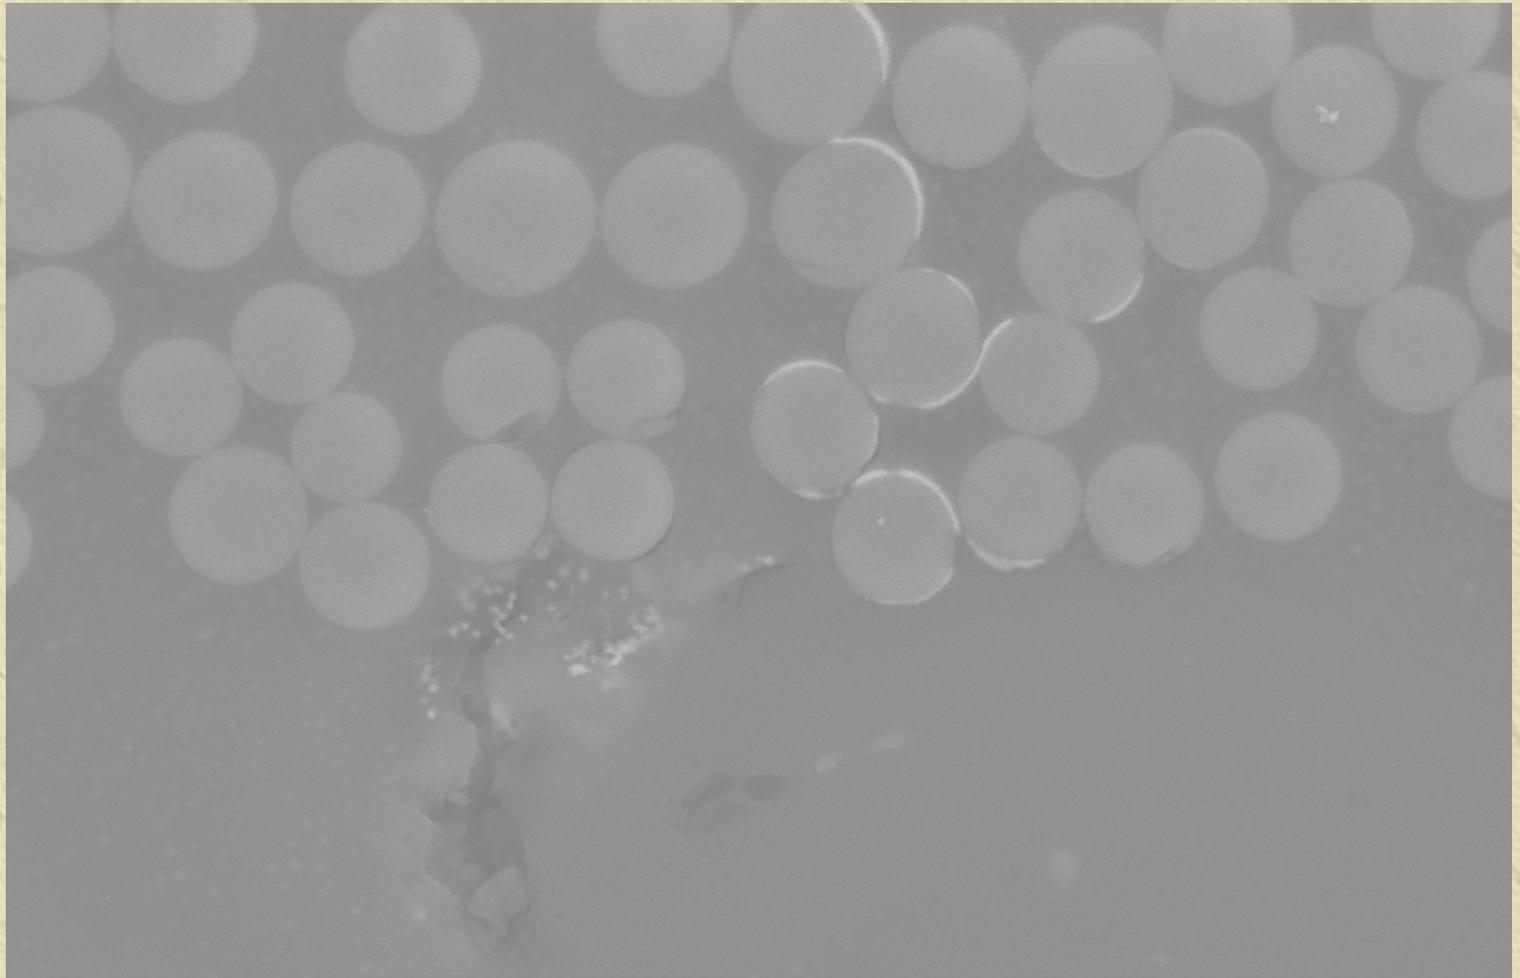
# SEM image of SN 612

- ✦ Copper was found in the shorted area and around the glass fibers. The copper can be seen as high brightness features, especially in the images taken at higher voltages.
- ✦ High concentrations of Zn, and Cl were found in the shorted area, even in the epoxy resin. The areas away from the shorted area have no Zn or Cl.
- ✦ Suspected RA flux with zinc chloride activator, but not used in the board construction
- ✦ There were balls of copper suggesting it had been molten and that the copper is all from heating due to current running through the layer.

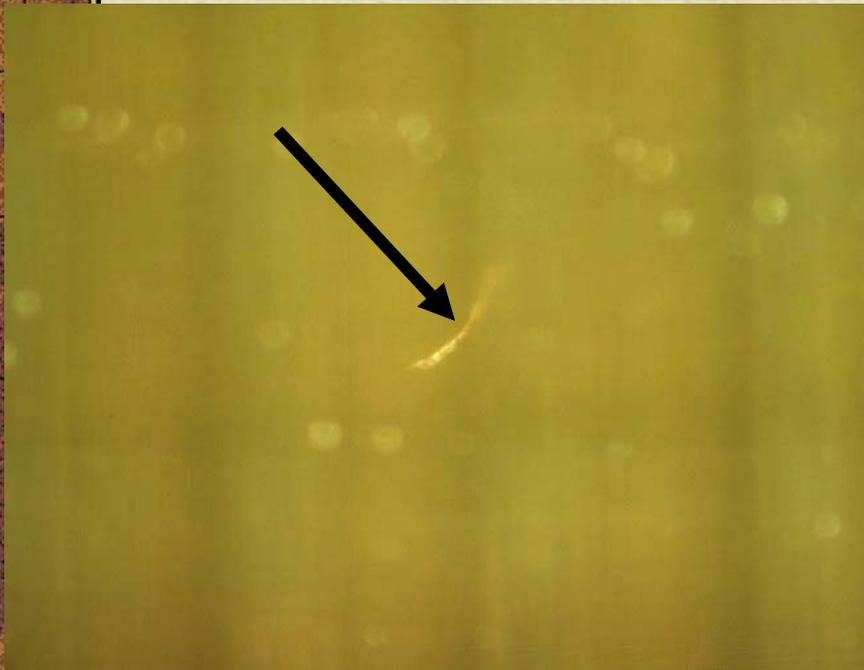
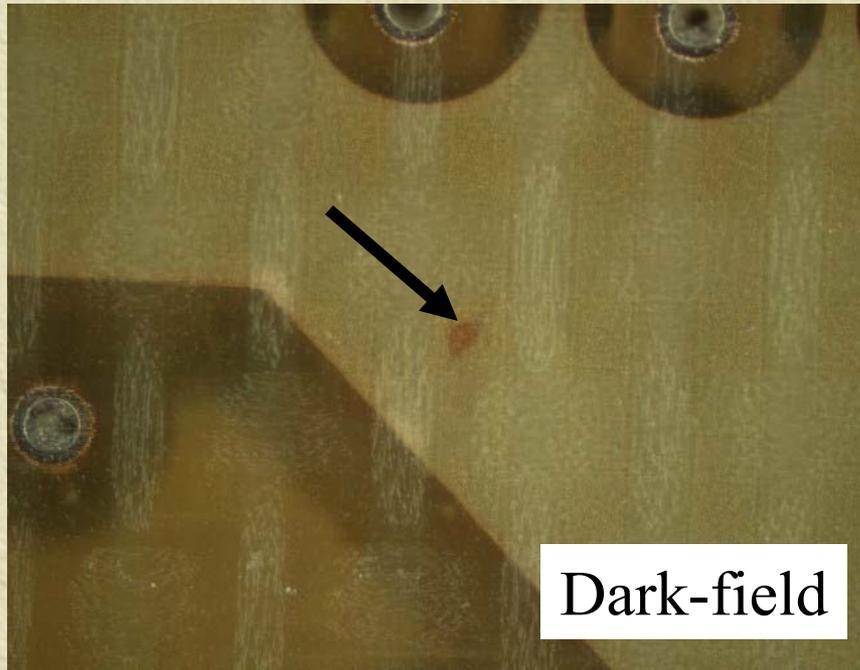
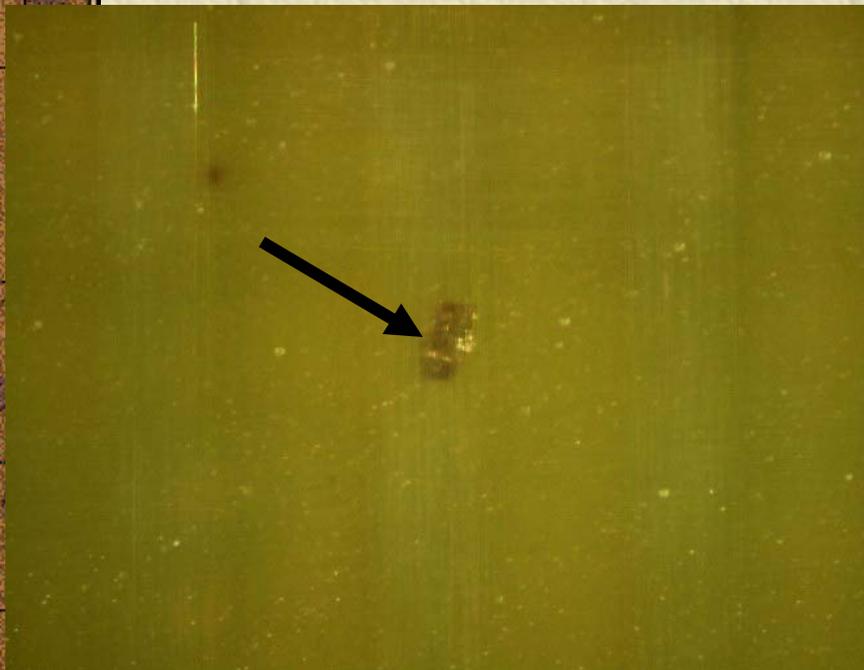
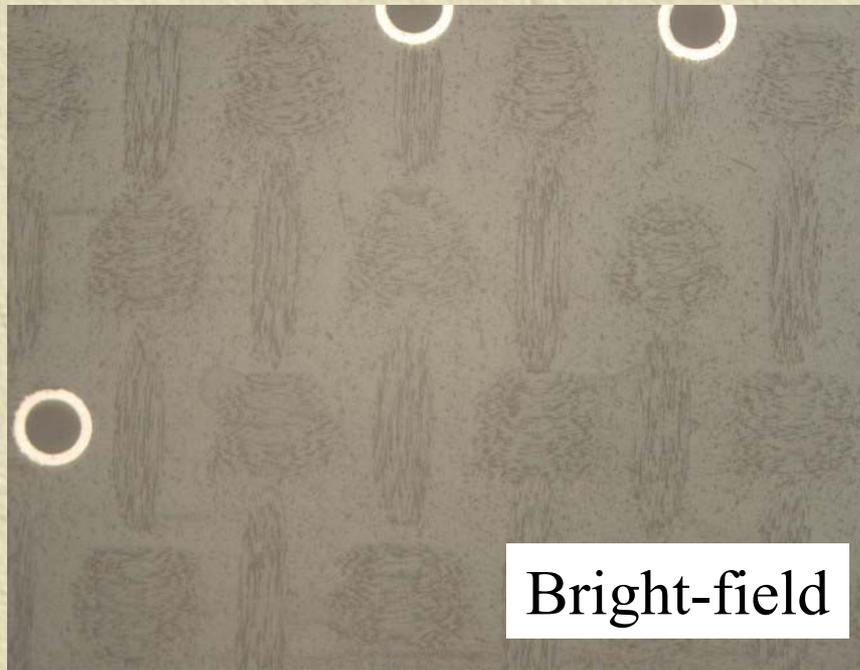
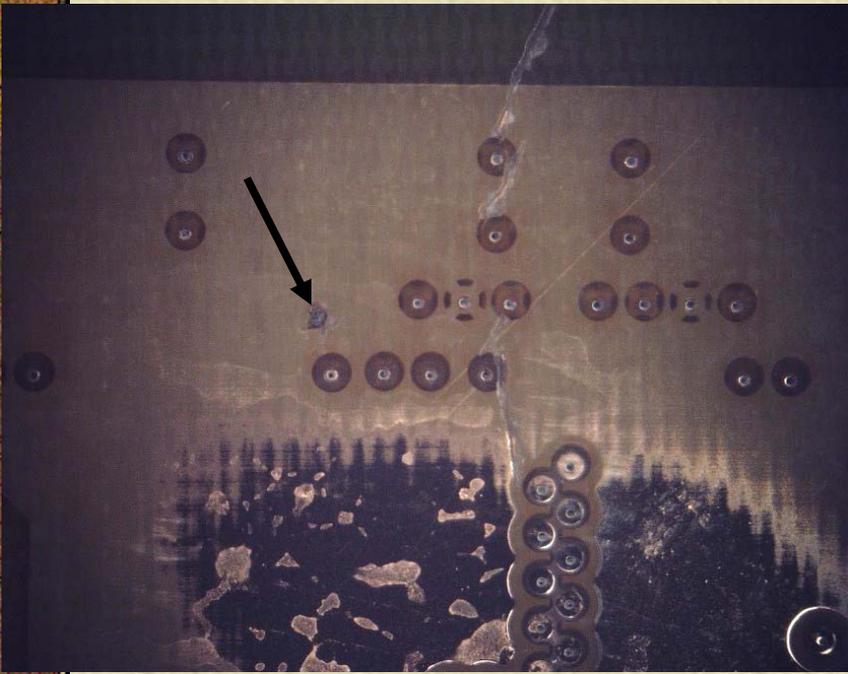
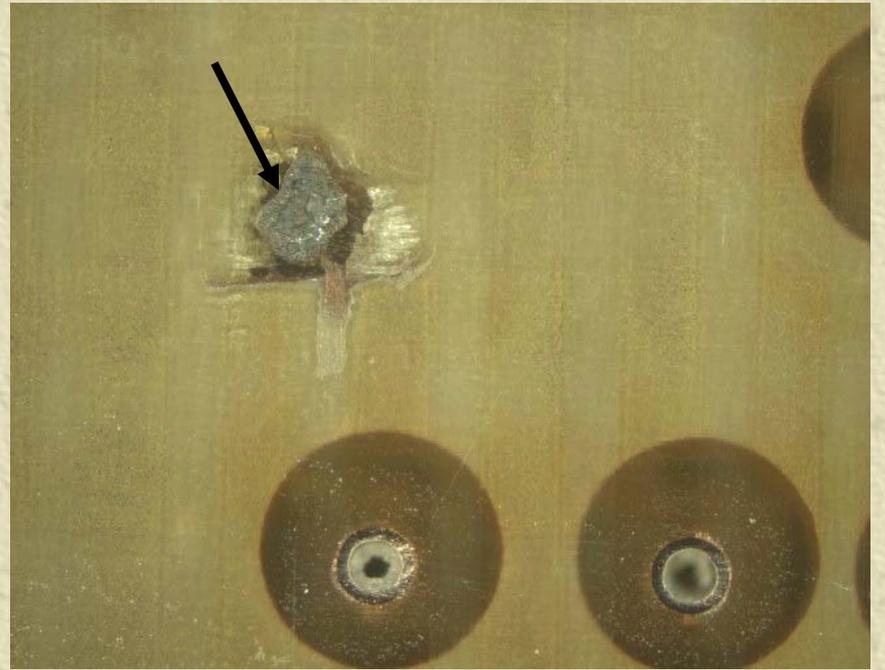
# Summary of DPA of SN 559 by Keith Rogers at CALCE

Based on what I saw during the cross-sections and my previous experience, I believe that there are some rather large particles embedded in the resin. EDS analysis of these particles indicate that they are some form of silica. Optical photos show that some of these particles are just as large as the vertical distance between the planes. It is very likely that some of these particles are actually larger than the gap between the planes and during the lamination process, the pressing of the laminates together can squeeze and crack these particles which bridge the vertical gap between the planes. Once a crack is formed, moisture can accumulate and allow the copper on the positive plane to ionize and go into solution, moving towards the negatively biased plane where the soluble copper ions change back to solid copper particles after passing through a pH gradient (from low at the positive side to high at the negative side). This copper migration through these cracks can cause the short circuits experienced. **Note: silica is often used in prepreg to match the CTE. It is NOT used in the Arlan 35N of the MCM.**

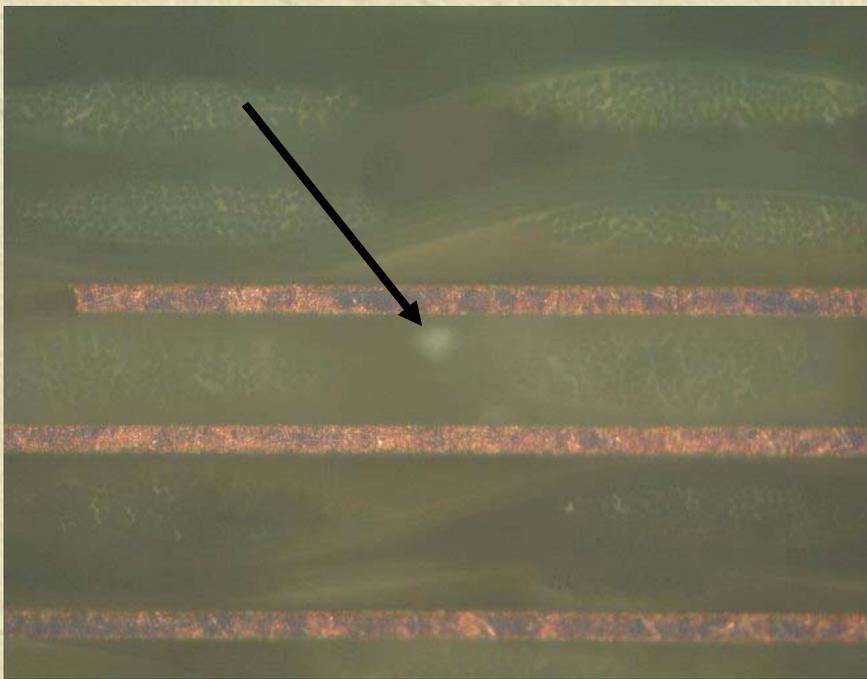
Photo focused on the surface

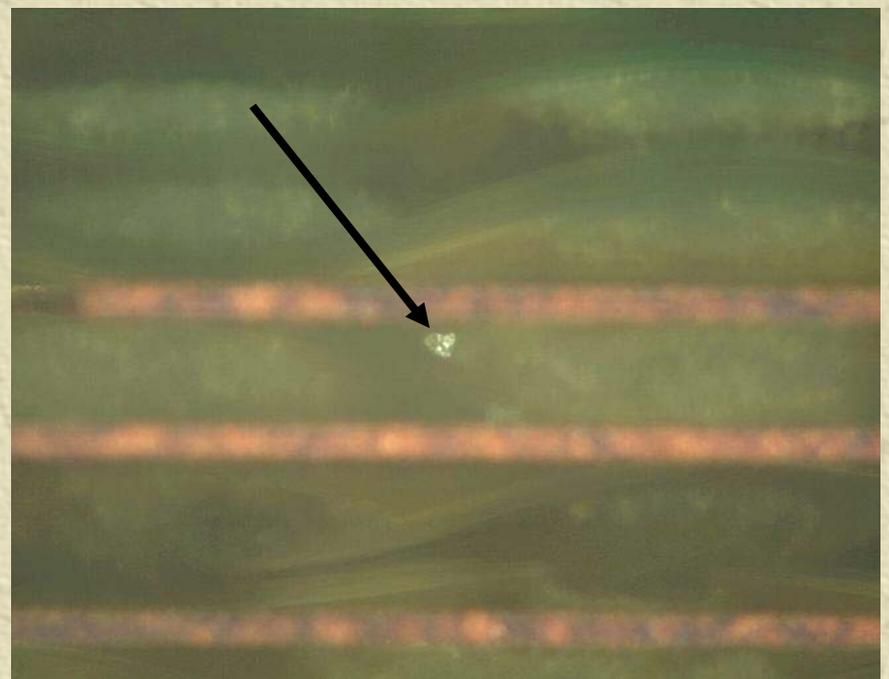
Photo focused on particle below the surface

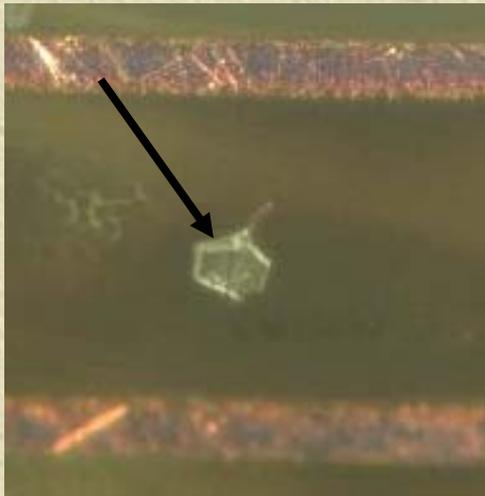
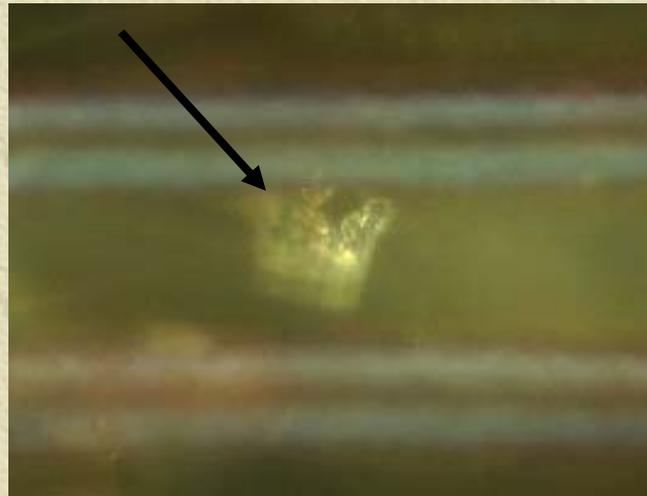
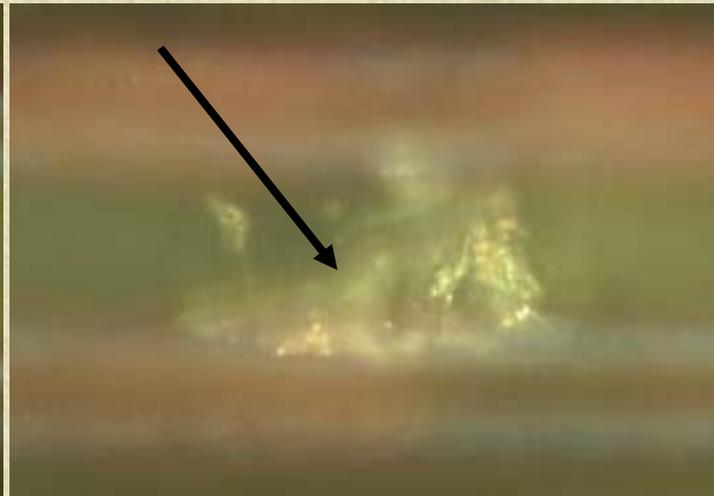
Photos of other particles embedded in the resin show that some almost bridge the vertical distance between the planes.

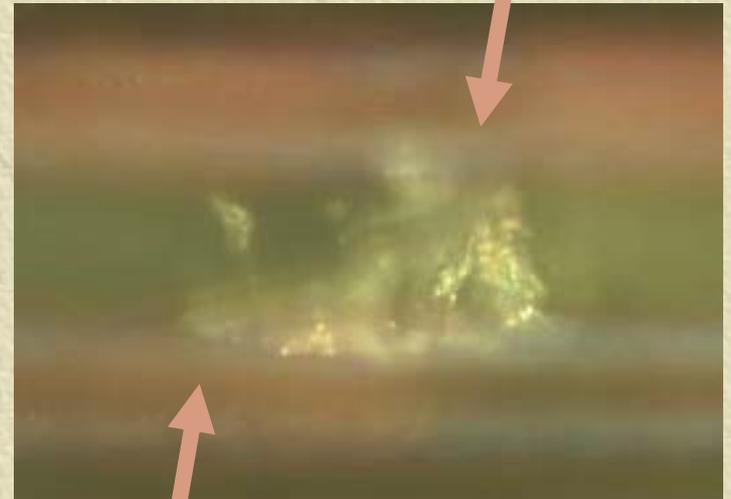
# Conductive Path Formation – CALCE report

Particle provided a path  
for  
copper migration

- ✦ Delamination
  - Hydrolysis, crack initiation
- ✦ Particle cracking (relatively brittle)
  - Pressing
  - Reflow

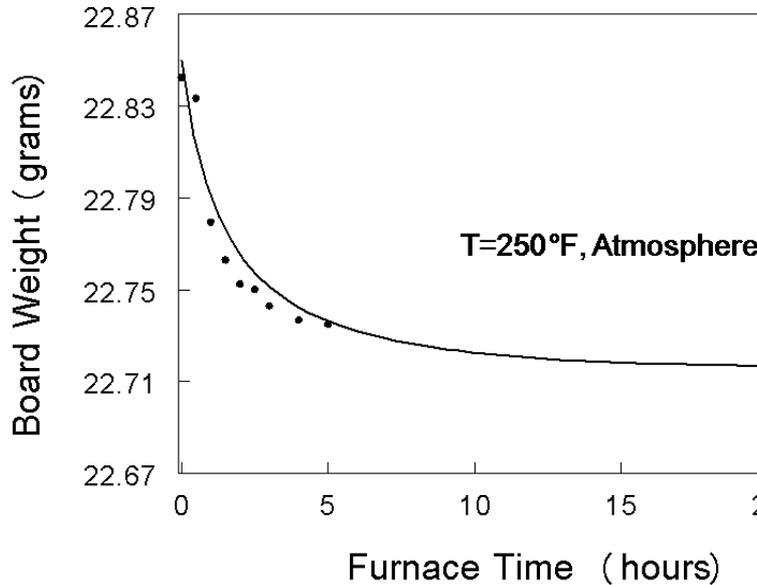
Water Desorption  
LAT-DS-00898,SN910

Loses .1 g or 0.4% of weight.

A 4 hour bake at 250°F is long enough to remove moisture

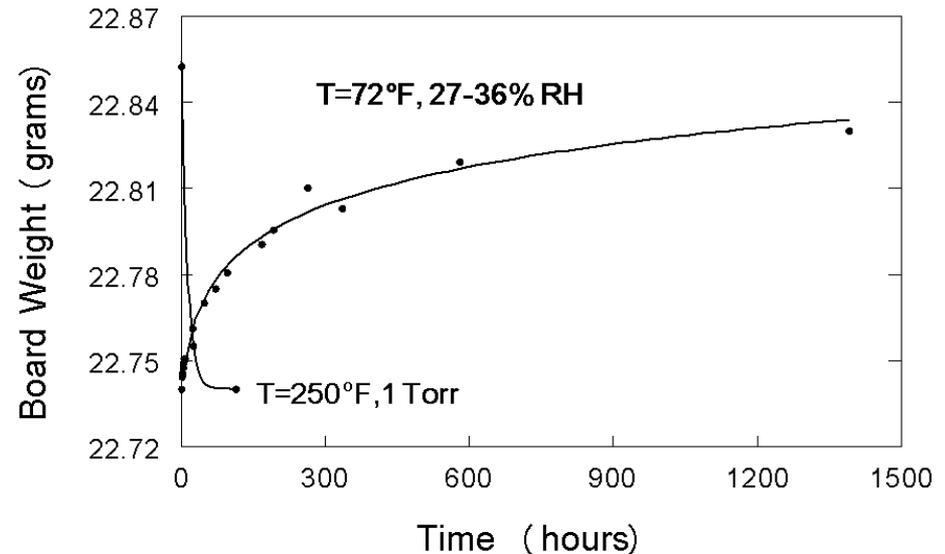
Water Desorption/Absorption

100's of hours to absorb moisture.
