# GLAST Large Area Telescope

## Tracker Subsystem

### MRB for NCR 122

### Bias Circuit Test Coupons

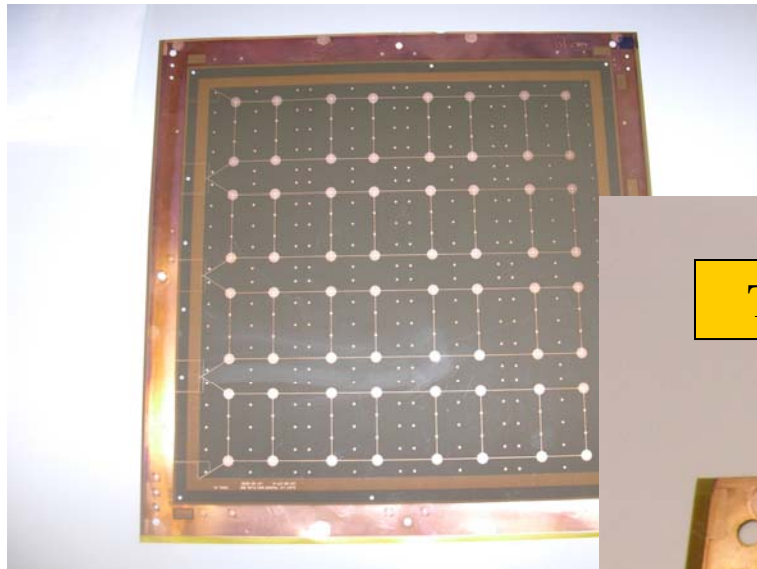
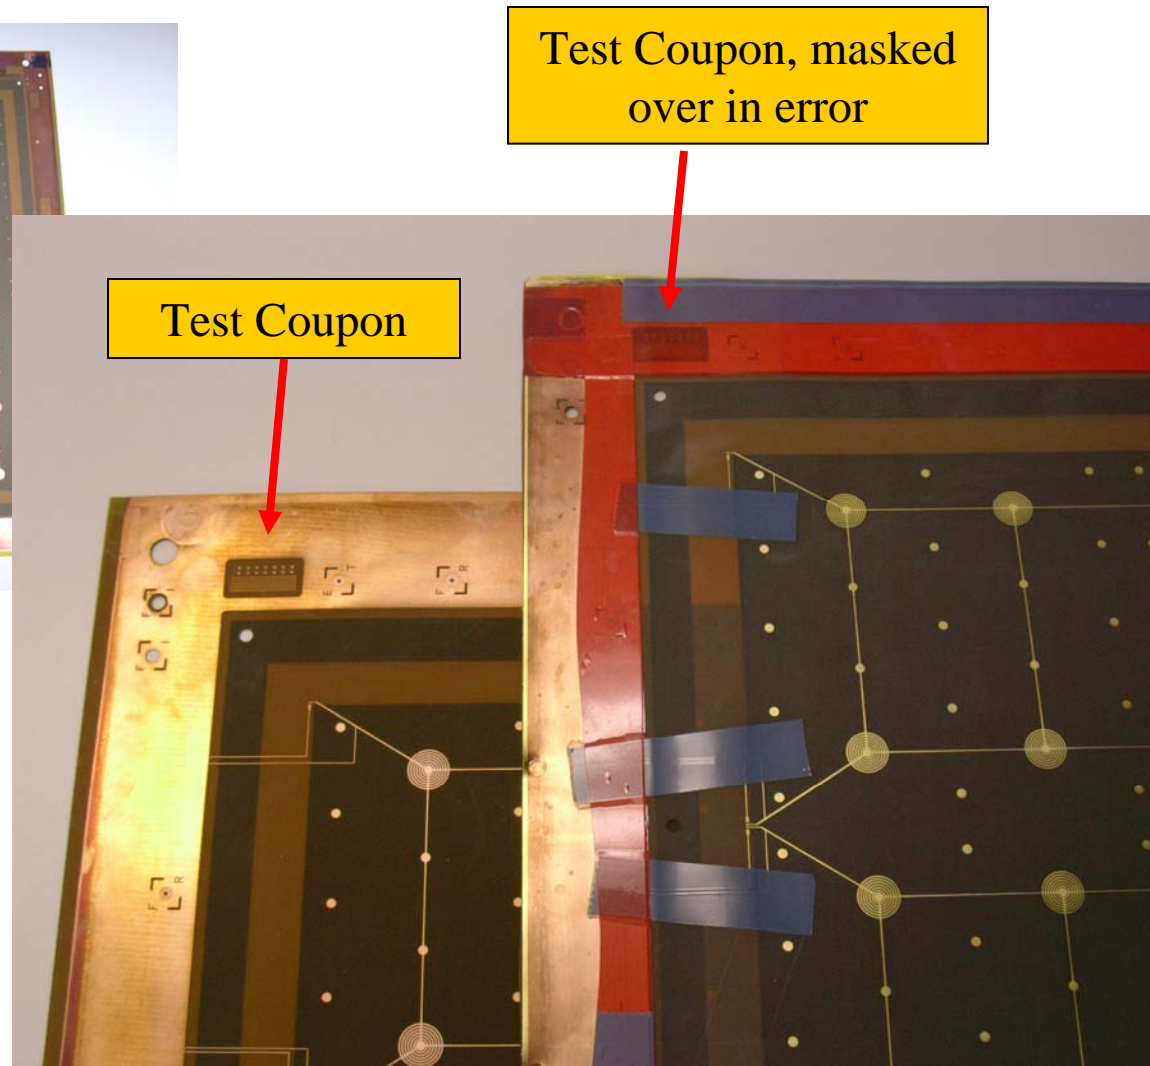
# Cause of the Problem

- **Root Cause**
  - **Prior to gold plating, the edges of the Bias Circuit were masked with tape; in some cases, the tape covered all or parts of the test coupons**
  - **Why: Incomplete training of masking personnel at Parlex, due to their oversight.**

Bias Circuit –  
approx 38cm x  
38 cm

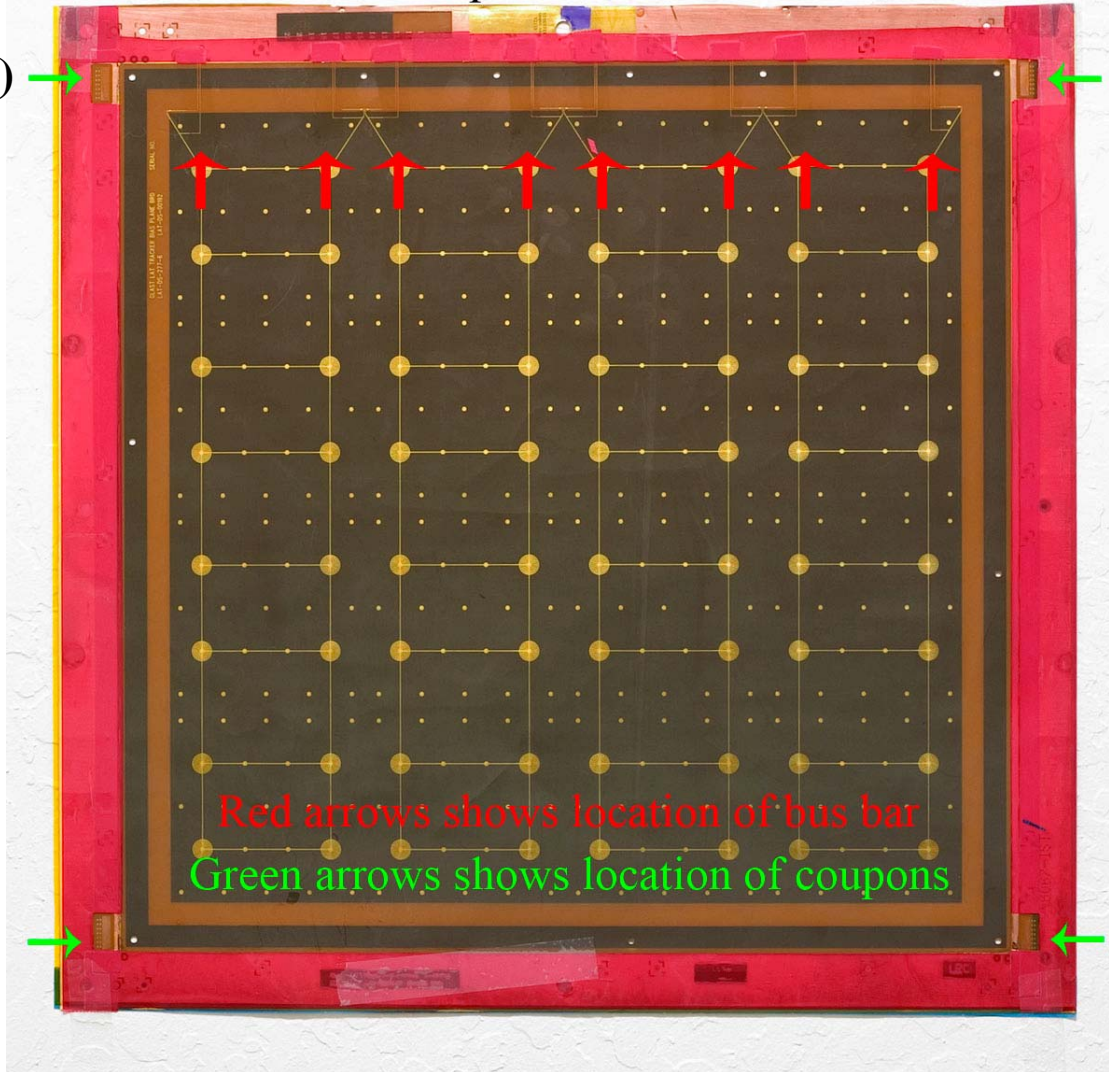
# NCR 122 – Corrected Masking

Topside After

Test Coupon (4 Plcs.)

Red arrows shows location of bus bar  
Green arrows shows location of coupons

- **Corrective Action to prevent recurrence**
  - Parlex generated a manufacturing process instruction MPI-PL-0005 Rev. A for masking operation.
  - Parlex has modified the masking operation to not cover the test coupons which caused the NCR (see photo #8)
  - Rationale for masking:
    - To add rigidity during plating and etching process
    - Tie-bar etching process
    - Control manufacturing cost (GOLD!)
  - Parlex added QA inspection point to verify proper masking
  - Modified traveler to add QC inspection point to ensure proper masking
  - LAT QA to perform visual inspection of coupons for presents of gold plating
