NCR/FM/INFN/RM2/1

Part number LAT-DS-00180(rev3)

Short NCR description Bias circuits delaminations

Thermo-vacuum test results

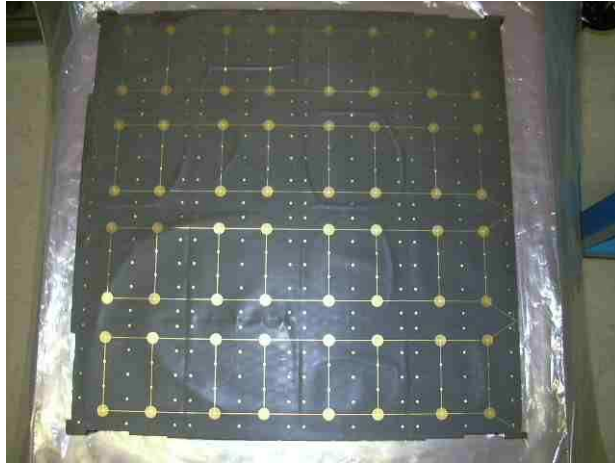
Tray Mid 006:

The following images shows the effect of the test on the trays Mid 006, Mid 008, Mid 015.

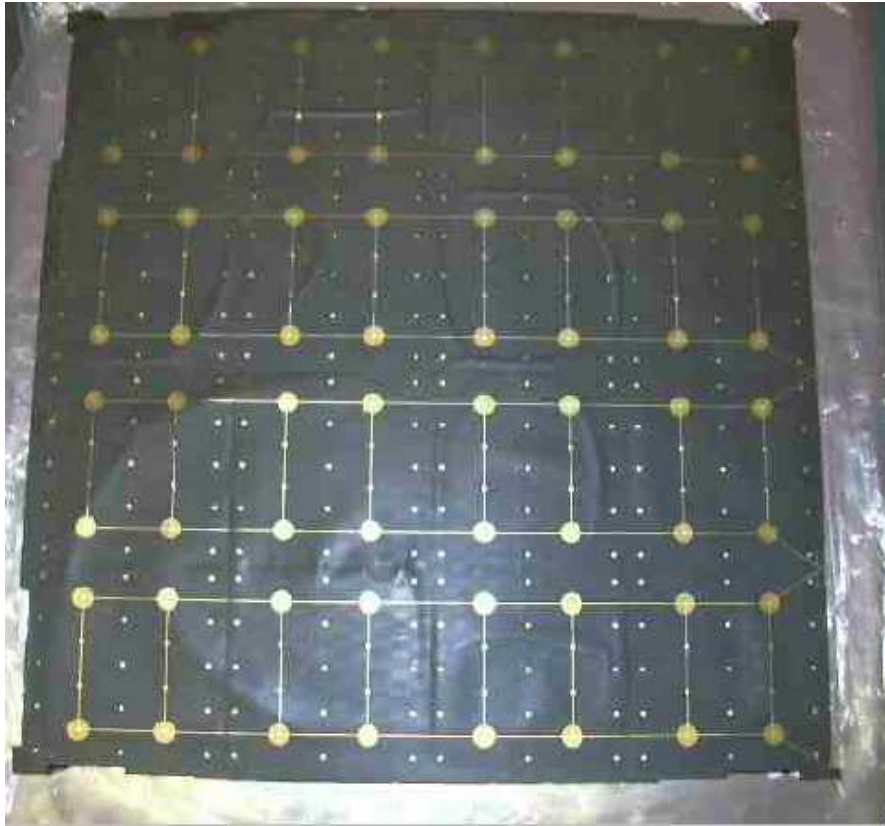
Mid006 Bottom Surface

The Thermo Vacuum Test of the trays Mid006, Mid008, Mid015, failed. The bonding between the Bias Circuit Foils and the panels relaxed and the foils showed a large surface wrinkling (see picture 1, 2, 3, 4):

These large debonding areas seem induced by the CTE differences between Cu shield layer ($CTE = 17 \cdot 10^{-6} 1/^\circ C$) and the tray ($CTE \approx 0$). The Shear Stress overcame The shear strength of the adhesive with regular and uniform deformations.

The Peak temperature of this test is $85^\circ C$; the **3M Scotch-Weld 2216** epoxy glue data sheet shows a relevant decrease of the typical Shear Properties (see table below):

We suggest to decrease the Peak temperature of the Thermo Vacuum test of the trays from $85^\circ C$ to $55^\circ C$, $5^\circ C$ Higher than the requested max temperature as for LAT-TD-03651.

- 1) Vacuum test of 4 trays at room temperature
- 2) If no debonding will be observed, perform a Vacuum test @ $55^\circ C$ for 4 hours
