Non conformance report

Pisa 23/10/03 #2

Object:	Al 50mm foil
Drawing	LAT_DS_00303,304,305,306

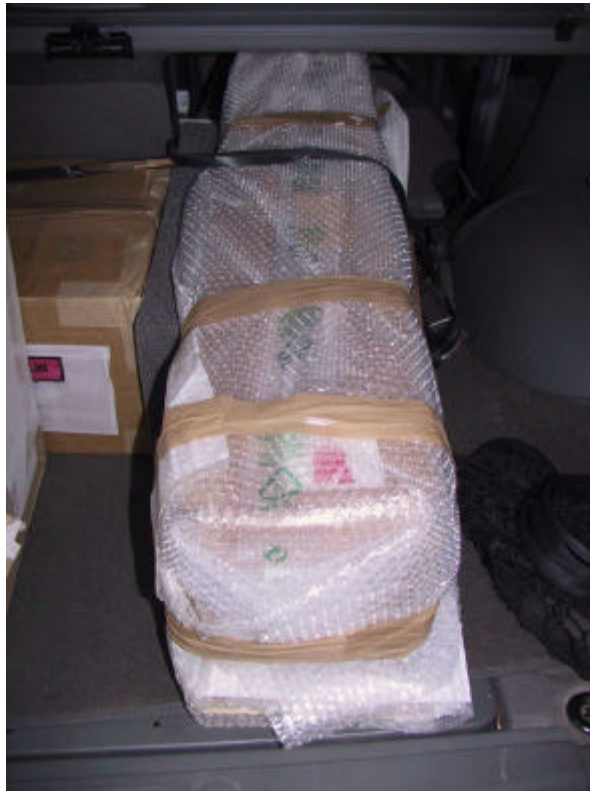
fig.1) The Al roll was shipped by car fixed on a wooden table with care

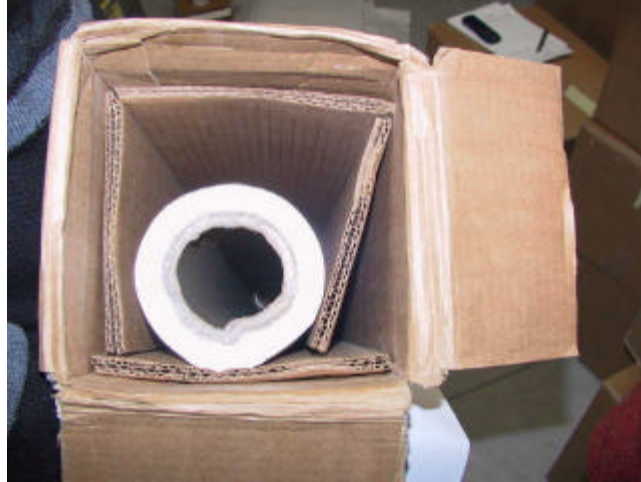
ID	Description	Action to take
	The Al roll was not properly fixed in the carton box There are evidences of strong deformations	reject

fig.2) The box was opened in Plyform first time. The Al roll inner cylinder is not regular, indicating shoks.
