NCR/FM/INFN/RM2/7

<i>Classification</i>	<i>Item name</i>	<i>Found on:</i>
major	Top Tray Assembly with Payload	08/09/2004 7:00:49 PM
<i>Part number</i>	LAT-DS-00764 (rev2)	
<i>Serial number</i>	001	
<i>Issued</i>	Marcello Marchetti	
<i>Short NCR description</i>	Bias circuit delamination	
<i>Approved by</i>	Alessandro Brez	
<i>Detected</i>	Test	
<i>Cause</i>	manufacturing mistake	
<i>NCR description</i>	Bias circuits delamination found after the thermo-vacuum test. See annex 1.	
<i>Action</i>	Refer MRB

Annex 1 to NCR/FM/INFN/RM2/007

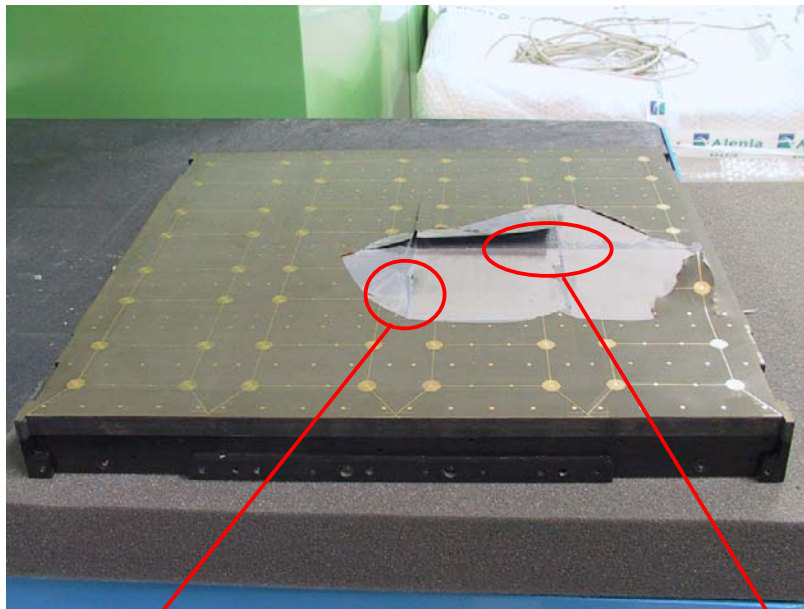
Fig.1

The top tray 001 was equipped with Tungsten plates and kapton bias circuits during the first week of august. On Friday of the same week, at 2p.m it was put in the RomaII thermo-vacuum chamber and left at 55°C 5 hours to complete the 3M2216 curing. At 7p.m. the chamber was depressurised. The thermal stress before, and the thermo-vacuum stress after, caused large de-bonding of the kapton bias circuit and the de-bonding of some tungsten tiles.

The failure of the test is due to two factors:

- Not perfect curing of the 3M2216
- Not perfect adhesion of the 3M2216 to the tungsten tiles (see NCR tray MID-047).

- A) Send to Plyform for rework of the Kapton and INFN-Pisa suggest to perform further investigation in order to verify the cause of the NCR.
- B) Verify rework with standard flow of tests (dimensional test-flatness, New TVAC test)
- C) Refer to MRB
