GLAST Large Area Telescope: Tracker Subsystem WBS 4.1.4

Persis S. Drell
Stanford Linear Accelerator Center
LAT Deputy Project Manager

Outline

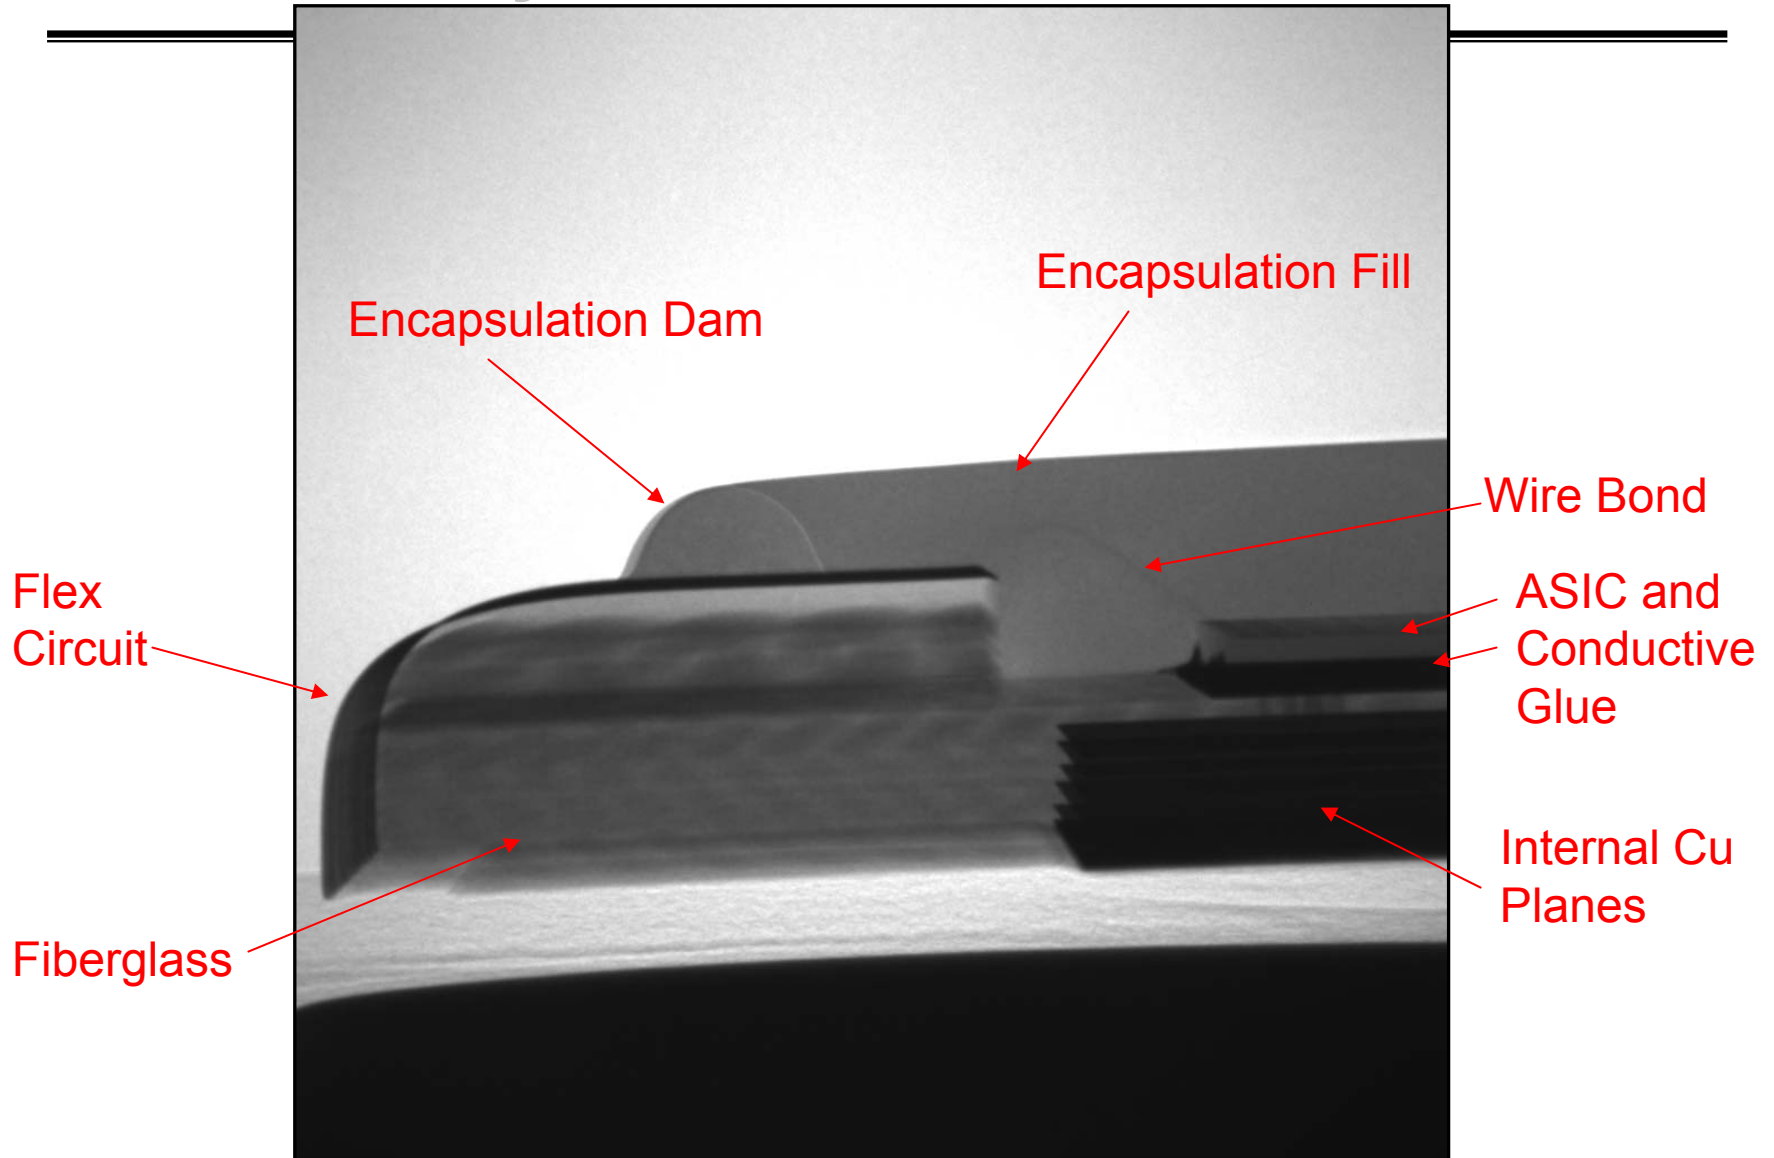
X-Ray Cross Section of an MCM

- **MCM Anomaly Found During Tower A Tray Assembly at G&A**
 - **First identified in tray production at G&A where MCM on tray found to have 300 disconnected channels**
 - **Subsequently found in MCM's at SLAC before shipping using new (as of November) electrical test fixture**
 - **Large numbers of missing channels seen in ~15% of MCM's screened at SLAC**
 - **Most in August and September MCM production runs**
 - **Delamination occurs mostly during 21 thermal cycles done on MCM's at SLAC (-30C to +85C)**
- **Missing channels due to wire bonds breaking at Pitch Adaptor to ASIC joint under black encapsulation due to delamination of the encapsulation**
 - **Root cause hypothesized to be silicone contamination from masking tape applied to entire surface of pitch adapter prior to reflow soldering**

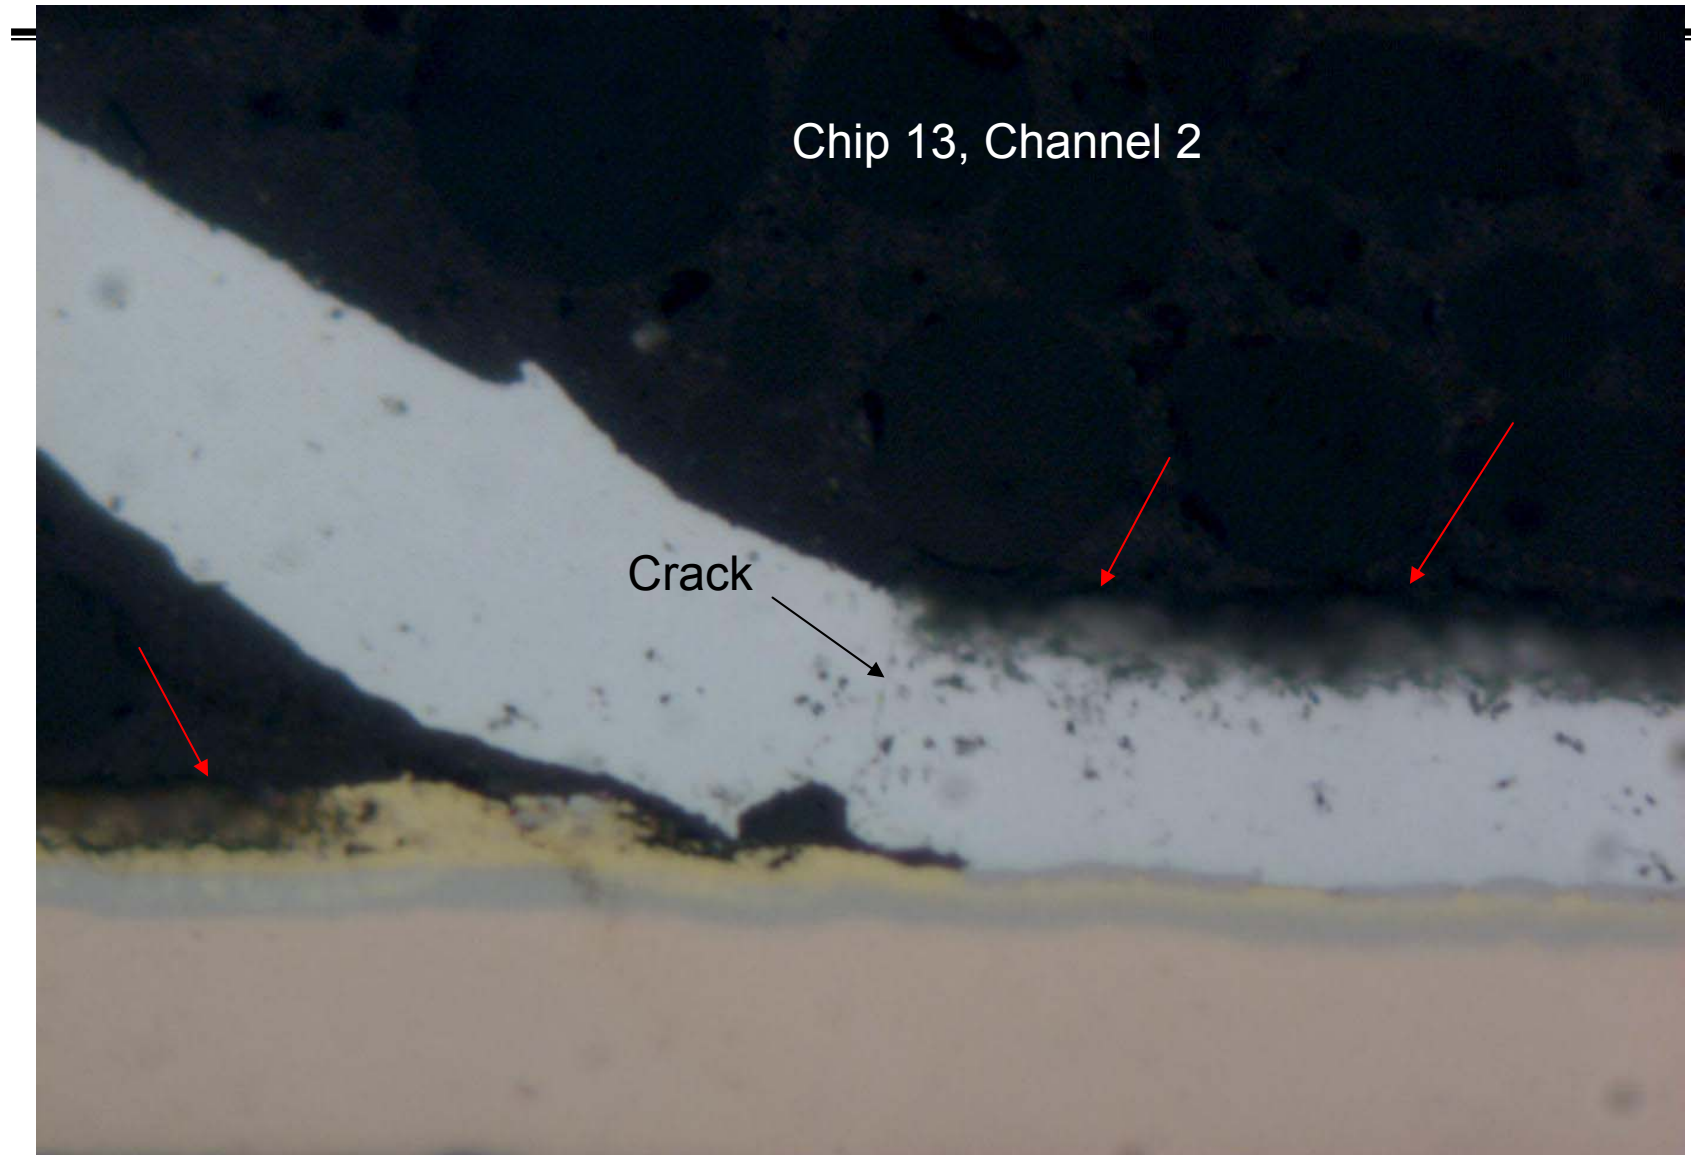
Example Wire Bond Crack

- **Done by Diane Kolos and Bruno Munoz at GSFC.**
 - **X-ray results**
 - **sectioning and polishing**
- **C-SAM sonar images of MCM's confirm delamination**
 - **some delamination likely in all MCM's but in most cases not enough to break wire bonds**

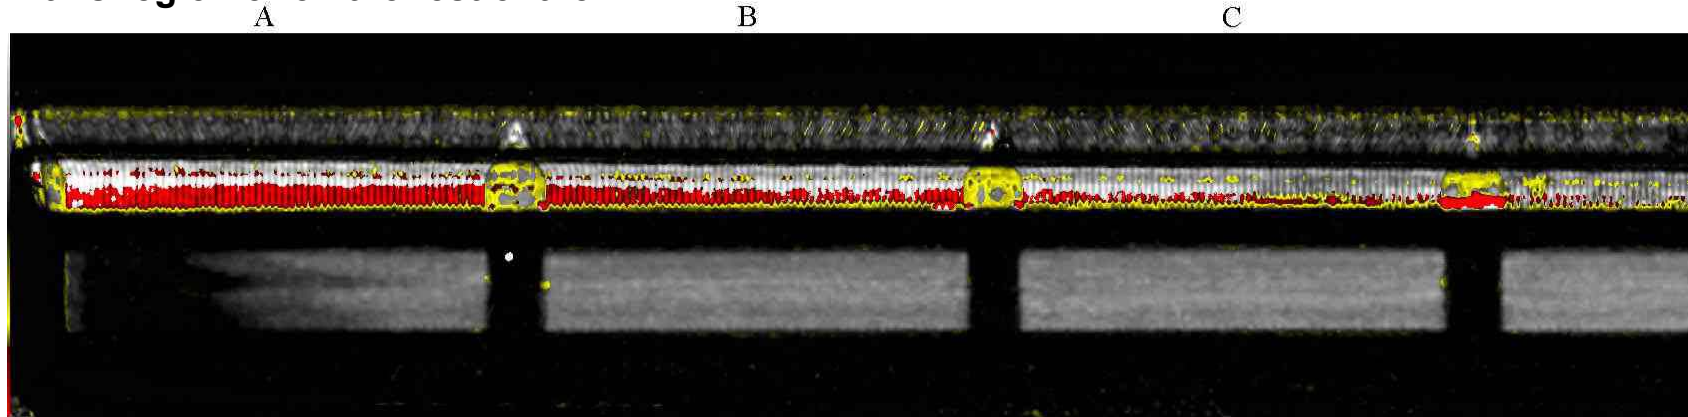
C-SAM sonar image of the left-hand end of MCM S/N 600. The red areas are where the encapsulation has delaminated from the pitch adapter. There are no broken wire bonds in this region or on the rest of the MCM.

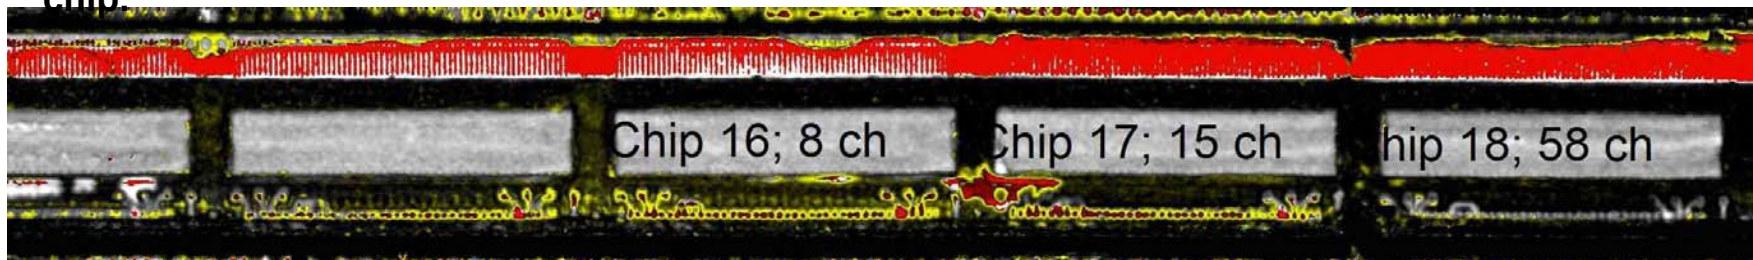
C-SAM sonar image of the region of MCM S/N 11046 where we find a transition from the left-hand 2/3 of the board, where no wire bonds are broken, to the right-hand 1/3, where nearly all the wire bonds are broken. The text indicates the number of broken wires for each chip.

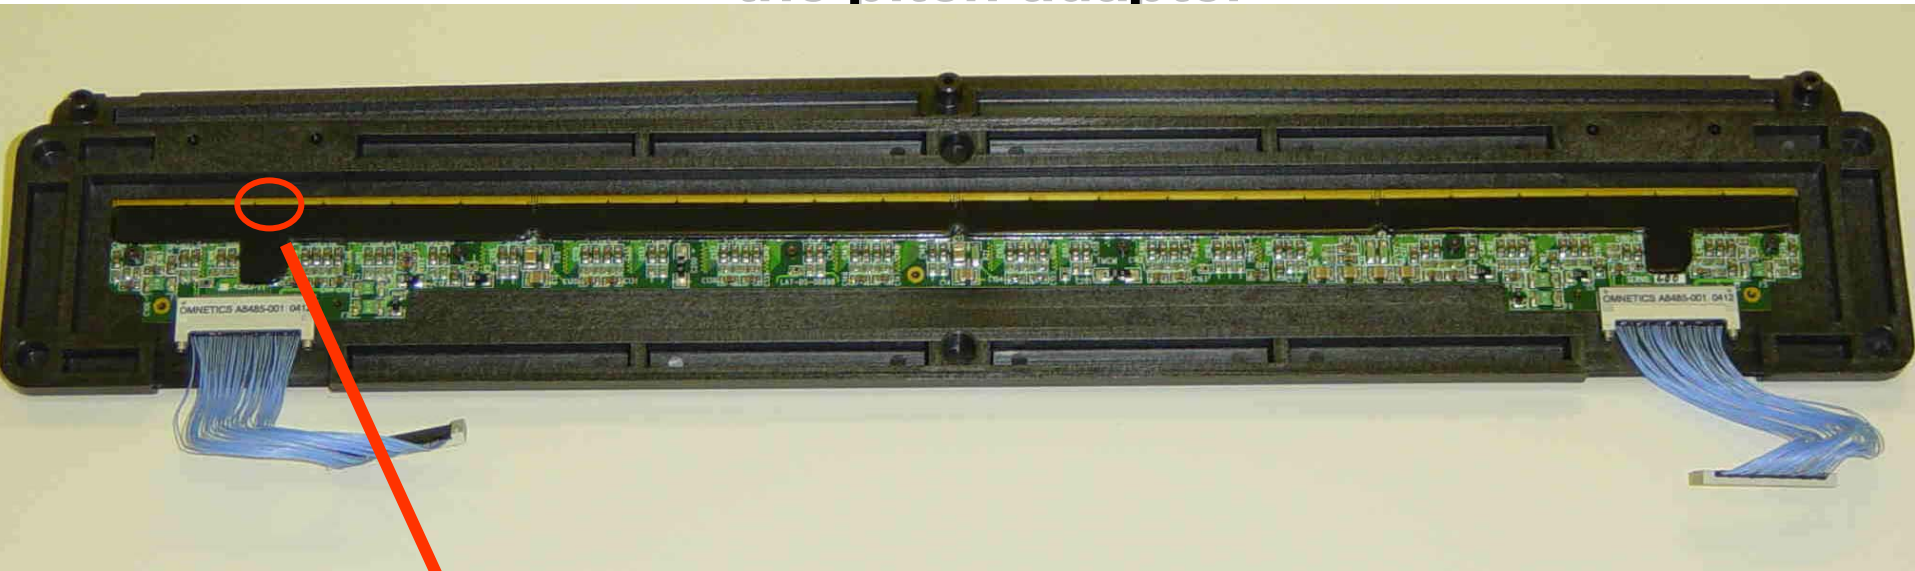
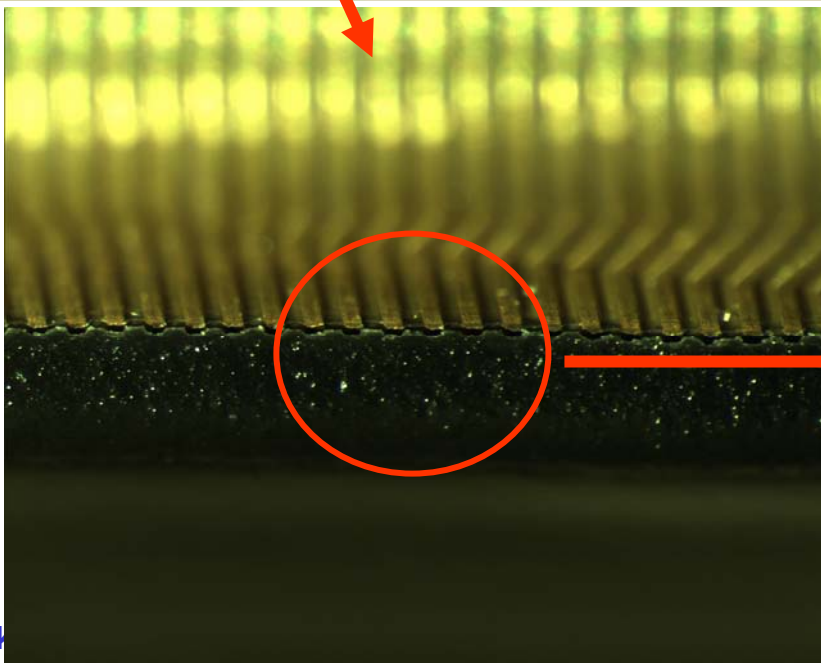
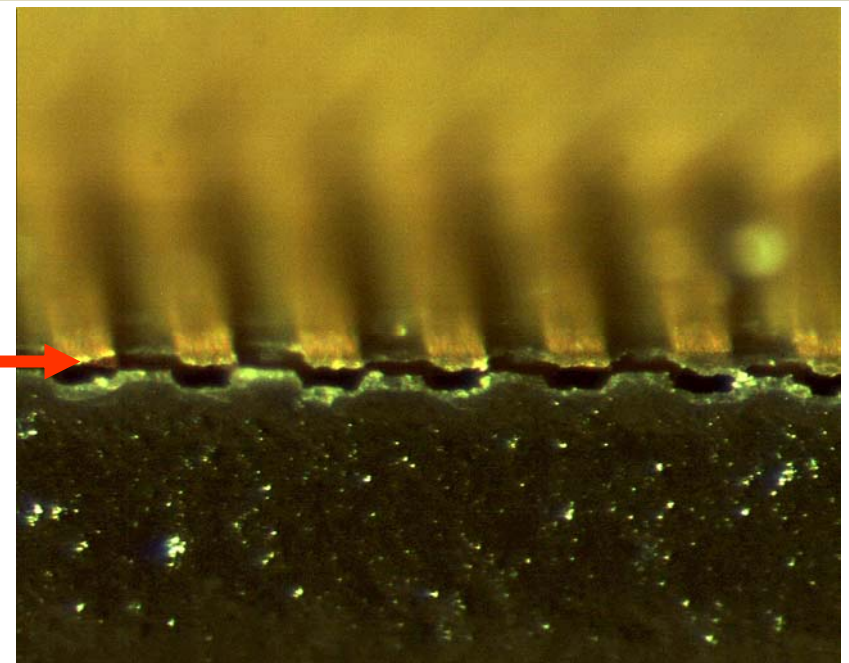
- **Electrical Test Procedure at SLAC effectively eliminates all MCMs with more than 15 broken signal wire bonds following thermal cycles.**
 - **Concern is additional delamination and breaking of bonds during tray and tower assembly and test**
- **In Tower A tray assembly, problems were seen**
 - **2 MCMs screened at SLAC developed significant delaminations in tray assembly (>125 consecutive wire bonds broken)**
 - **Different signature**
 - **Location of delamination**
 - **Near MCM ends rather than MCM center**
 - **Visible gap between encapsulant and pitch adaptor**
 - **Early MCM delivery**

Failure of the wire bonds where they connect to the pitch adapter

- **Tower A**
 - Two trays in Tower A have large numbers of missing channels (~150 each)
 - Accepted trays to keep Tower production on schedule
- **Tower B**
 - Continue to put MCM's on trays with modified procedures to avoid encapsulation delamination
 - Modify procedure for mounting MCM to tray
 - Reduce amount of adhesive
 - Visual inspection to look for debonding of encapsulant before silicon installed
- **Tower 1**
 - MRB before proceeding (1/3/05)
 - Disposition to continue to use existing MCMs on Tower 1 trays
 - Including full electrical screening at SLAC
 - Modified procedures and visual screening at G&A

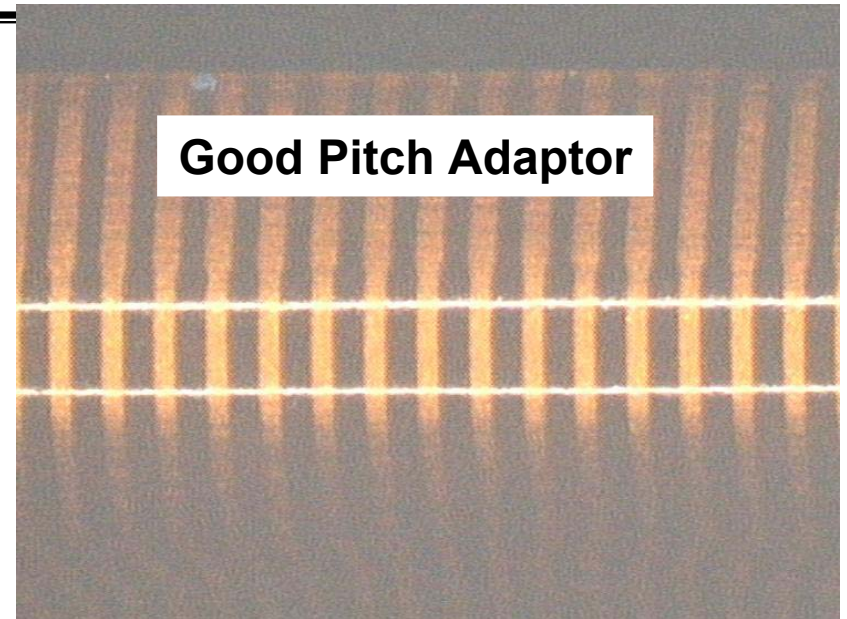
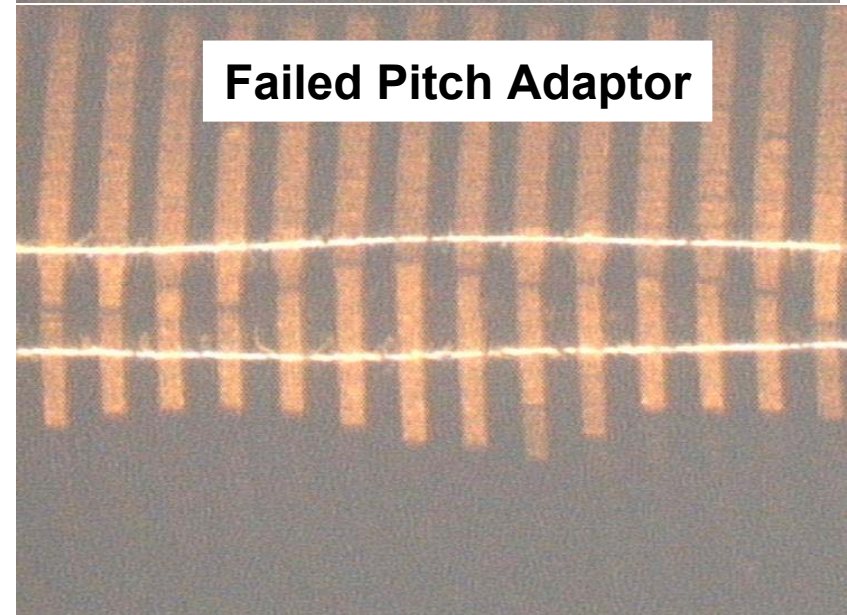
- For good PA, bright lines straight and parallel
- For bad PA, bright lines are wavy and non-parallel.
 - traces do not fade away at the same rate.
 - interpreted to mean that the radiused corner has variations along its length.
 - Note cracks in many traces, and sometimes multiple cracks in each trace.

- **Known process changes**
 - **PWB boards are radiused with custom tool bit.**
 - **Small irregularities were observed, and a step was added in early November where SLAC manually “deburred” the bare boards before shipping them to Teledyne**
- **Other possibilities**
 - **PA may be from different production run (exploring with Parlex)**
 - **Test data**
 - **Plating verification**
 - **PWB radius may be incorrectly put on**
 - **Change in tension put on PA during bonding**
 - **PA from 2nd vendor being evaluated**
- **Intensive effort to determine root cause and get Teledyne production re-started**

Issue	Plan	Status	Who	Date
Pitch Adaptor Cracking	1. Assess impact of PWB edge debur	1. In process	CCY	1/5/2005
	2. Evaluate PA from 2nd vendor	2. In process	CCY	1/5/2005
	3. Evaluate process changes at Parlex	3. In process	RGobin	1/5/2005
	4. Evaluate process changes at Teledyne	4. In process	CCY/RG	1/7/2005

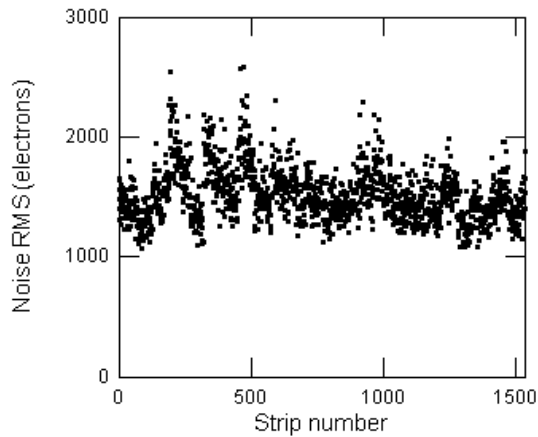
Channel Noise for layer X12

Noise profile shows a group of channels with lower noise.

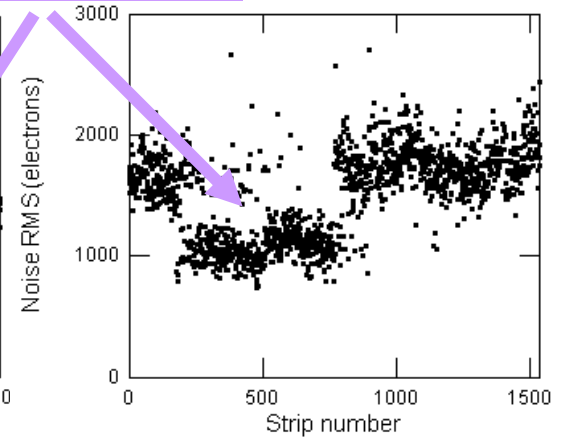
Channel Noise for layer Y4

Reduced noise

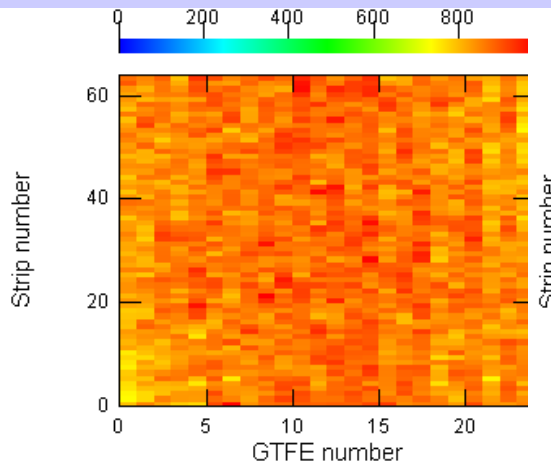
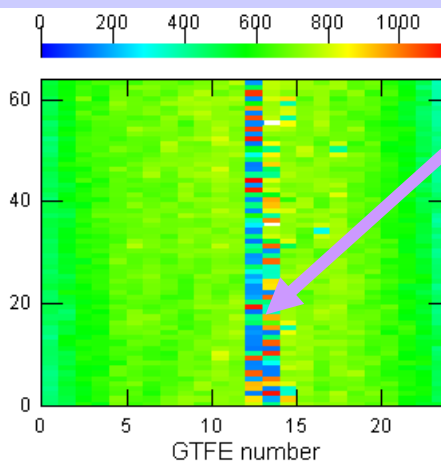
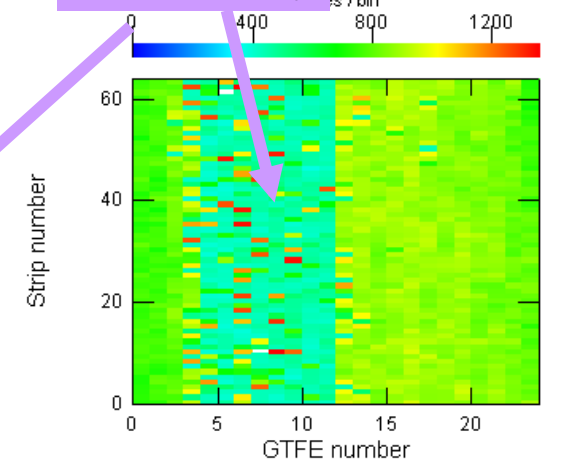
CR hitmaps show less than 100% efficient region

Low efficiency

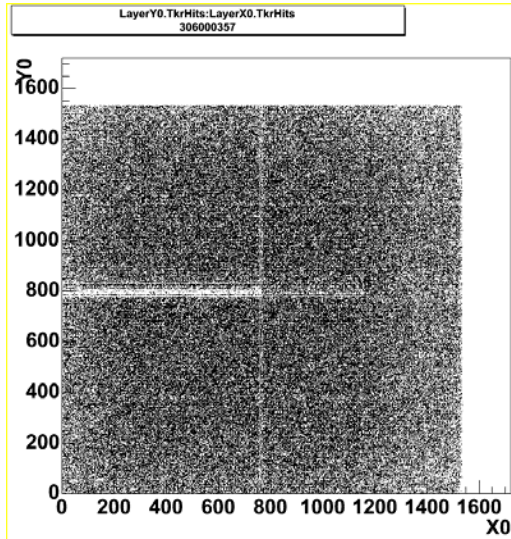
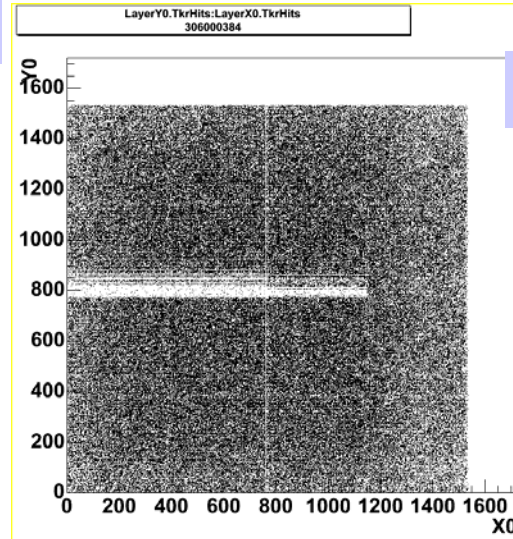
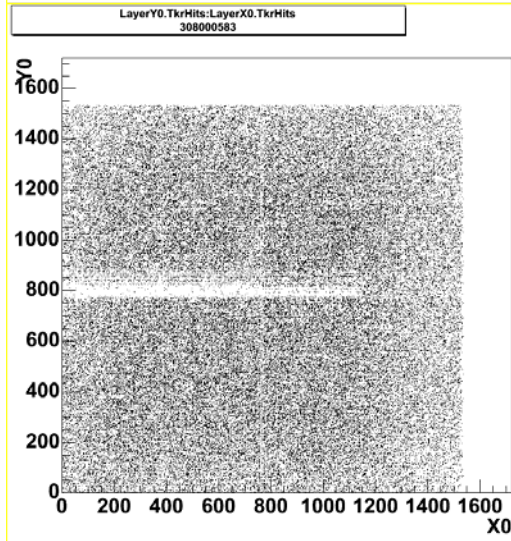
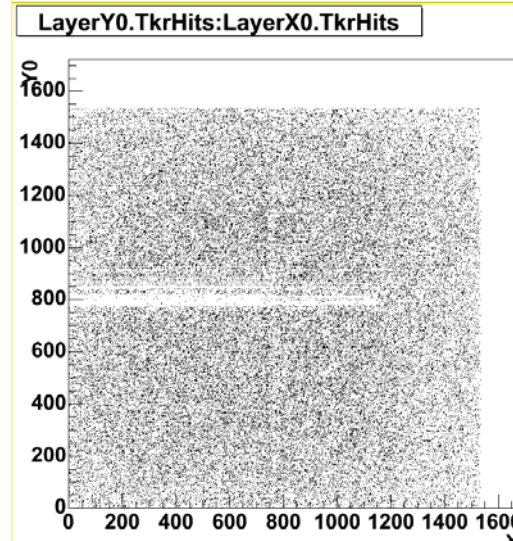
Y0 Bot 003

=96.1%

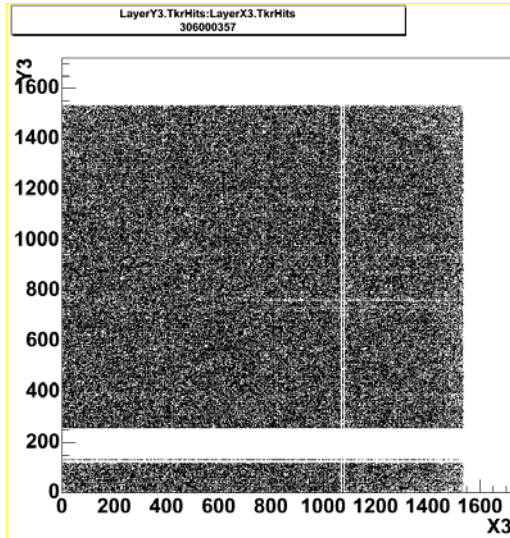
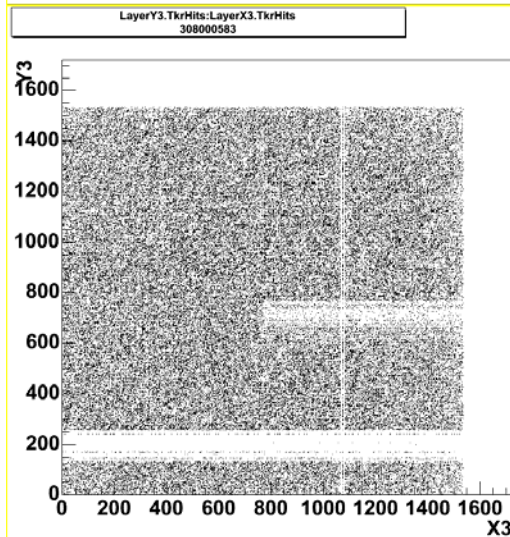
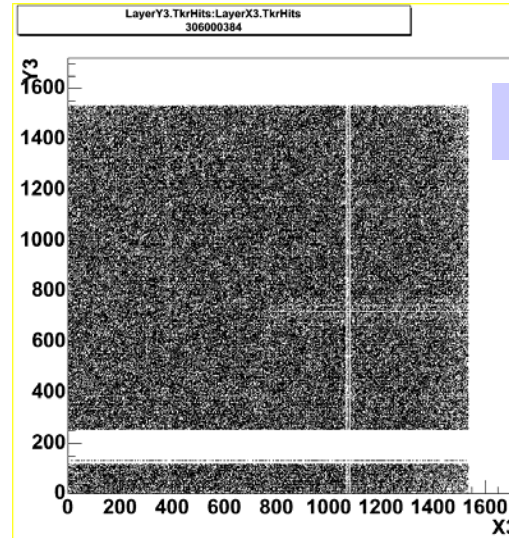
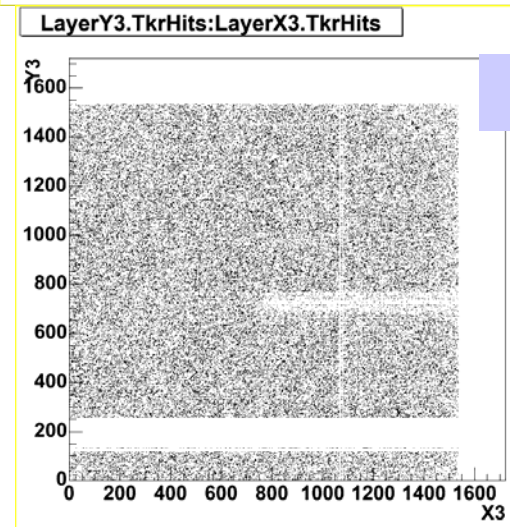
Y3 Heavy 20

=91.2%

=89.9%

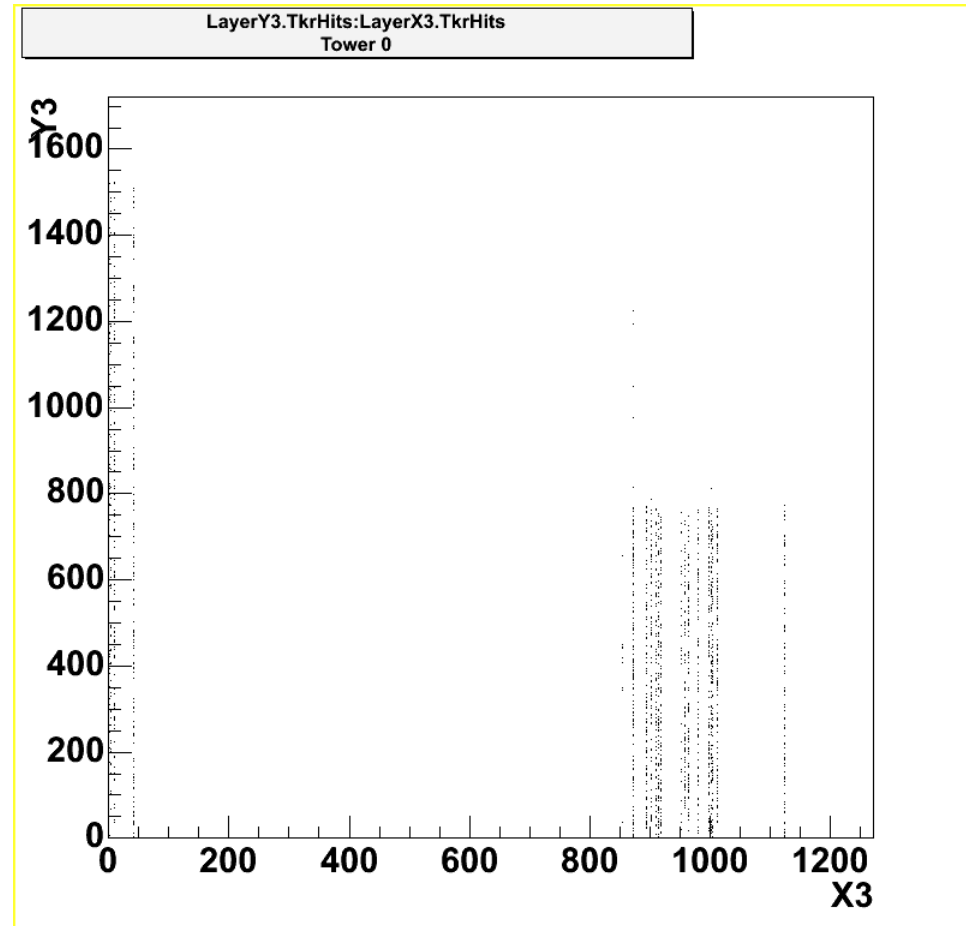
- Went back to tower 0 data
- Recall tower 0 heavy trays lost large numbers of channels due to encapsulation between silicon and MCM (removed for Tower A and beyond)
- For Tower 0, the only tray showing interrupted strips had very few live channels (NCR INFN/PI-92)
 - The problem was there in Tower 0
- Have taken Tower 0 heavy trays and thermally cycled them in Perugia
 - Decrease lower temperature
 - See continued breakage of ladders

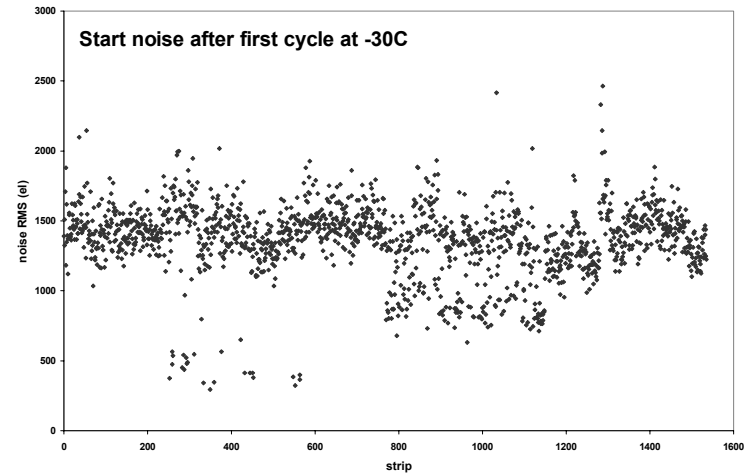
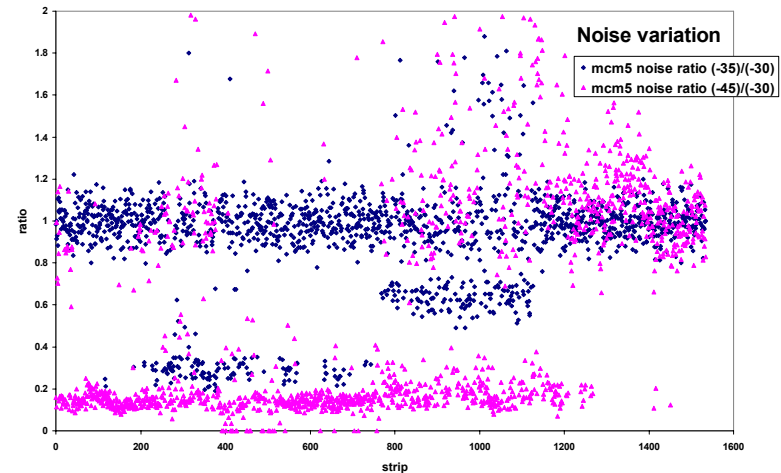
- Perugia testing of Tower 0 heavy trays:
 - -30 C
 - -35 C
 - -45 C
- New Tray level thermal cycling lower limit for Tower B and beyond
 - -15 C

Issue	Plan	Status	Who	Date
Ladder Breakage	1. Mine Perugia and Twr B data, including visual inspection of broken ladders from Perugia trays		Pisa	1/12/2005
	2. Assemble existing analysis to understand root cause for heavy tray problems and margin for mid-trays		Ku	1/12/2005
	3. 1/12/05 MRB	INFN/PI_318 /319	Pisa	1/12/2005
	4. Proceed to make heavy trays for Tower 1 using ladders without encapsulation		Pisa	1/17/2005
	5. Use analysis and prototype ladders without encapsulation to retire risk		Pisa/Ku

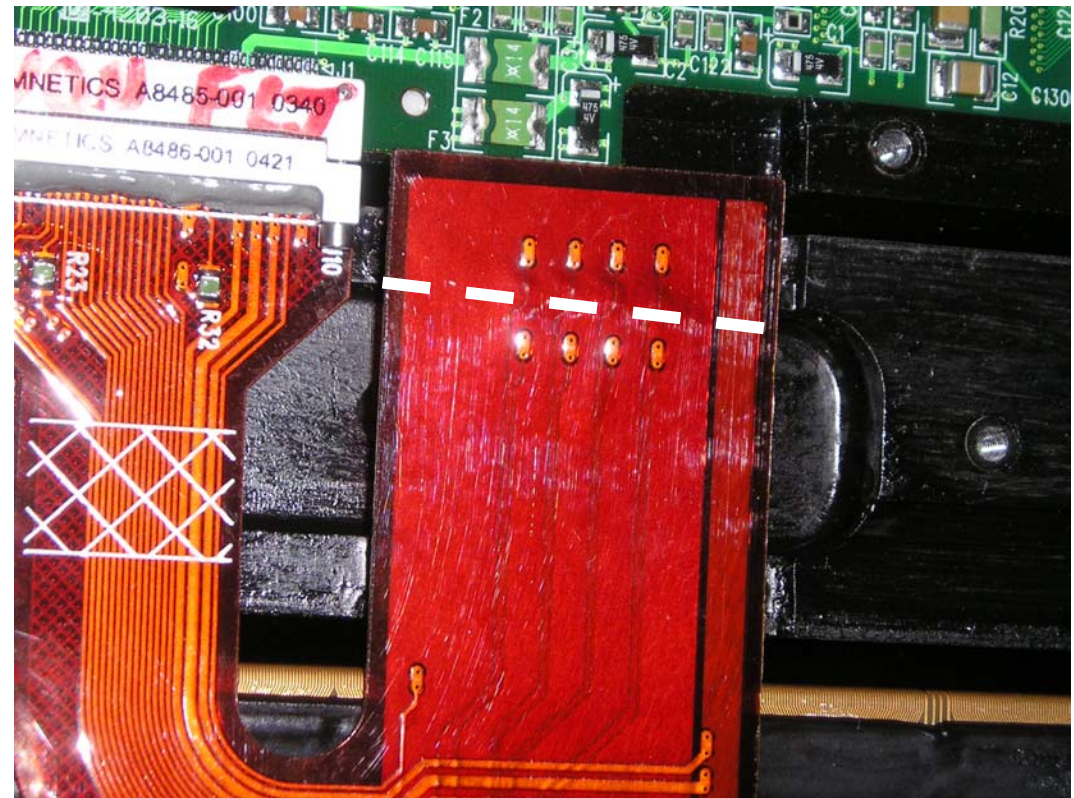
- Tower A Environmental test went very smoothly
 - The tower went through vibe perfectly
- Half way through thermal cycling, the C6 readout line failed.
 - Diagnostic capability was limited
 - Initial prejudice was a TEM problem
 - When the T/V chamber was opened, the TEM was exonerated
 - Tests were then done to determine if we are seeing a cable or MCM problem.
 - Failure traced to short on C6 CKLM trace
- Root cause analysis by Robert Johnson led to the hypothesis that the C6 termination resistor was shorting against a closeout due to a design flaw.

- Fit check of flex cable C6 on tower 0
 - white dashed line is the actual edge of the cavity in the closeout.
