GLAST Large Area Telescope: Pitch Adapter Trace Cracking Issues

Charlie Young
SLAC

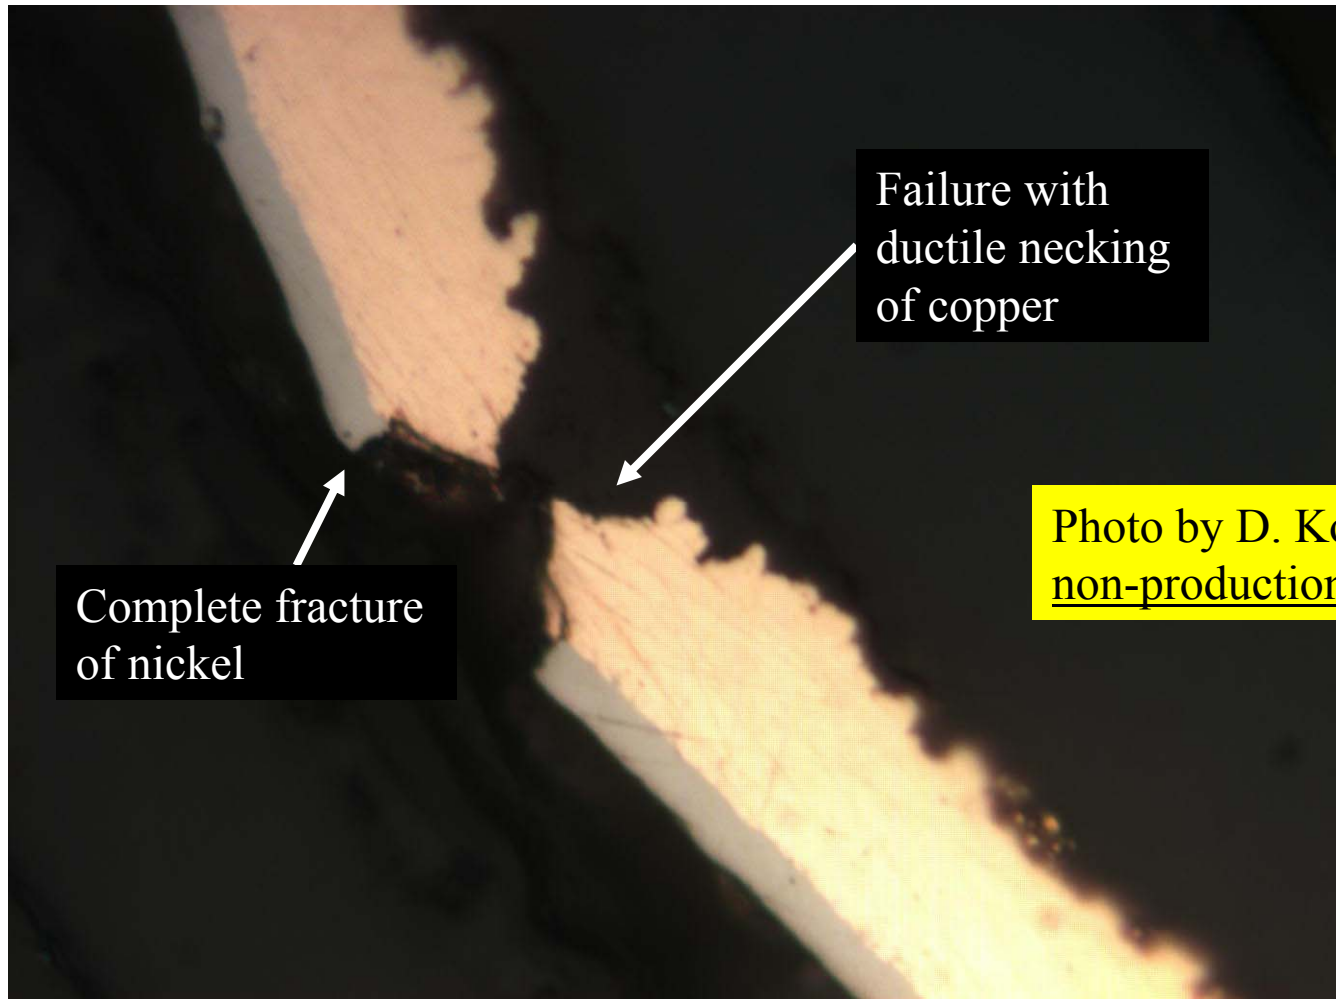
Picture of Cracked Trace

Complete fracture
of nickel

Failure with
ductile necking
of copper

Photo by D. Kolos of
non-production PA

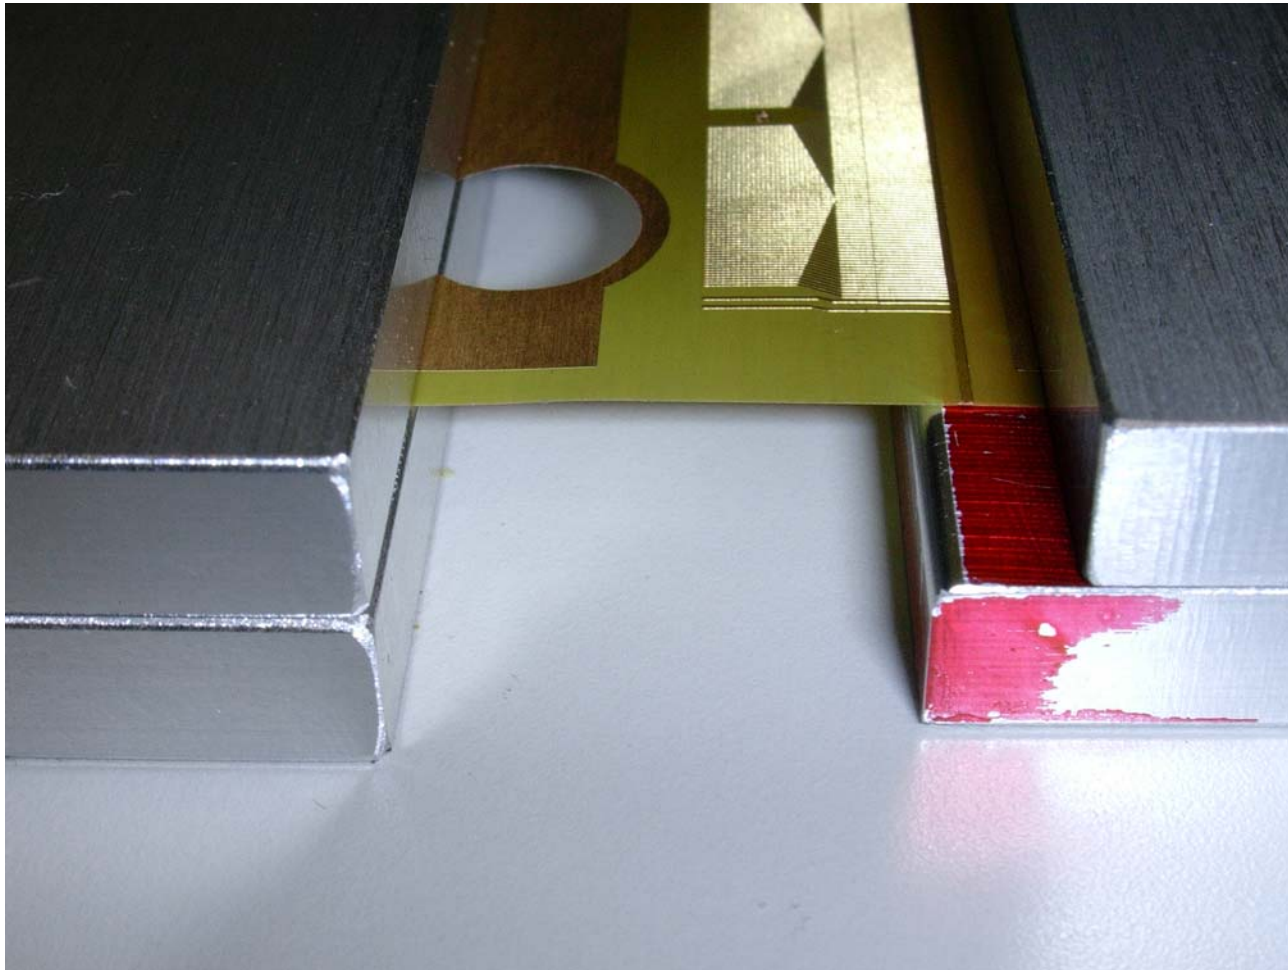
Mandrel Test

- Test electroplated PA's using 1-mm radius mandrel.
 - All electroless samples failed with massive cracking.
 - Parlex “Sep 04”.
 - Parlex “Nov 04”.
 - Tested 3 Parlex “Jan 05” electroplated samples.
 - One thin: 54 μin nickel.
 - Two thick: 129 and 158 μin nickel.
 - All 3 samples passed with no cracked traces.
- Two thick PA's also tested on 0.5-mm radius.
 - Pulled as hard as possible by hand.
 - Both samples passed with no cracked traces.
- Bonding test at Teledyne right now.
 - This is the acid test.

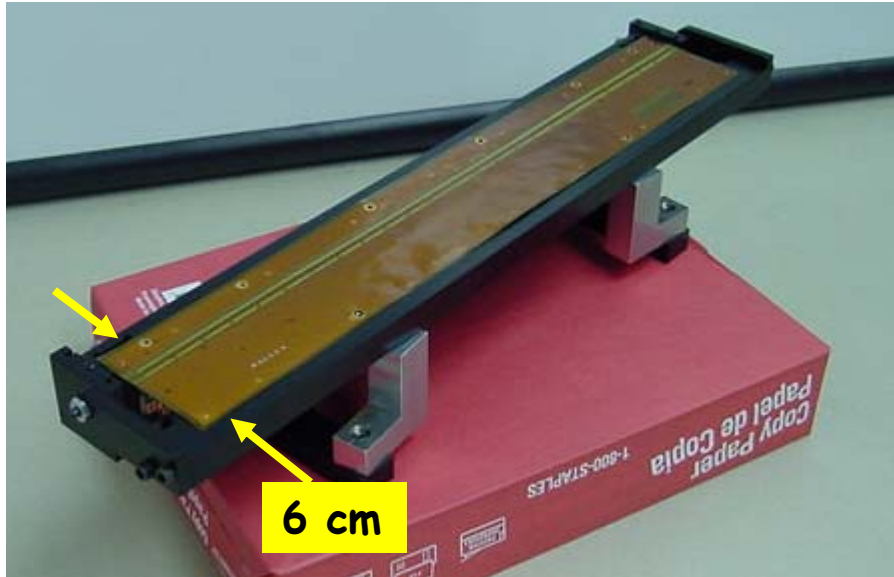
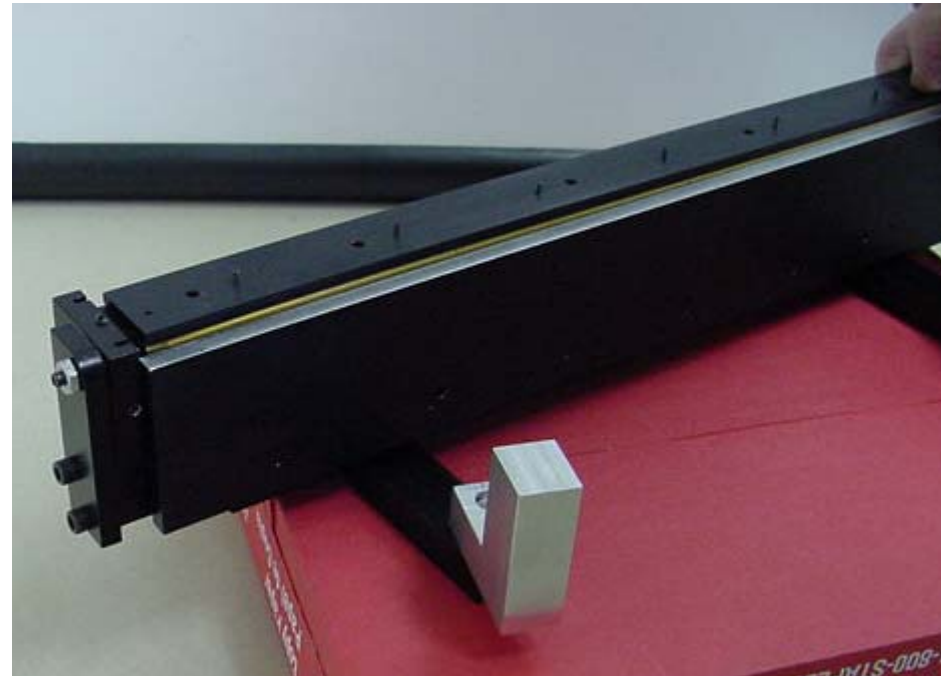
Teledyne Gluing Fixture

- **Identified as second in importance.**
- **Production fixture at Teledyne stretches PA by ~1.5 mm.**
 - **Consequence of fixture design.**
 - **Confirmed stretch in tests.**
- **Rejection rate ~O(20%) in early 2004 implies it is not an absolute killer.**

- **Prototype G&A fixture does not stretch PA.**
 - PA held in a mold.
 - Works well in tests.
 - But fixture has its own problems.
 - Alignment holes drilled through middle of PWB.
- **Modified design.**
 - Contract engineer.
 - Design review with Teledyne this morning.
 - Production drawings this week.
 - Fabricate and test fixture.

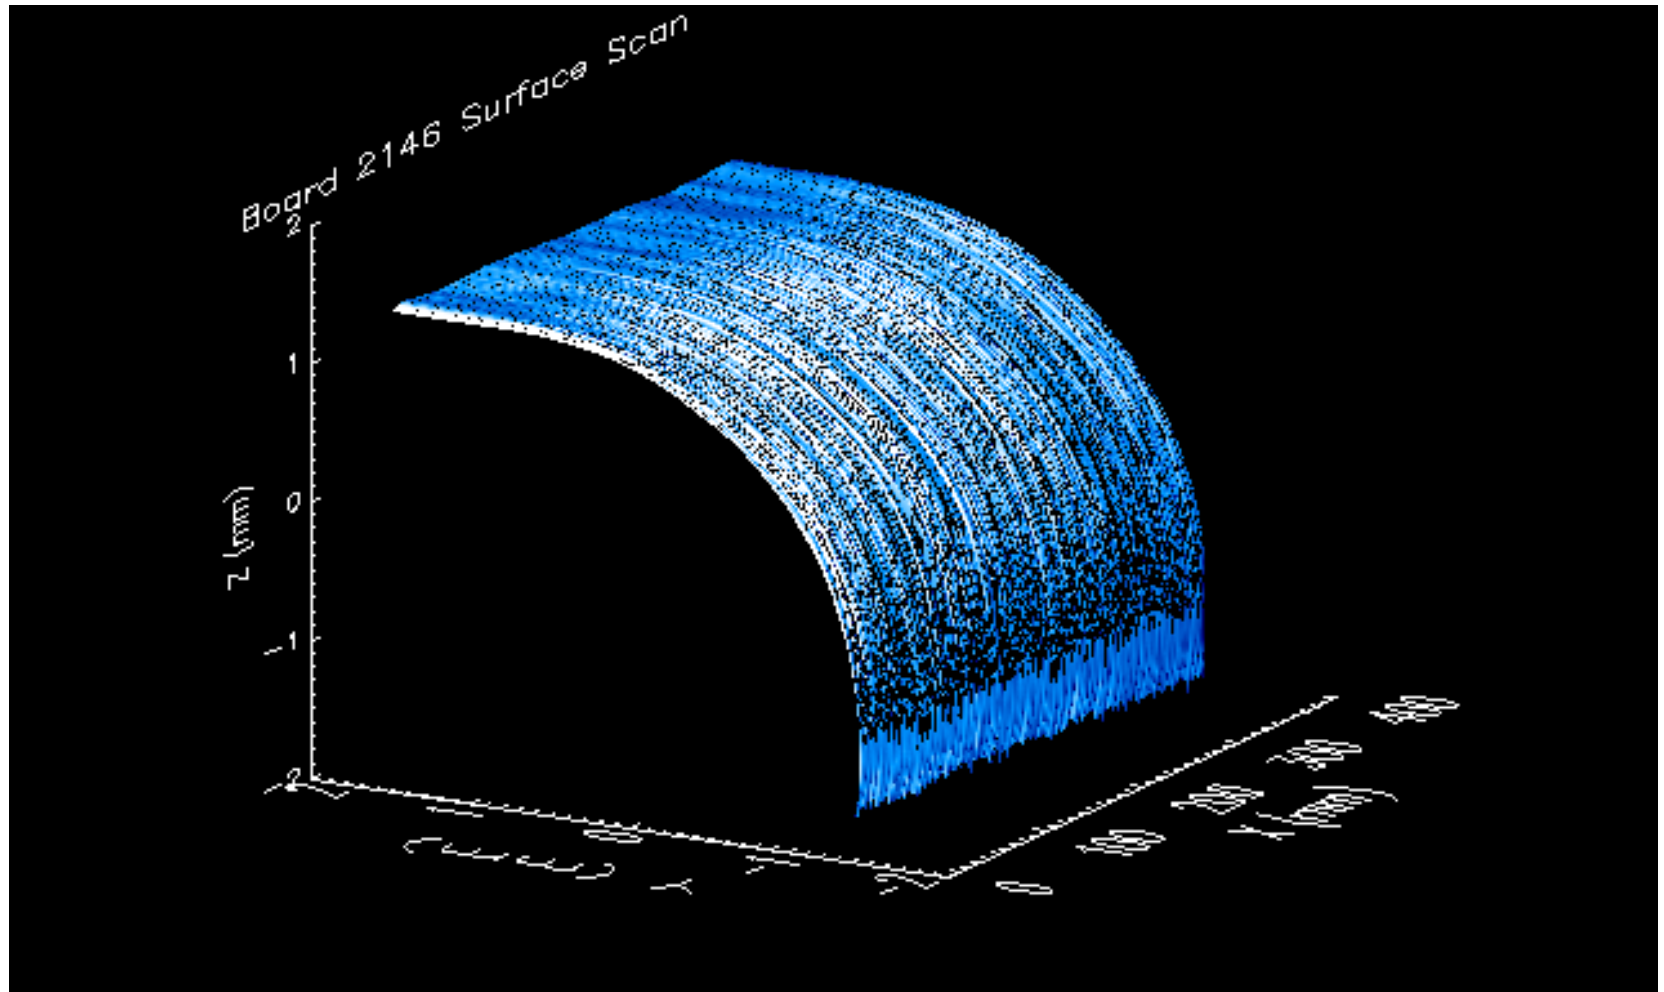
Radius Profile for S/N 2146

- **PWB cut to nominal 1-mm radius.**
 - **Some visual imperfections led to manual “deburring”.**
 - **Did we make them worse and hence break traces?**
- **Empirical test of deburred and undeurred PWB.**
 - **Same results from both.**
- **Detailed CMM measurements of ~10 boards.**
 - **Not perfectly 1-mm radius.**
 - **However, defects are small and not expected to be an issue.**
- **Stopped deburring.**
- **Will QC all flight parts prior to bonding.**

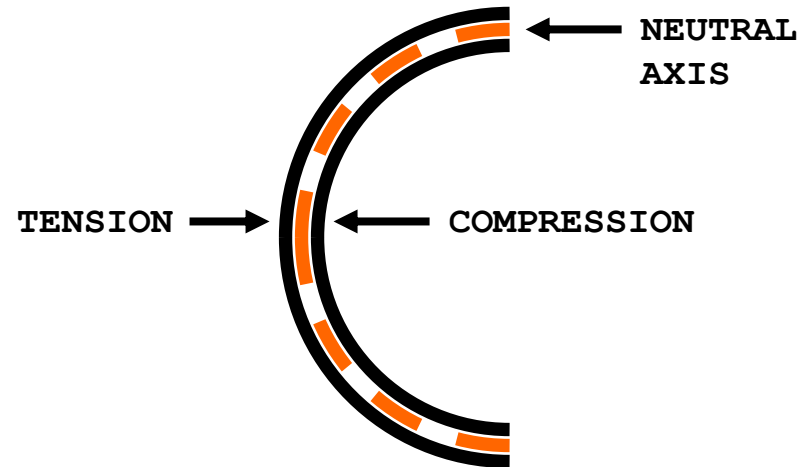
- **Kapton-metal-Kapton structure.**
 - Two Kapton layers under tension and compression.
 - Metal on neutral axis.
 - Minimize strain.
- Cannot cover entire circuit.
 - Need room for wire bonding.
- Difficult to cover just the flex region.
 - Manufacturability issues from alignment.
- Continue without coverlay.
