GLAST Large Area Telescope

Systems Engineering

Test Status, NCRs and Verification Status

Stanford Linear Accelerator Center

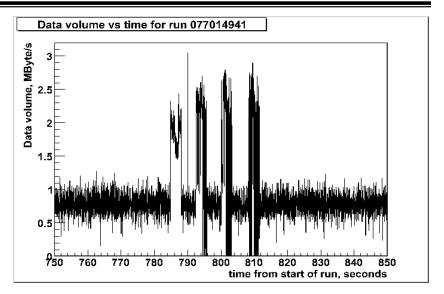
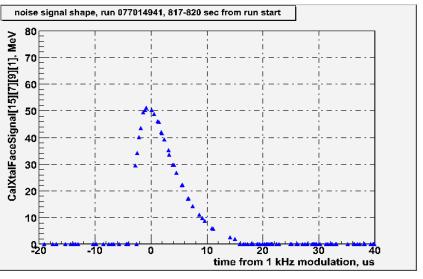
Calorimeter Susceptibility

- Symptoms of susceptibility observed near 280 MHz, both polarizations
 - Excess CAL triggers and occupancy in phase with 1 kHz pulse modulation of RF test equipment

- Predominantly in 4 towers near (+X,+Y) corner
 - Excesses seen only within ~10 us of leading edge of RF pulse
 - Transmitter uses 1 kHz pulse modulation with 50% duty cycle

- **Speculation:**
 - Affected towers are near one of two rise-to-altitude vents on +X face of EMI skirt
 - Perhaps this particular vent is source of RF leakage

- Upper panel: Large LAT data volume
 - Four episodes of high volume
 - Correspond to 4 freq steps near 280 MHz
 - Each freg step = 3 sec RF on, ~4 sec RF off
 - Data dropped during last 3 freq steps when:
 - CPU load rises to 100%
 - error messages seen in Diagnostic stream
- Lower panel: Profile of signal induced in CAL
 - Observation: Excess CALLO triggers are precisely periodic at 1 kHz
 - Use that periodicity to look for CAL signals
 - Measure duration and strength of signal in CAL
 - CAL pulse height has been phasealigned with 1 kHz spike of CALLO triggers
 - TKR-triggered muons (one per blue dot)
 - Trace out excess signal in CAL
 - Consistent with very fast spike through 3.5 us shaper
 - Absence of signal beyond 10 us from time of 1 kHz spike means that this is not a sustained effect in CAL
 - Trigger and data excess is associated with leading (or trailing) edge of RF pulse

- No on-orbit issue, no emitters at this frequency, waiver in process

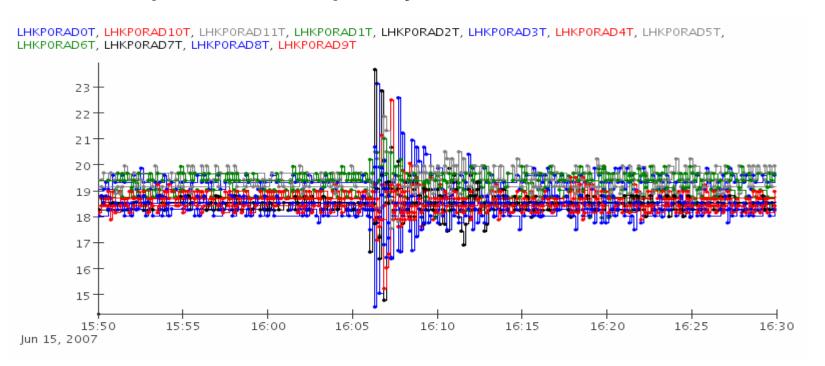
- Observatory RS103 testing reconfirmed a known susceptibility between 30 – 100 MHz of certain RTDs.
 - Radiator
 - VCHP Reservoir
 - ACD Shell
- An example of the susceptibility

- Flag #102 written to document the susceptibility
 - Originally documented in NCR 939
- The susceptibility is consistent with what was found at LATlevel testing.
- Waiver to be submitted

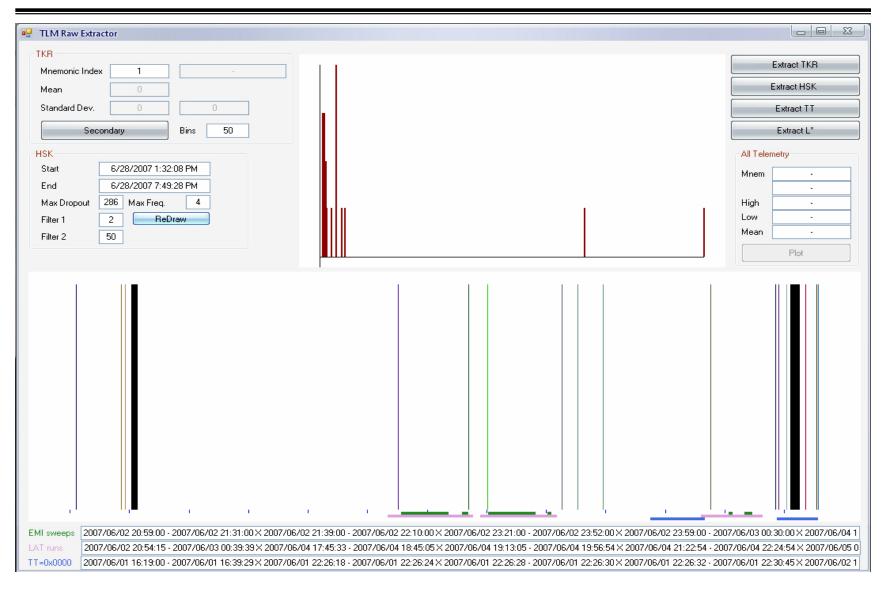
Telemetry and GPS Dropouts

- VCHP-XLHP Temperature Sensor anomaly (see next slide)
- Details of the following set of observed issues in the Spacecraft presentation
 - Housekeeping telemetry dropouts and glitches
 - Instances of dropped telemetry packets or corrupted data
 - Typically correlated to changes in telemetry rate or downlink
 - See next slide for typical frequency
 - Science data dropouts
 - Instances of dropped packets or potentially corrupted packets
 - Non-contiguous SSR dumps
 - SSR/UDL dropped frame
 - Corrupt sync pattern
 - None occurred during susceptibility testing and thus are not EMI related
 - GPS lock dropouts
 - GPS lock flags showed many instances of lost GPS lock
 - See Spacecraft presentation

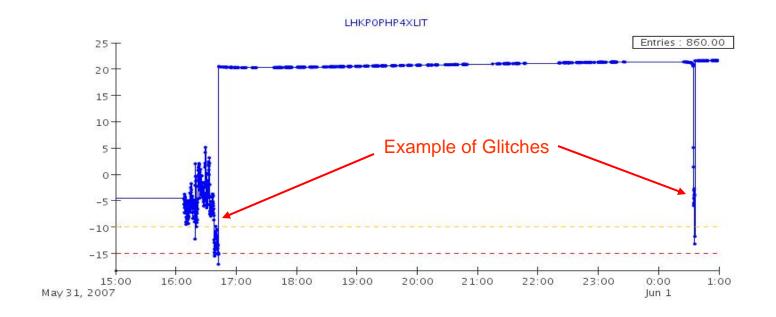
VCHP-XLHP Temperature Sensor Anomaly

Telemetry glitches were found for the +Y VCHP-XLHP heatpipe #4 primary thermistor.

- The glitches were first noticed during self-compatibility
- Review of the telemetry history reveals glitches during LAT pre-TV CPT
 - Magnitude of the glitches range from ~3 DegC to ~9 DegC

- Duration is on the order of minutes
- Glitches are occurring more frequently since the start of EMI testing
 - Magnitude is much larger, duration is longer in many cases

- We do not believe the glitches are EMI test related
 - Glitches found during LAT pre-TVAC
 - Some instances occurred during LAT power on in preparation for EMI testing or in between EMI tests

- LAT recommendation for troubleshooting after the radiators discussed in FRB, potentially to be performed on Monday.
 - Inspecting the interface connector pins, wires and sensors

- With a Ohm-meter connected at the interface connector via BoB, apply hand pressure along wire routing to see if a change in resistance occurs.
- May need to change LAT TCS to read the VCHP-DSHP interface sensor instead if the cause of the glitches cannot be fixed

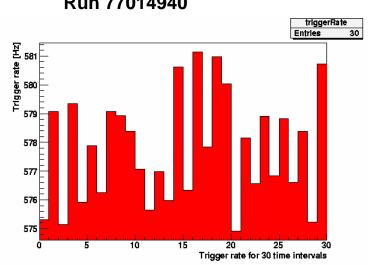
Run 77014940

- The following charts show 4 of the 64 plots for each Digi report
 - Compares run 77014940 (100MHz to 180MHz) to run 77014941 (180MHz to 1GHz)
 - Plots selected to show calorimeter susceptibility effects
- Trigger rates for 30 time intervals showed the spike in events
- Number of CAL LO triggers per tower showed that the triggers all came from tower 15
- Time interval between adjacent events in milliseconds showed that the interference had a 1 msec periodicity
- Average number of crystal hits in a particular CAL layer showed that the effect covered more than tower 15

Trigger rate vs time
