# Anti-Coincidence Detector

Tile Detector Assembly (TDA)  
to

Tile Shell Assembly (TSA)  
Mounting Issues –

Report to SLAC on Nov. 18, 2003

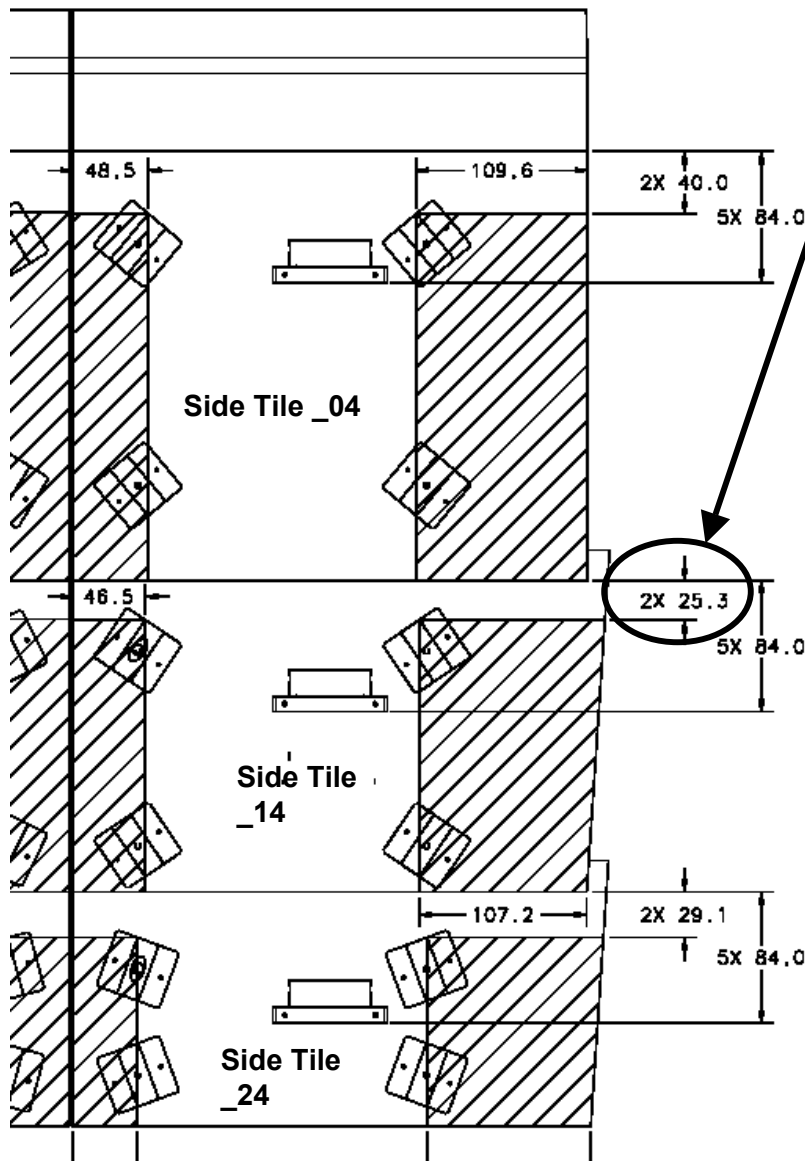
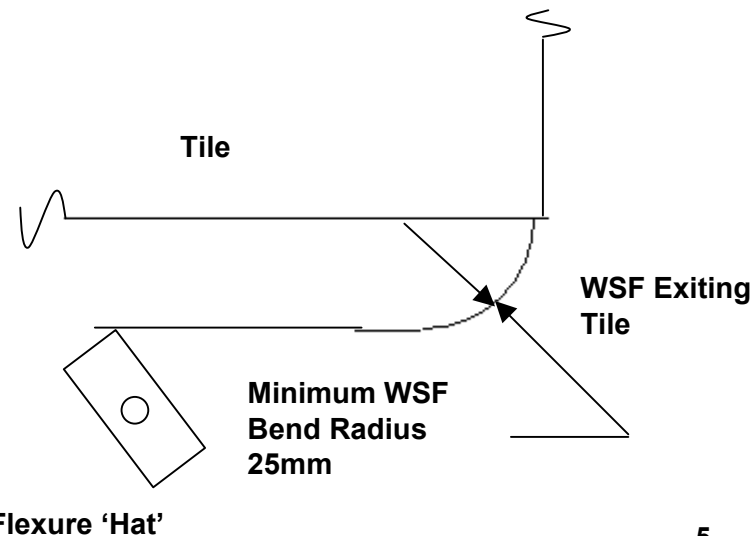
# Tile Spacing Issue – Worst Care

## **BIGGEST CHALLENGE**

•Spacing Between Crown Tile (Row 1) and Row 2 Tile Flexure (Upper) :

•25mm WSF Bend Radius Spacing was the Design at the Time Issue Was Found

•Brings the WSF too Close to Tile Flexures.

- TDA to TSA MOUNT SPACING
  - *Solutions Implemented*
    - ✓ Establish Design Envelope Between TDAs and TSA Mounts.
      - ✓ Worked With FERMI to Establish Acceptable TDA Envelope
        - ✓ FERMI Changed How the Fibers Exit the Tile
    - ✓ Moved Upper TSA Flexure Mounts 5mm for Row 3 TDAs
      - ✓ Tile Edge to Tile Flexure is Now 30.3mm

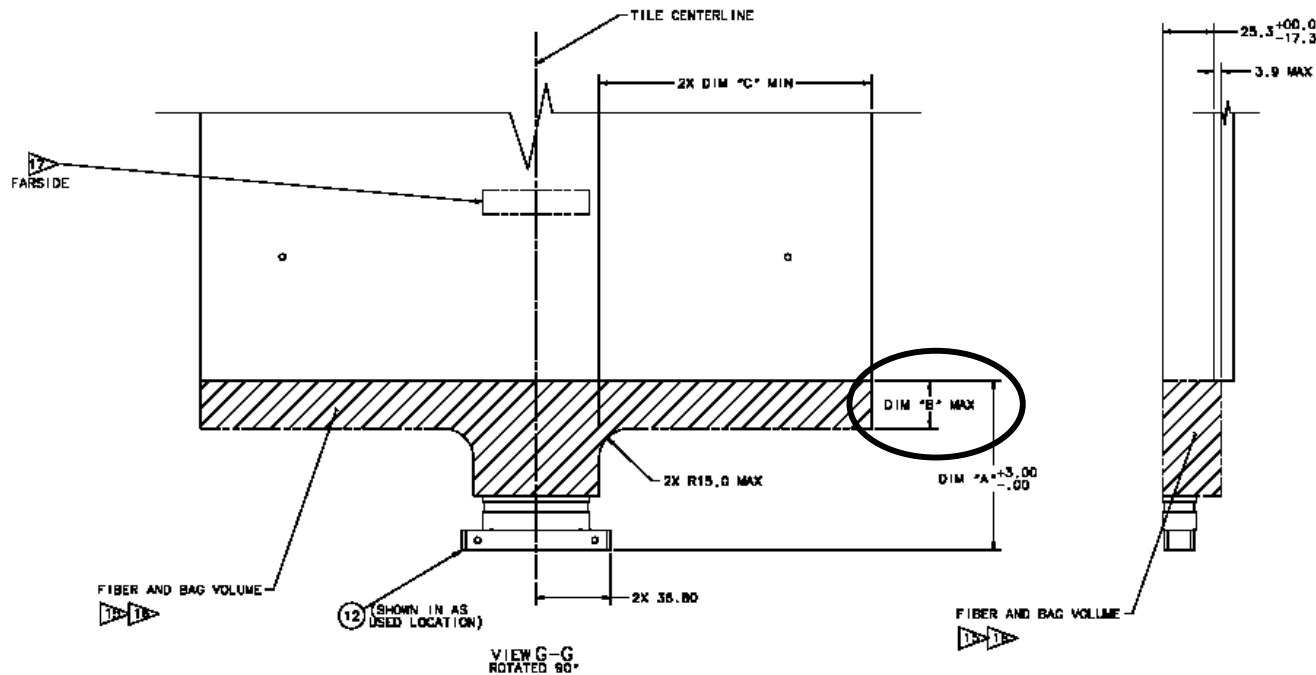
# TDA Envelope Drawing

- Smallest Tile to WSF Envelope (X-Hatch) Dim 'B' is now 23.7mm (MAX)
- Smallest Tile Edge to Tile Flexure is now 29.1mm
- Minimum of 5.6mm Clearance is now Achieved.

- Revised TDA Drawings to Define TDA / WSF Envelope

- Conforms the Numbers (Dim B) FERMI Demonstrated and Agreed with.

- TDAs Inspected Prior to Delivery.

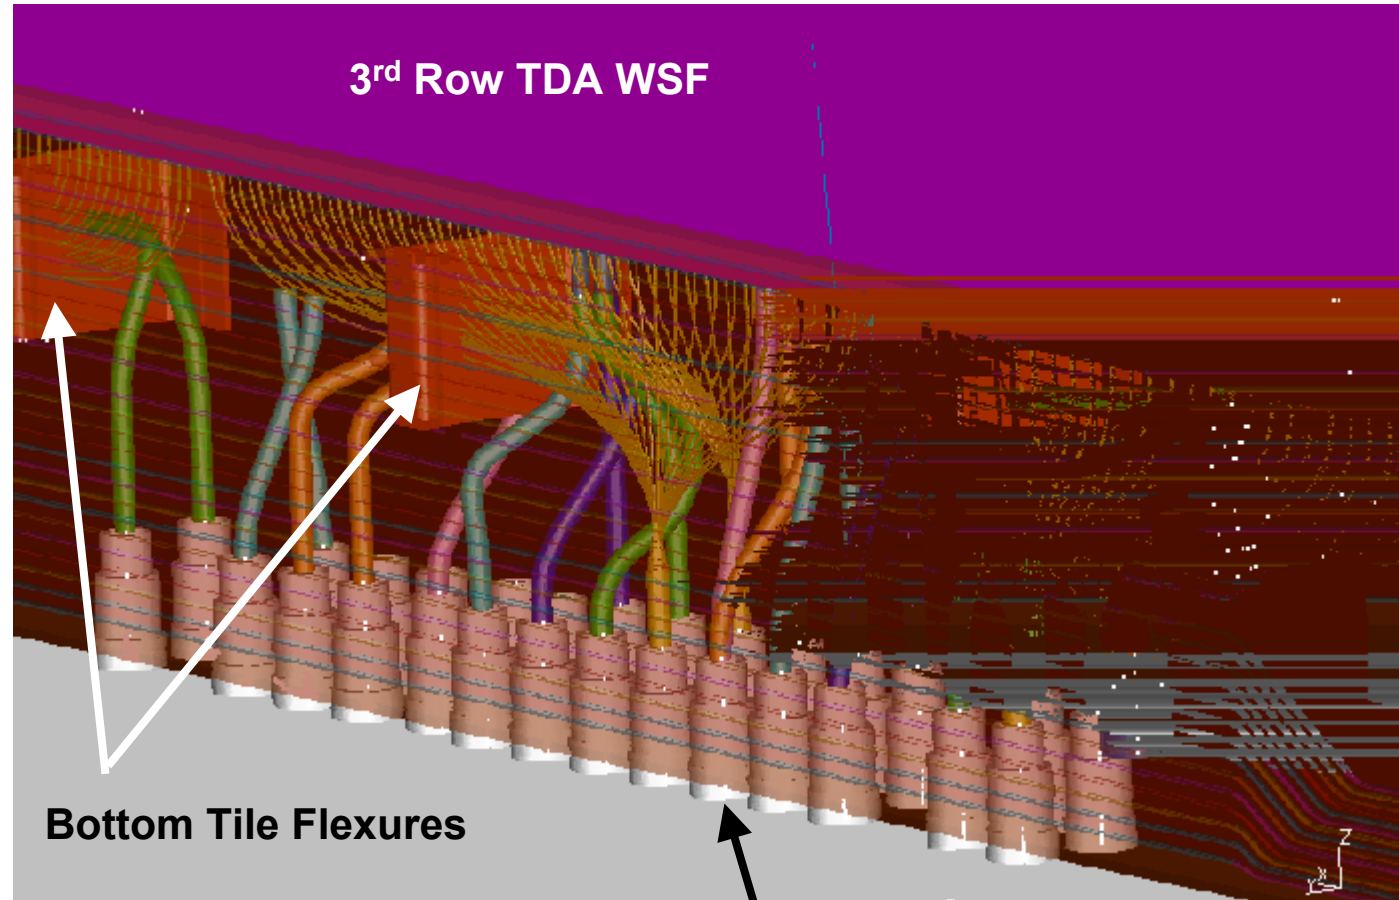
## PROBLEM

- The Bronze Colored WSF Interfere with the Bottom Tile Flexures Shown

- Note: The WSF terminate directly into the PMTs

Bottom Tile Flexures

Clear Fiber Cable  
and WSF  
Terminations
