GLAST Large Area Telescope

LAT Observatory PER

Stanford Linear Accelerator Center

LAT Environmental Test Flow

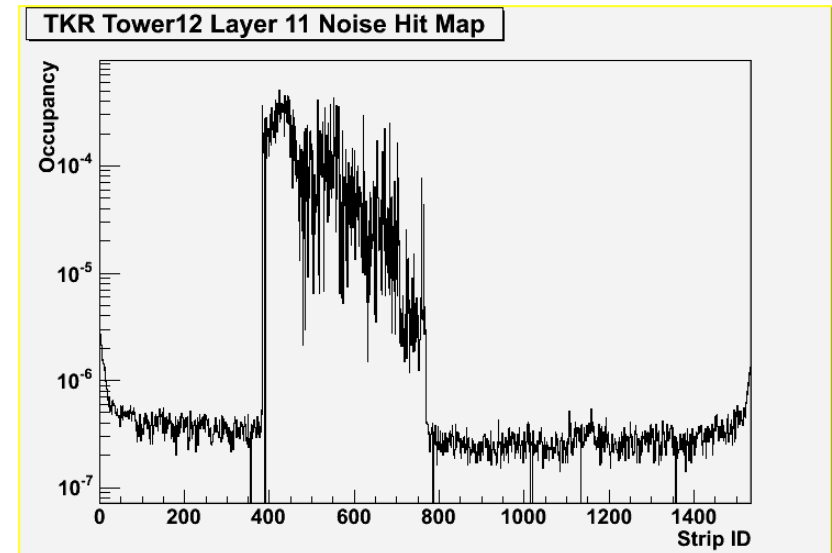
TKR Performance: Noise Flares

- TKR “noise flares”
 - Transient increase in noise occupancy
 - Duration is minutes to hours
 - Little or no dependence on
 - Time (i.e. no increase in rate of occurrence)
 - Temperature
 - Bias voltage
 - LAT-average noise occupancy
 - Mean = 1.3×10^{-6} over June-July muon runs
 - Including flaring episodes
 - Mean drops to $\sim 5 \times 10^{-7}$ when flaring is excluded
 - Worst 90-minute period = 1.5×10^{-5}

Note: LAT occ = Layer occ / 576

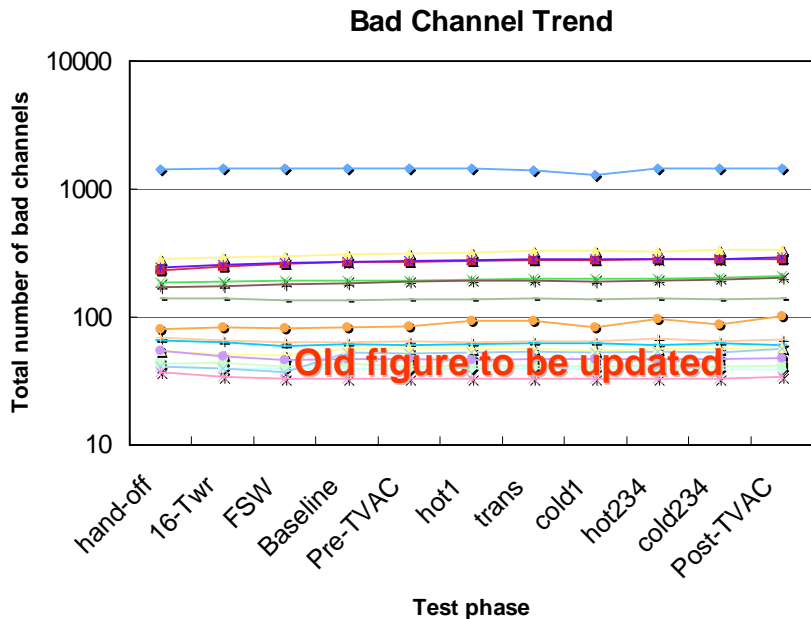
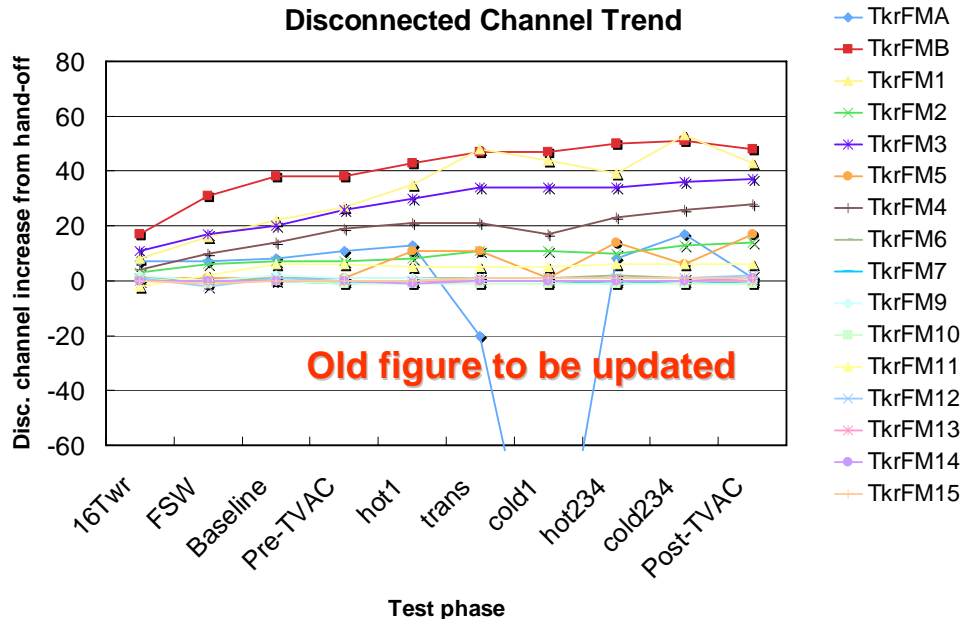
TKR Trending

- **Bad channel trend**
 - Trend is essentially flat
 - Total number of bad channels after LAT env test = 3400
- Total number of TKR chans ~ 900,000
 - Total number of bad channels is within spec
 - <0.3% of channels

- **Bad channel trend**
 - Total increment since LAT completion
 - +XX disconnected strips
 - Small increase in bad count during environmental test
 - <XX% increase
