TMCM J1 J2 Connector Conformal Coat Flow Analysis

- This presentation illustrates an effort pursued by the TMCM Quality team at GLAST/SLAC to find cause of conformal coat flow and contamination into the mating surfaces of the J1 J2 connectors.
- P/N LAT-DS-00898, S/N SN11016, a non-flight unit, was inspected for evidence of conformal coating flow beneath connector bodies and selected because it exhibits what has become a typical reject trend observed while performing incoming inspection, as received from vendor.
- The J1 J2 connector body were destruct lifted from the surface of the PWB, solder joints left intact, for this investigation.
- For the purpose of this report, when referring to J1 J2 connectors, the term 'front side' is used when viewing the connector from the circuit side. 'Backside' is used when viewing from the connector saver (hookup) side.

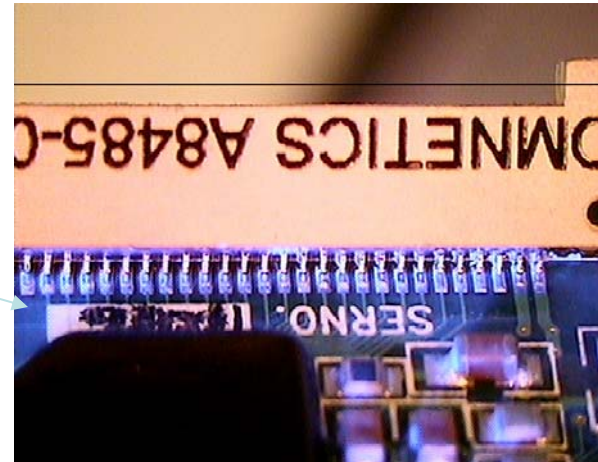
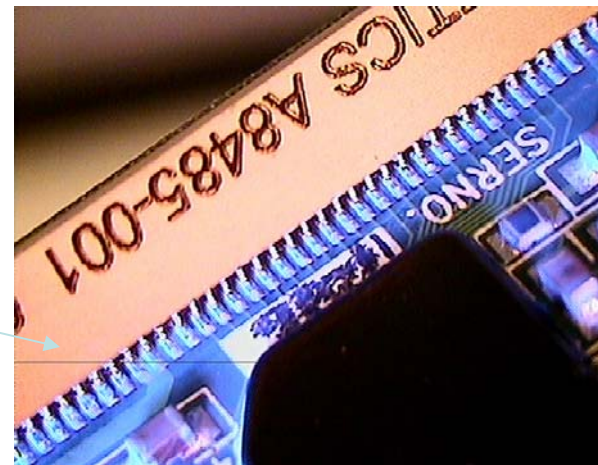
- J1 PWB SMT (front side) view
- *Purple luminescence is caused by the use of UV light*
- J1 PWB SMT view2

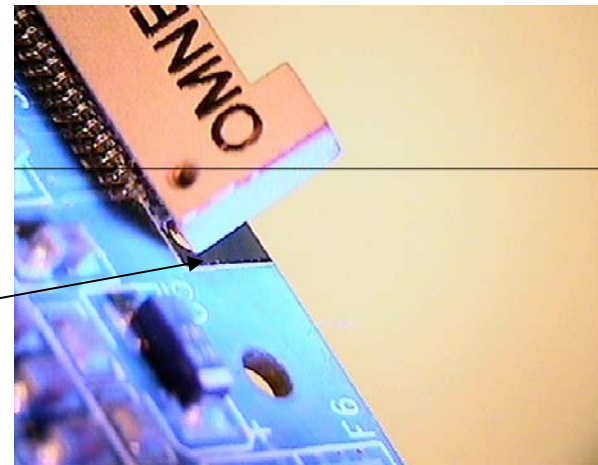
- J1E PWB SMT view
- Note flow of conformal coat and where it stopped.

(SMTs are shadowed by connector body)

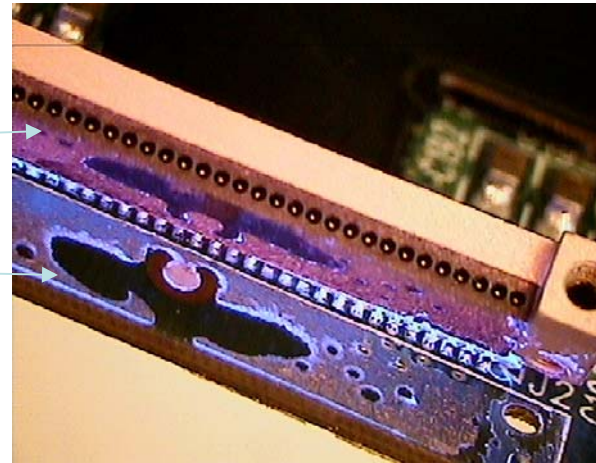
- J2 edge beneath
connector body
PWB

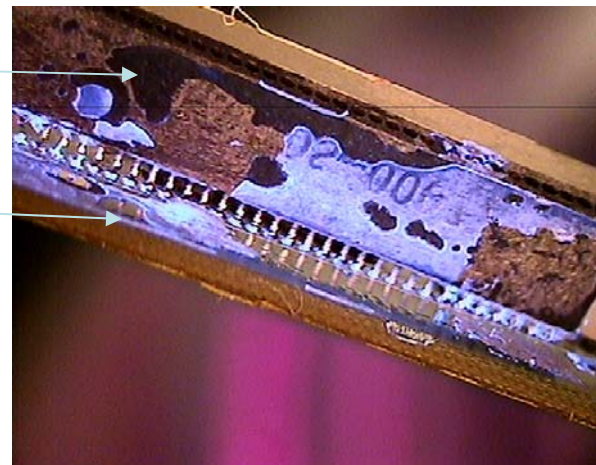
- J2 connector body
bottomside
to PWB

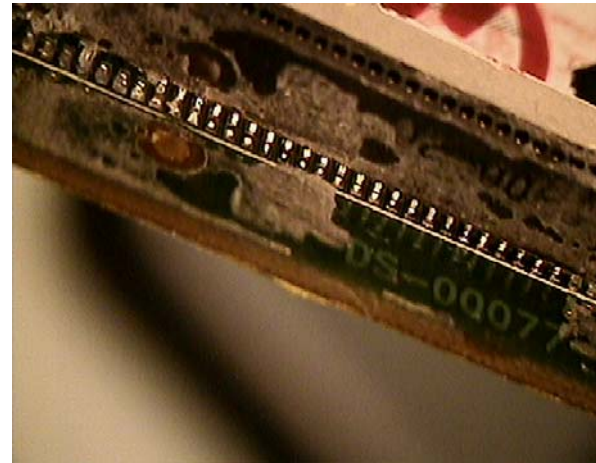
- J2 bottomside to PWB (no UV) →

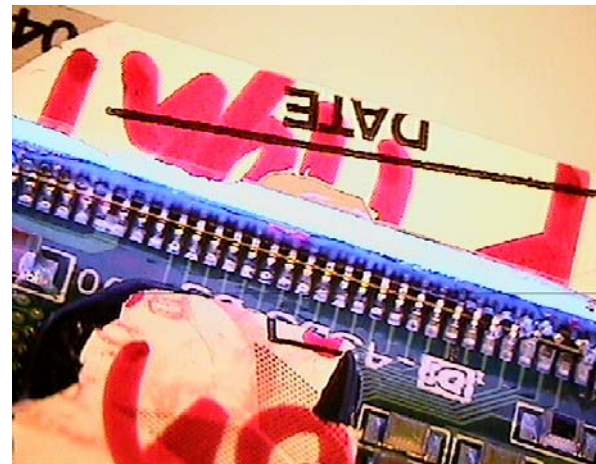
- J2 PWB SMT view →

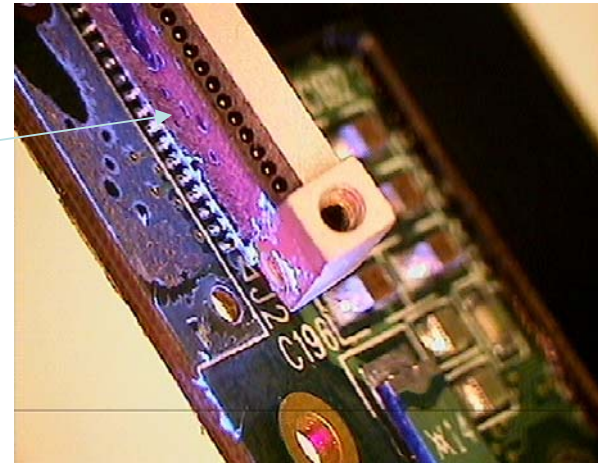
- J2E backside
beneath connector
body

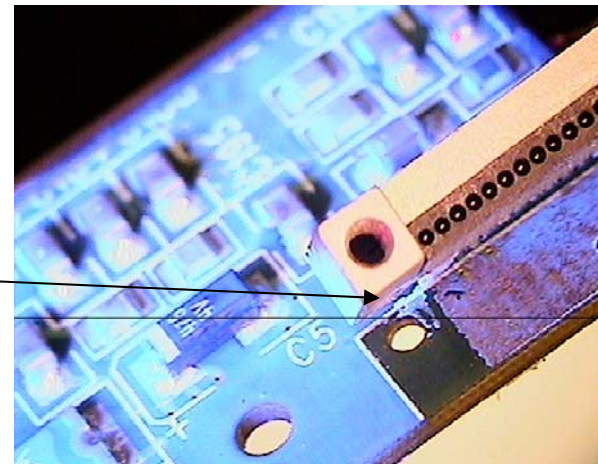
- J2W backside
beneath connector
body
