Status Report GSFC W Tile Etching & Priming For GLAST Trays 5 October 2004

Ben Rodini
Swales Aerospace

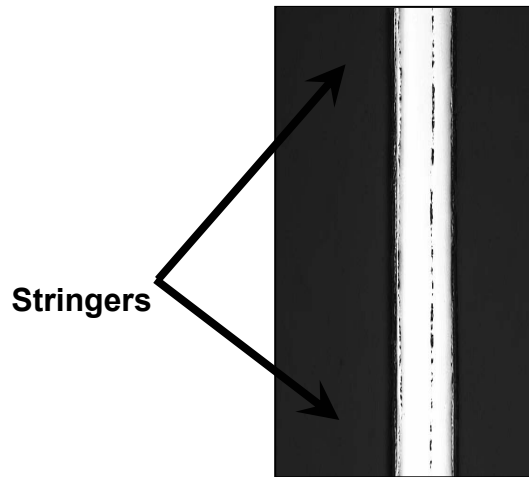
Figure 3. Cross section of tungsten foil showing "stringers" of included material. ~ 200X

Photomicrographs Show Carbon-like Foreign Material and Layered Nature of Tile

- Etch Must Remove Surface Material Beyond Nearest "Stringer" to Surface
- Stringer Areas May Weaken Tile

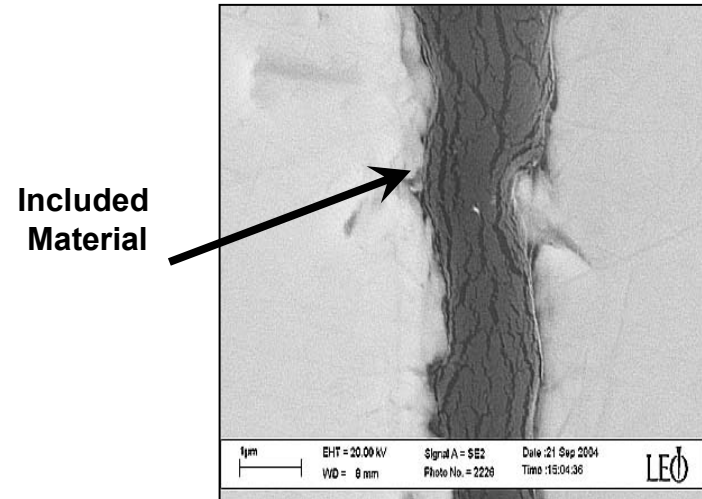
Figure 5. SEM photograph of included material. EDS revealed very high carbon, low tungsten content in included material as opposed to tungsten base material

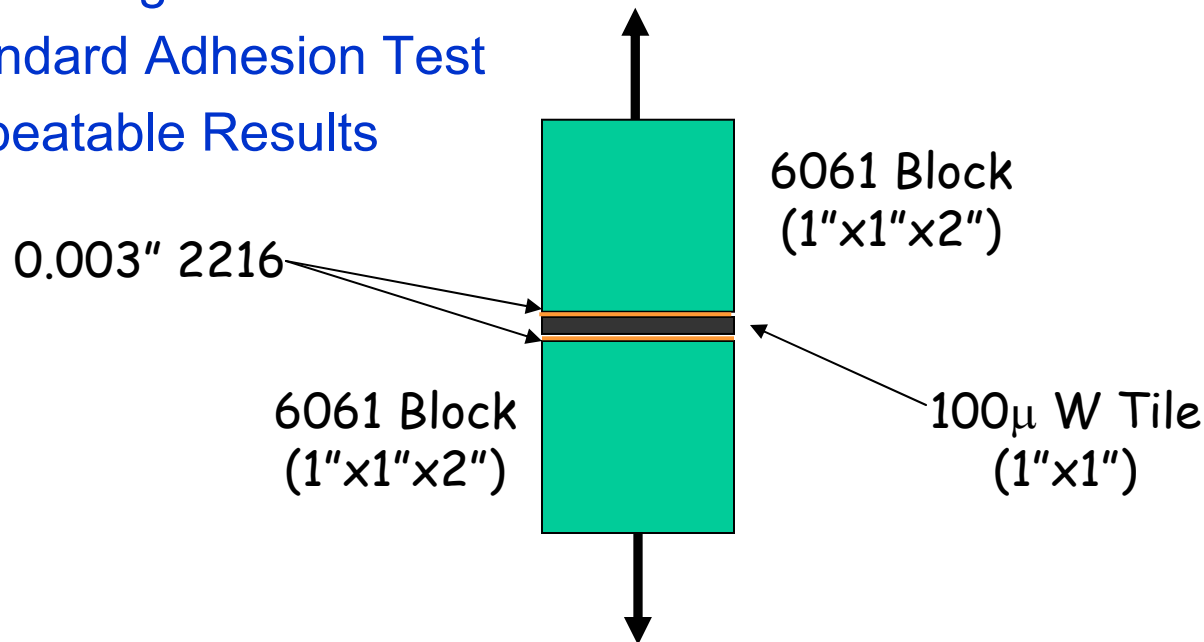
- Original Test Specimen was T-peel Type
 - Flexing of Adherents is Inherent in Specimen
 - Flexing Loosens Primer Unrealistically Compared to Expected Tray Deformation
- Switched to Flatwise Tension Specimen (Modified ASTM C297)
 - No Flexing of Adherents
 - Standard Adhesion Test
 - Repeatable Results

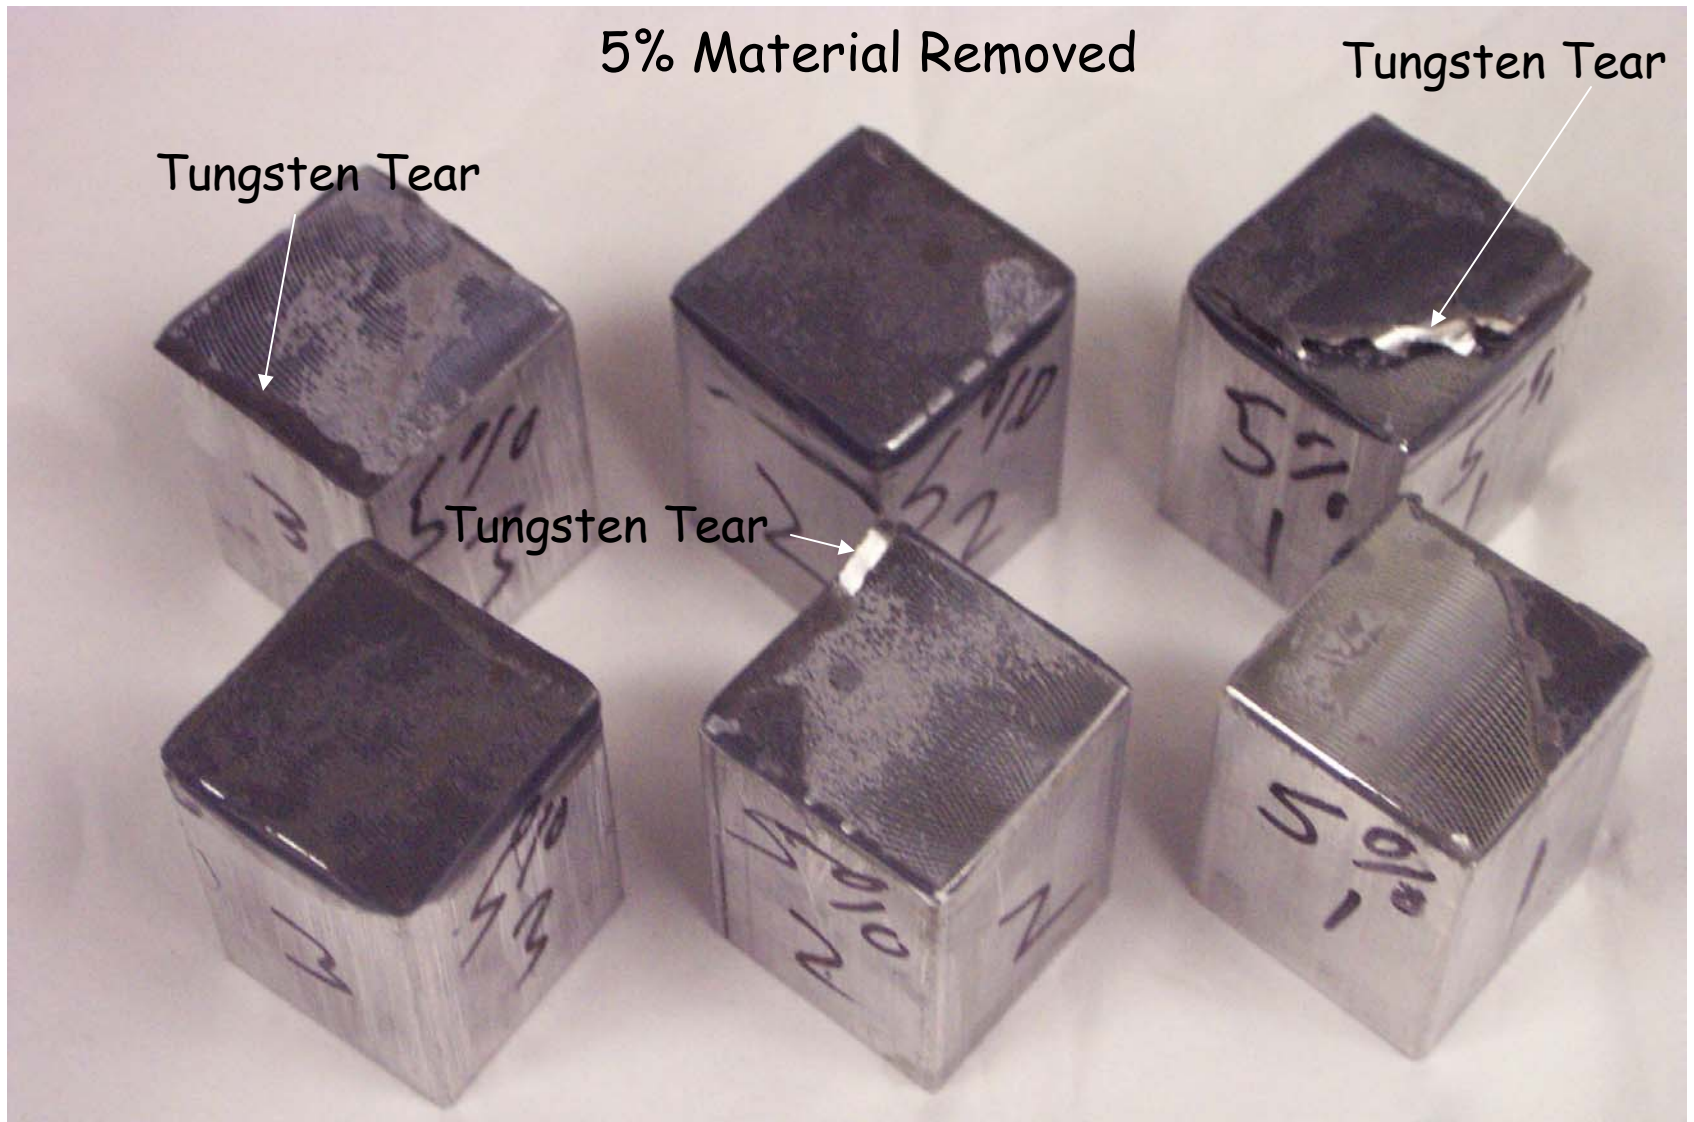
5. Flatwise Tension Specimens: 1,2,3

100-micron W Tiles:
Ammonium Bifluoride Etch and BR-127 Primer; 5% Weight Removed by Etch
Production Size Bath

Specimen	Failure Load (lb)	Failure Mode
1	Problem with Test Machine	W Tear over 1/8 of Specimen ¹
2	2345	W Tear on Specimen Edge ¹
3	2451	W Tear; 2216 Cohesive Failure to Block ¹
Average	2398

¹BR-127 Remained Attached to 2216

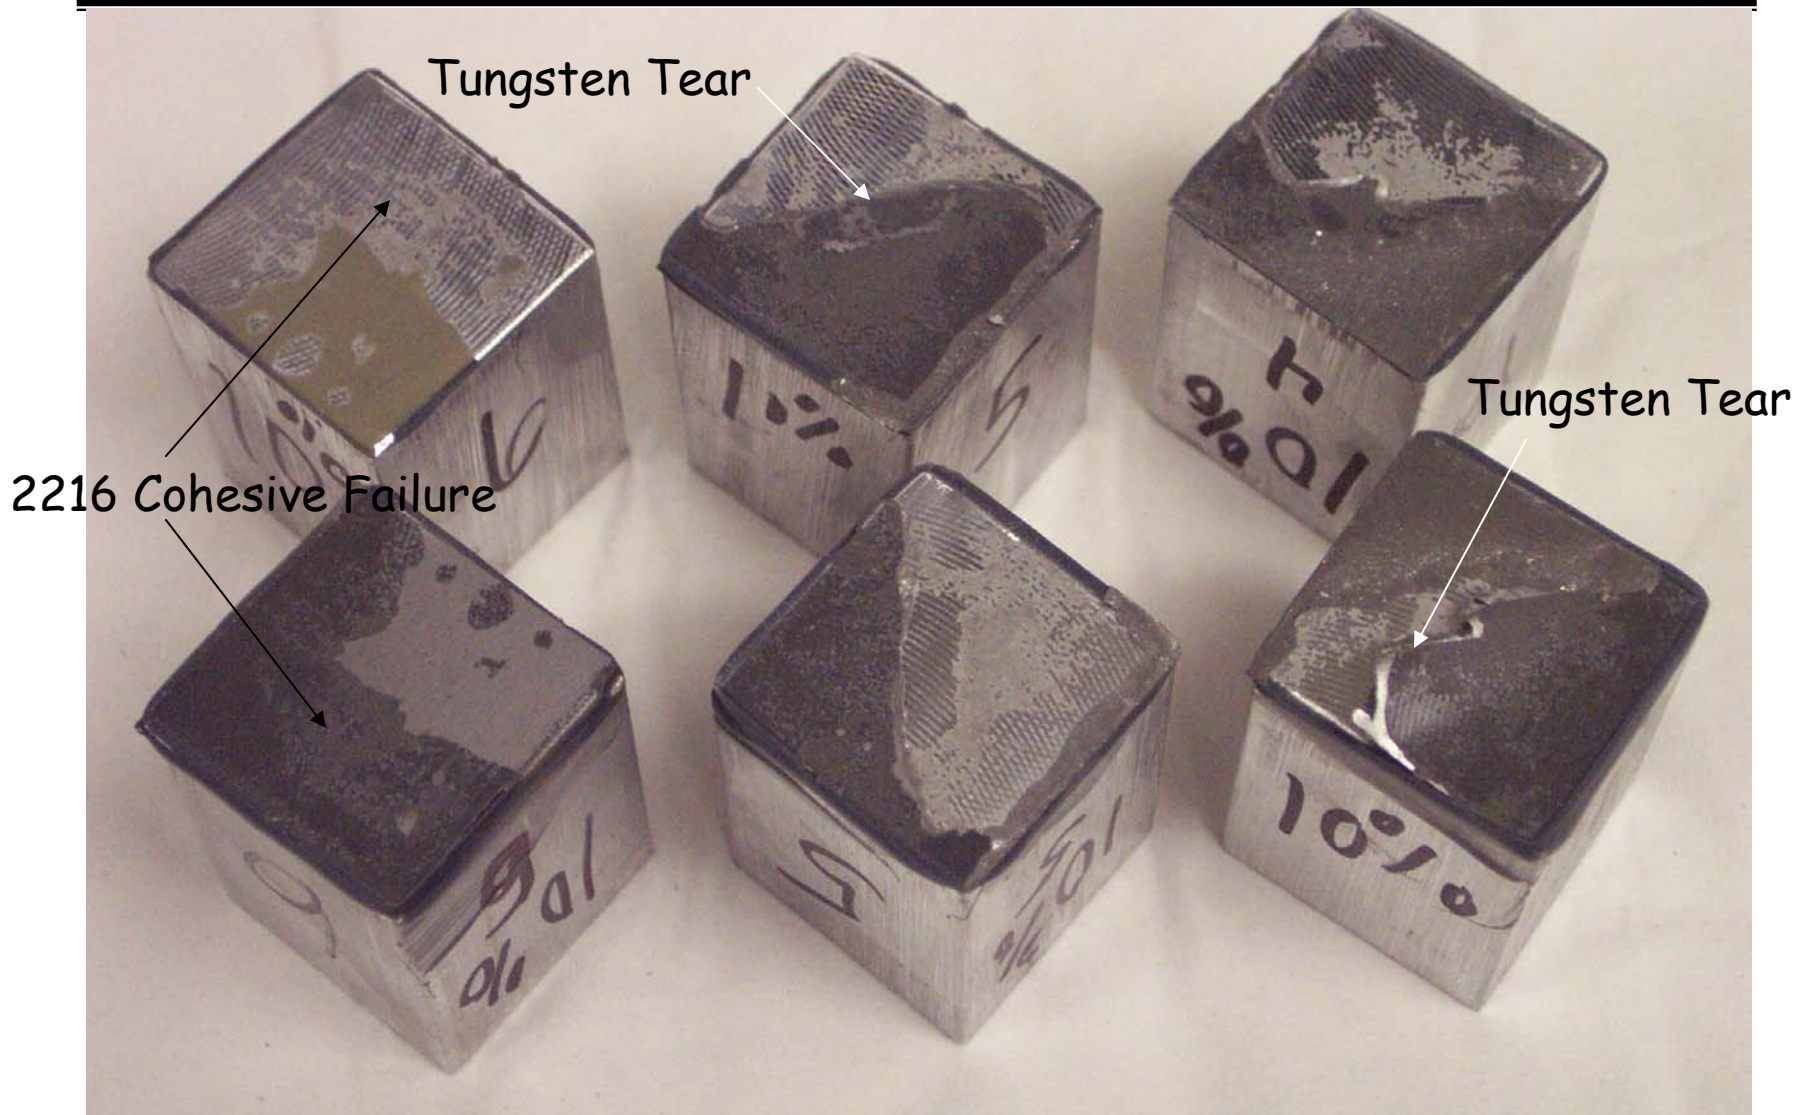
5. Flatwise Tension Specimens: 4,5,6

100-micron w tiles:
Ammonium Biflouride Etch and BR-127 Prime; 10% Weight Removed by Etch
Production Size bath

Specimen	Failure Load (lb)	Failure Mode
4	2460	W Tear over 50% of Specimen ¹
5	2476	W Tear over 50% of Specimen ¹
6	2456	30% Adhesive to Tile; 70% cohesive to Block ^{1,2}
Average	2464

¹BR-127 Remained Attached to 2216

²2216 Likely Failed to Block First and Caused 2216 to Fail to Tile

- a. Samples with 5% & 10% Material Removed Performed Equally Well
- b. Select 5% Material Removal to Minimize Science Impact
- c. BR127 Adhesion to Etched W is Very Good
- d. BR127 Adhesion Can Exceed W Delamination Strength
- e. Ammonium Bifluoride Etch and BR127 Should Work for Tile Bonding
