***NCR Number***  
NCR/FM/INFN/RM2/1

<b><i>Part number</i></b>	LAT-DS-00180(rev3)
<b><i>Serial number</i></b>	006, 008, 015
<b><i>Issued by</i></b>	Francesco Belli
<b><i>Short NCR description</i></b>	Bias circuits delaminations
<b><i>Approved by</i></b>	Alessandro Brez
<b><i>Detected during</i></b>	T. Vac test
<b><i>Cause</i></b>	other (see description)
<b><i>NCR description</i></b>	Bias circuits delamination found after the thermo-vacuum test. See annex 1.
<b><i>Action</i></b>	Refer MRB

## ANNEX 1 to NCR/FM/INFN/RM2/001

### Thermo-vacuum test results

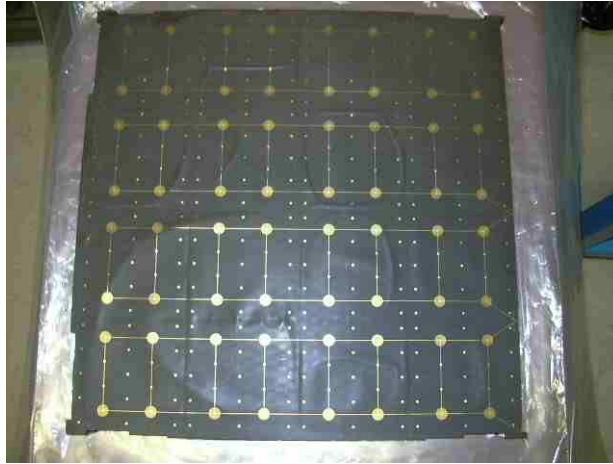
Tray Mid 006:

The following images shows the effect of the test on the trays Mid 006, Mid 008, Mid 015.

The Thermo Vacuum Test of the trays Mid006, Mid008, Mid015, failed. The bonding between the Bias Circuit Foils and the panels relaxed and the foils showed a large surface wrinkling (see picture 1, 2, 3, 4):

These large debonding areas seem induced by the CTE differences between Cu shield layer (CTE = $17 \times 10^{-6}$  1/°C) and the tray (CTE $\approx$  0). The Shear Stress overcame The shear strength of the adhesive with regular and uniform deformations.

<u>disposition ID:</u> 2		
S/N 006, 008 send at Plyform for rework on the Kapton, the following action have been decided: A) to remove the old Kapton at 60°C B) to increase rugosity on Tugsten C) verify rework with standard flow of tests (ESPI, dimensional test, TVAC test)		
<u>Finding</u>		
<u>responsible</u> Alessandro Brez	<u>due date (mm/dd/yyyy)</u> 6/30/2004	<u>closed</u> <input type="checkbox"/>

<b><u>disposition ID:</u></b>		4
Change thermal-vac test temperature to Tmax = 55°C and update test document accordingly for future test cycles.		
<b><u>Finding</u></b>		
<b><u>responsible</u></b>	<b><u>due date (mm/dd/yyyy)</u></b>	<b><u>closed</u></b>
Alessandro Brez		<input type="checkbox"/>

We suggest to decrease the Peak temperature of the Thermo Vacuum test of the trays from 85°C to 55°C, 5°C Higher than the requested max temperature as for LAT-TD-03651.

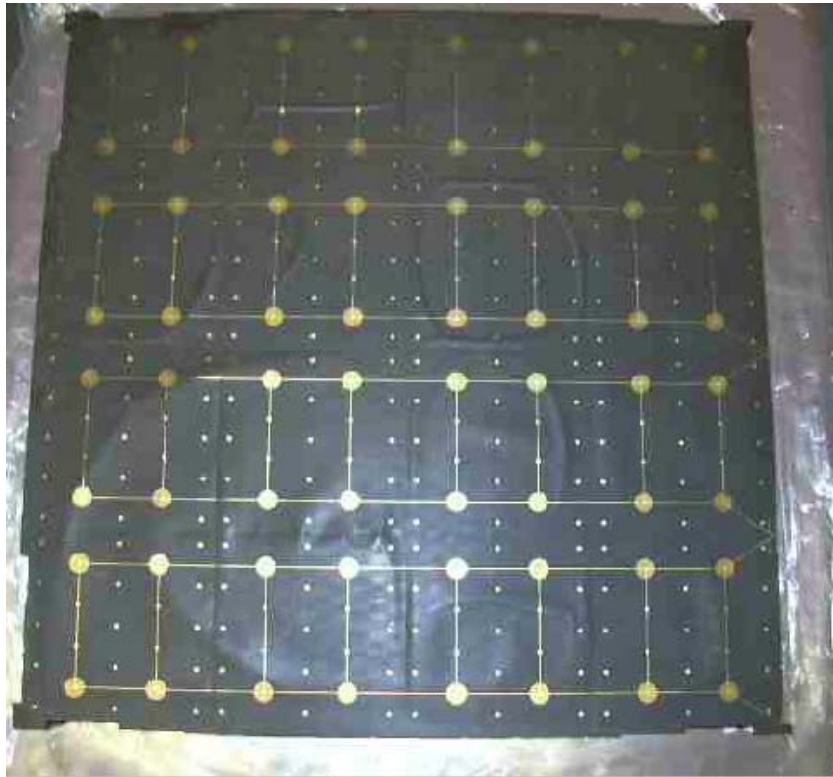
**Mid006 Bottom Surface**

The Peak temperature of this test is 85 °C; the **3M Scotch-Weld 2216** epoxy glue data sheet shows a relevant decrease of the typical Shear Properties (see table below):
