Mechanical Systems Mechanical / Thermal Hardware October 2005 Status

Marc Campell, Subsystem Manager

Grid Qual Static Load Test

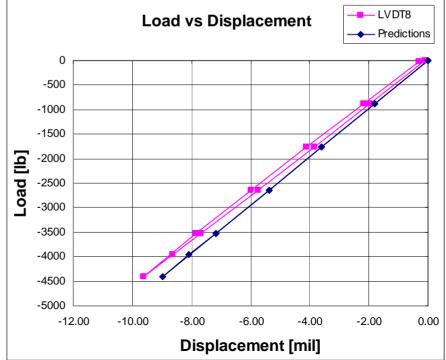
LC 3 Grid center displacement

- LC 5 & 6 stiffness testing without CAL baseplates deleted
 - Test results from LC3 & 4 have been reduced and show good correlation to the model
 - Tap test of the Grid performed with good correlation to predicted frequencies
 - 34 Hz torsion mode within 8.5%
 - 182 Hz Drumhead mode within 14%

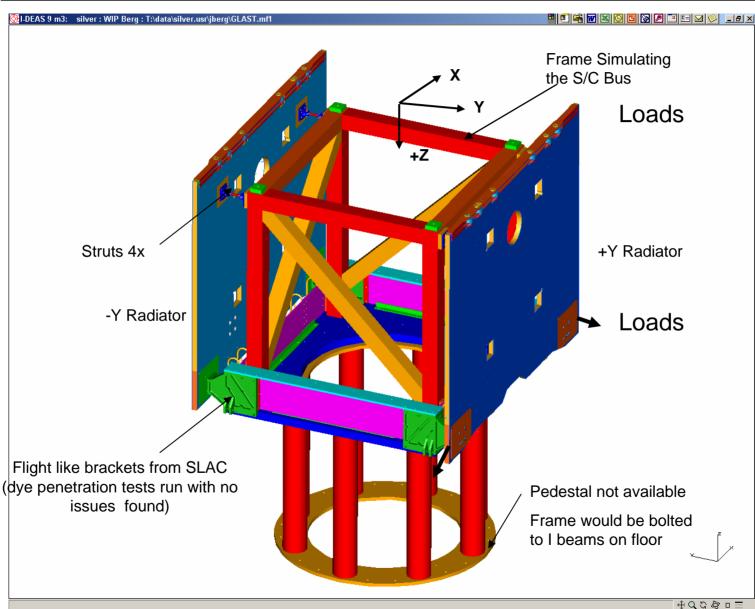
Static Load Test Test Configuration

- Radiators would be mounted to flight like interfaces on the Acoustic test fixture
 - Load fixtures would mount to handling inserts on the X sides of the panel
 - Panel is pulled at –Z corner to produce shear load and moment at RMB interface
 - X and Z load components are approximately 200 lbs
 - Handling insert coupons were tested in shear and B basis capability is 525 lbs

- Agree on test approach
- Detail out Static Load Test implementation
 - Fixture tie down, load application, data acquisition, strain gage requirements, pass/fail criteria, cleanliness approach
 - Fabricate fixtures
- Complete review of LM Acoustic test data to see if MECO modes can be found or if additional testing is required
- Conduct TRR
- Conduct test
- Process required waivers
 - No sine vibe of Radiators
 - No 0 150 Hz sine sweep for MECO modes
