GLAST Large Area Telescope: Tracker Subsystem WBS 4.1.4

Persis S. Drell
Stanford Linear Accelerator Center
LAT Deputy Project Manager

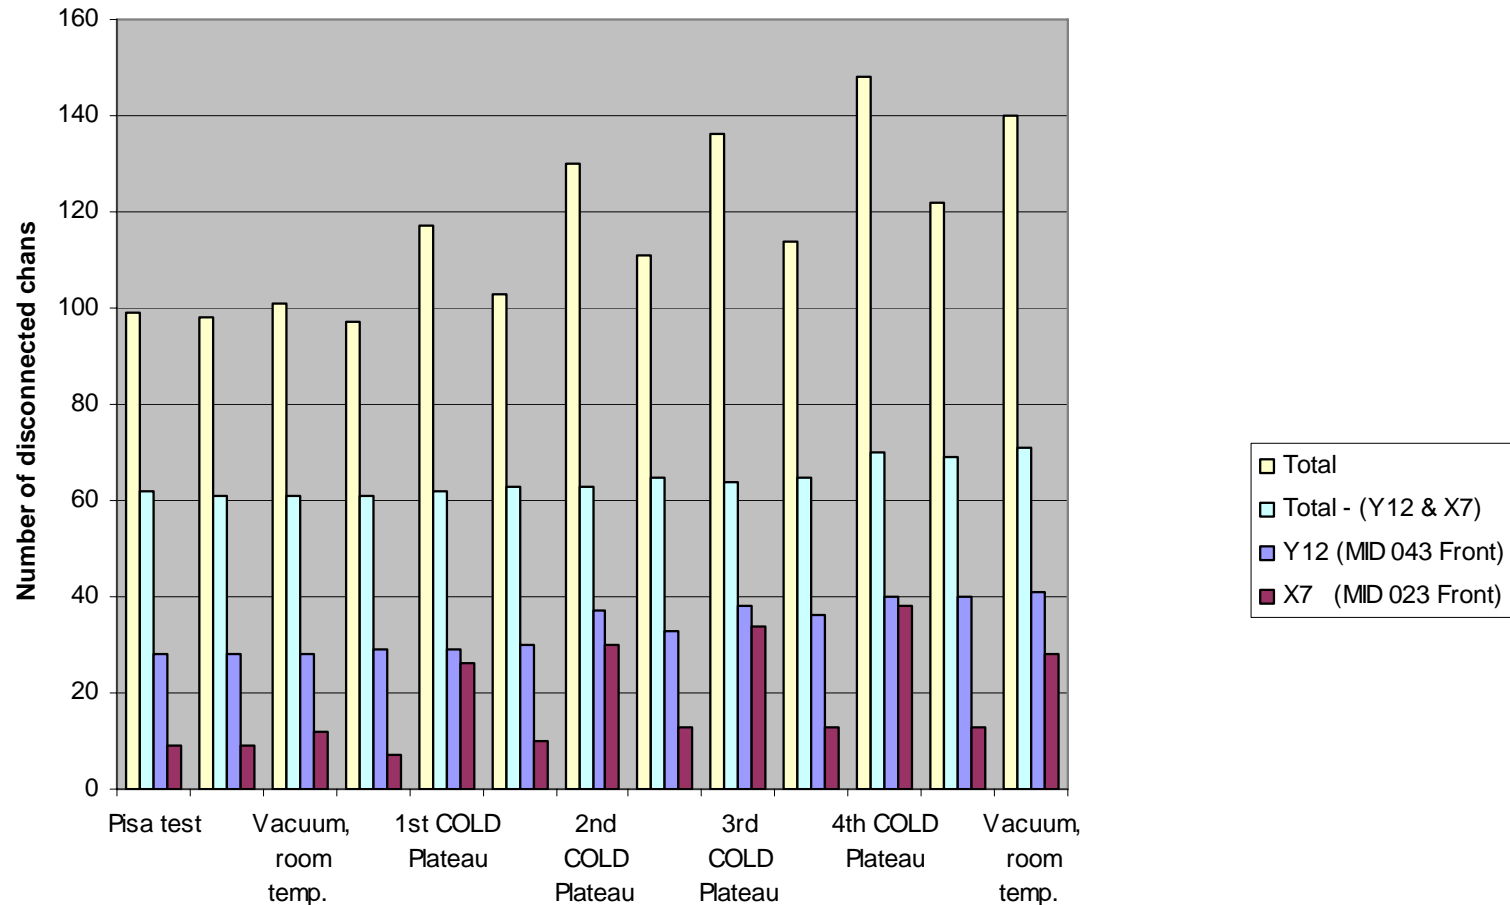
Missing Channels vs T/V cycle for Tower B

Tower	Layer	SLAC	G&A	T-Cycle	Vibe	T/V
A	X1	0	156	174	177	178
A	X3	4	21	22	22	22
A	Y3	2	128	138	140	128
A	Y6	0	34	36	36	51
A	X0	1	4	6	6	9
B	Y9	7	13	16	16	19
B	Y12	15	17	28	28	41
B	X7	7	8	9	9	28
1	X17	1	0	19		
1	Y3	1	22	23		
1	Y0	0	11	19

Disconnected channels in different runs

- **MCM Anomaly Found During Tower A Tray Assembly at G&A**
- **Missing channels due to wire bonds breaking at Pitch Adaptor to ASIC joint under black encapsulation due to delamination of the encapsulation**
 - **Root cause hypothesized to be silicone contamination from masking tape applied to entire surface of pitch adapter prior to reflow soldering**
- **Root cause verified:**
 - **Seen in MCM sectioning**
 - **“Seen” in C-SAM images**
- **Electrical Test Procedure at SLAC effectively eliminates all MCMs with more than 15 broken signal wire bonds following thermal cycles.**
 - **Concern is additional delamination and breaking of bonds during tray and tower assembly and test**

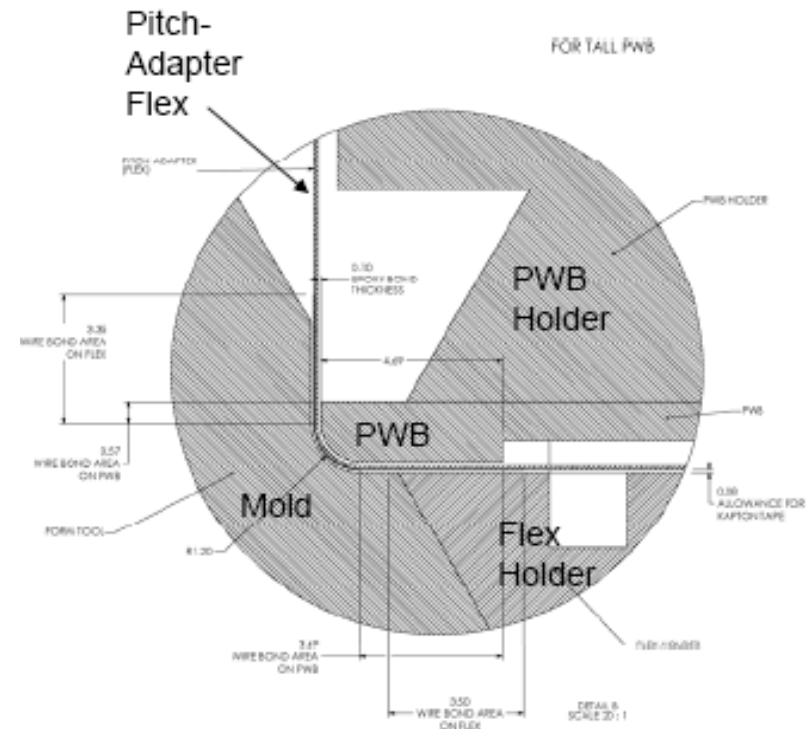
Pitch Adaptor Bonding

- In process of PA investigations recognized Teledyne process for bonding PA is not satisfactory
 - Uncontrolled tension
 - Uneven surface for wire bonding in Italy
 - Large incidence of voids that need rework
 - Poor alignment control
- New fixture designed to form bend in mold
- First article test of new fixture in process

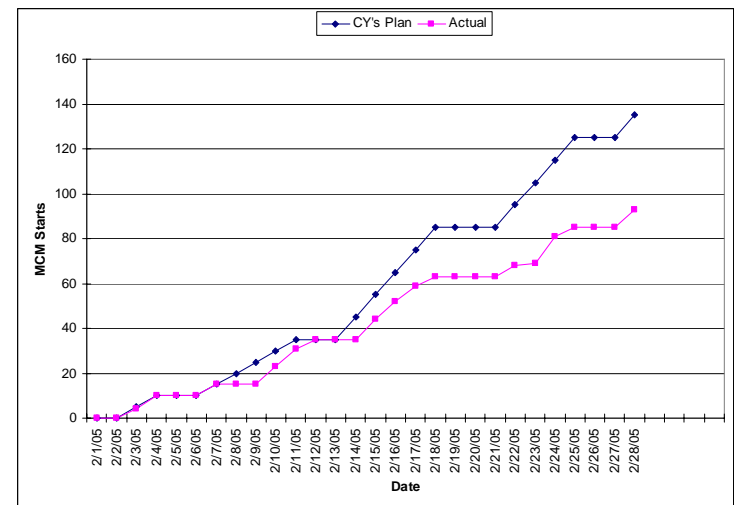
- Production restarted 2/3/05
- As of 2/28/05
 - 93 MCM starts
 - 60(7) MCM's have pass(fail) at MIP-1
 - 23(2) MCM's have pass(fail) at MIP-2
 - 6(1) MCM's have pass(fail) at MIP-3
- Charlie's goal:
 - 10 starts/day
 - 6 days/week
 - recall yield is not 100%
- The plan to increase production and yield (both are needed!)
 - Saturday shifts
 - Deploy new bonding fixture
 - to increase yield
 - ease flex bonding bottleneck
 - Hire new operators to get to 12hr/day operations
 - flex bonding and encapsulation is where they are needed

- **Critical path for tracker schedule is through MCM production now**
 - **MCM production critical path for Tower 4, 5, 6**
 - **Aggressively pursuing options to speed up production**
 - Burn in removed as bottleneck by installing second oven in Bldg 33
 - Detailed discussions with Teledyne on how best to improve ramp up
 - **Current schedule has Tower 4 completed at G&A on 3/31**
 - **Tower 4 MCM's delayed a week from original ramp up plan but...**
 - We have 5 spare trays that can be used in Tower 4
 - We have 8 MCM's (old production) that can be used on Tower 4 trays
 - Need only 18 new production MCM's to complete Tower 4

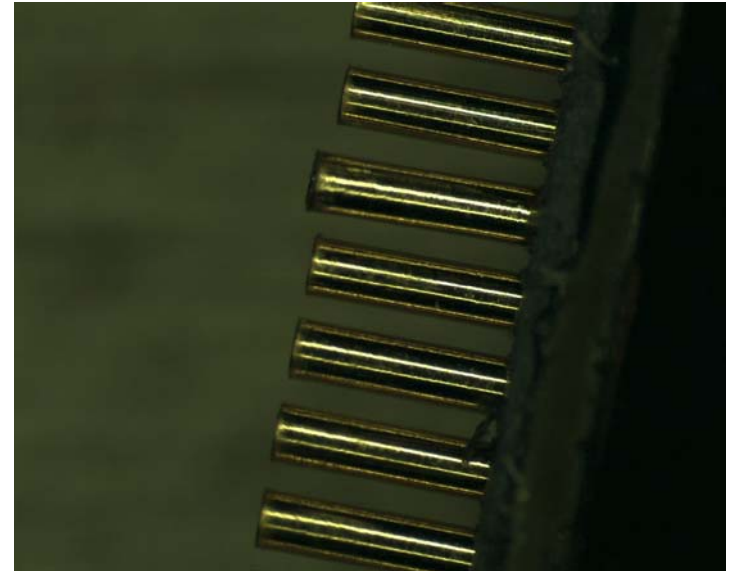
- **Tower 2: Continued**
 - Late breaking news: pin18 on flight cable C3-008 was found to be broken on the J9 connector
 - Hand carry a replacement later this week (bad coupon)
 - MRB 3/2/2005..add to NCR 350
- **Tower 3:**
 - 3 cables with bad coupons, none paired on the same side
