GLAST Large Area Telescope:

Tracker Subsystem WBS 4.1.4

Persis S. Drell
Stanford Linear Accelerator Center
LAT Deputy Project Manager

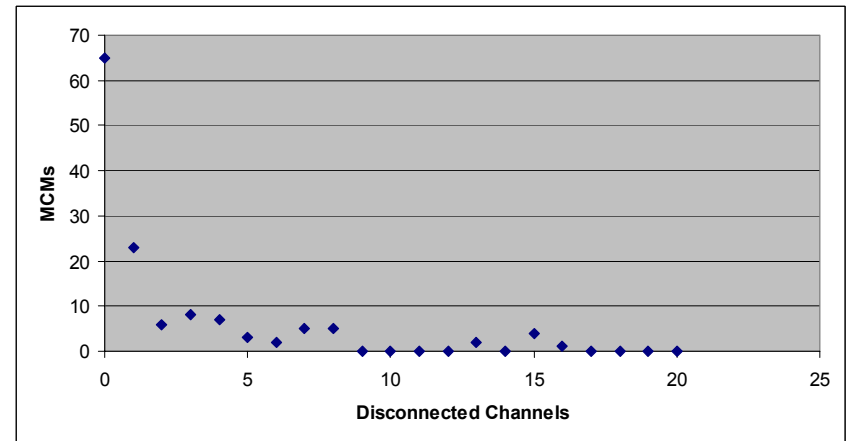
11% of the MCMs have >15 bad connections.
Average number of broken connections/MCM after rejecting those 11% is only 2.

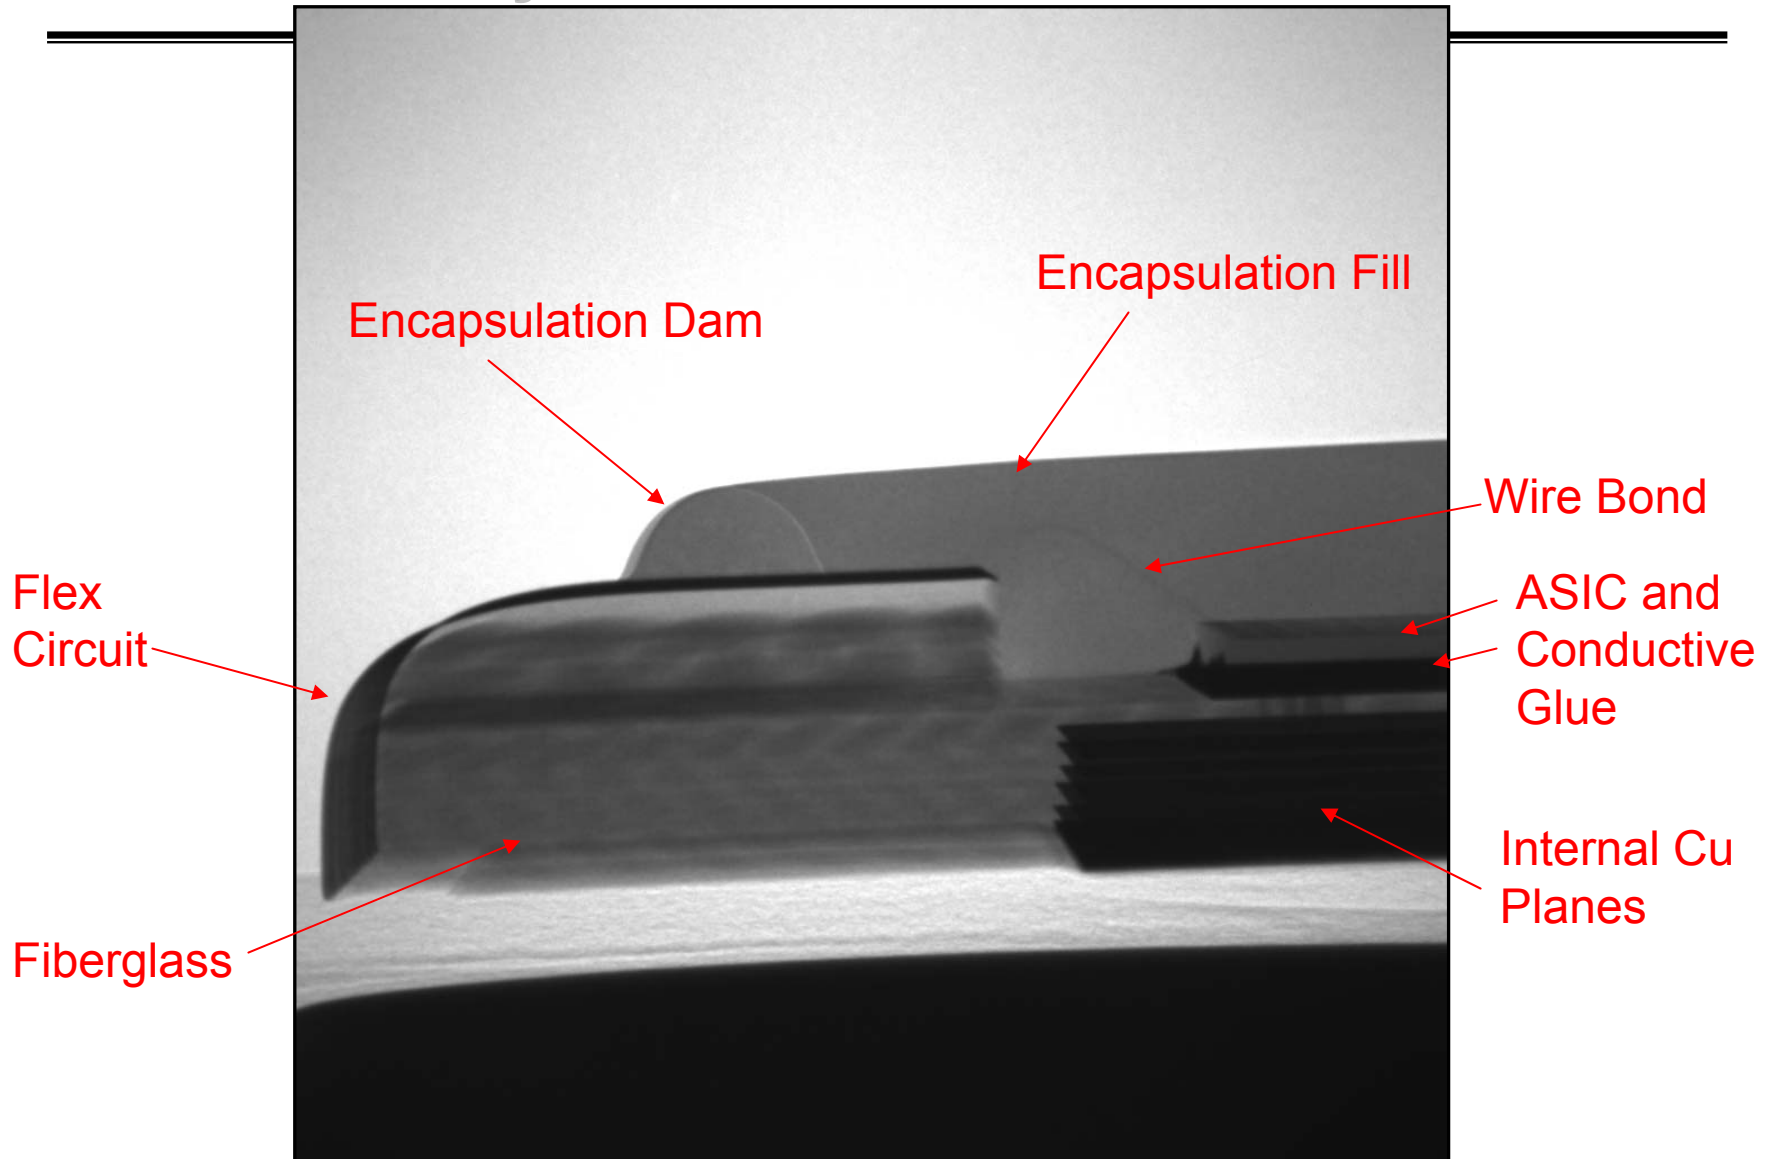
X-Ray Cross Section of an MCM

- **Done by Diane Kolos and Bruno Munoz at GSFC.**
- **MCM SN 775, with ~180 missing connections.**
- **Diane sectioned the MCM at the location of a few of the known bad connections.**
- **Bruno x-rayed the MCM.**

- **The results verify that the wire bonds are broken at the pitch-adapter end, at the “ankle”.**
- **The results also indicate debonding of the encapsulant from the substrates in the affected regions.**
