Open Issues

Tower Zero Assembly Activities

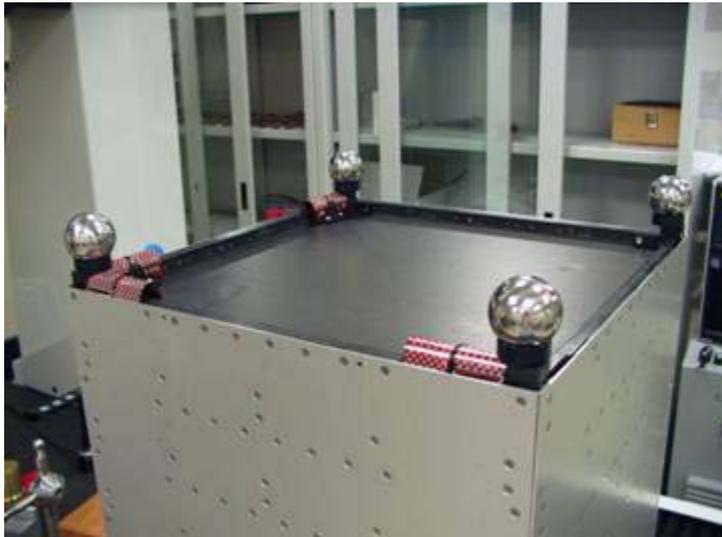
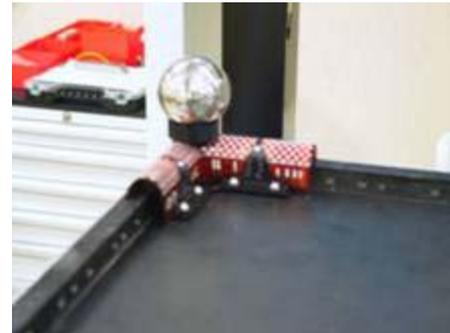
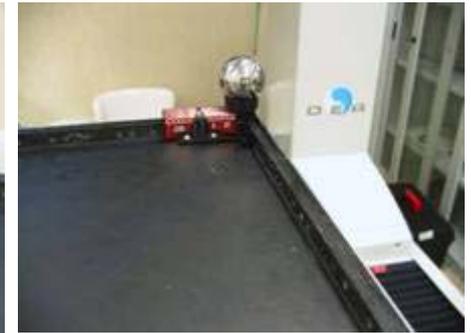
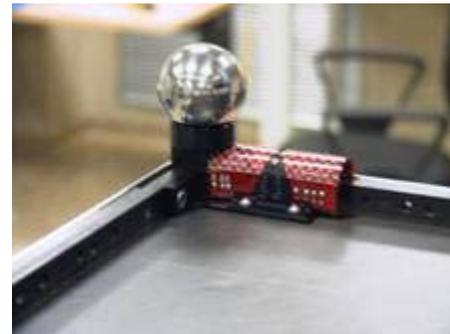
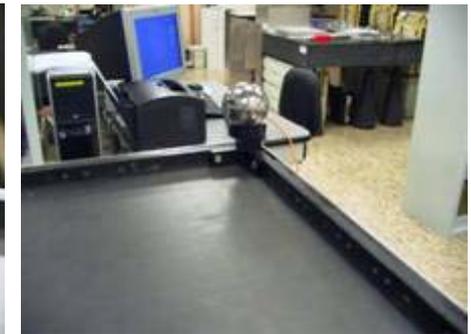
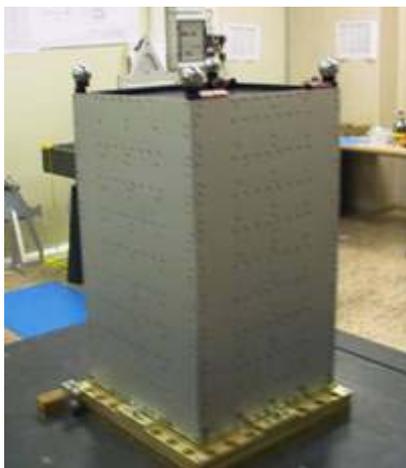
Top Bending and installation of Top Tooling Ball

Tower Zero CMM measurements confirm that the Tower is well done:

Tower offset from BCS to TCS

134 microns
