# **MRB on MCM Leakage Current Problem**

**Tom Himel**

**SLAC**

**February 4, 2005**

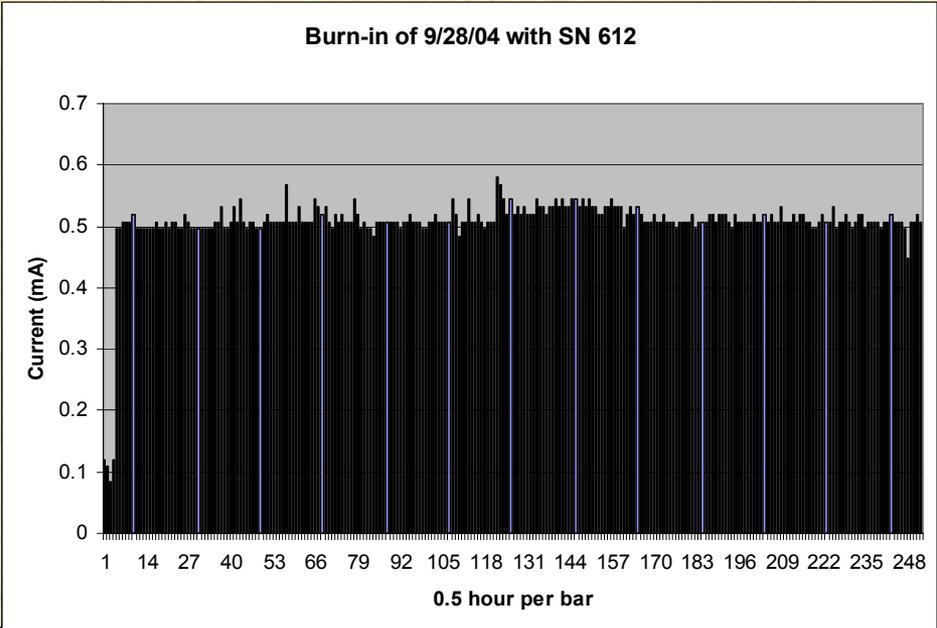
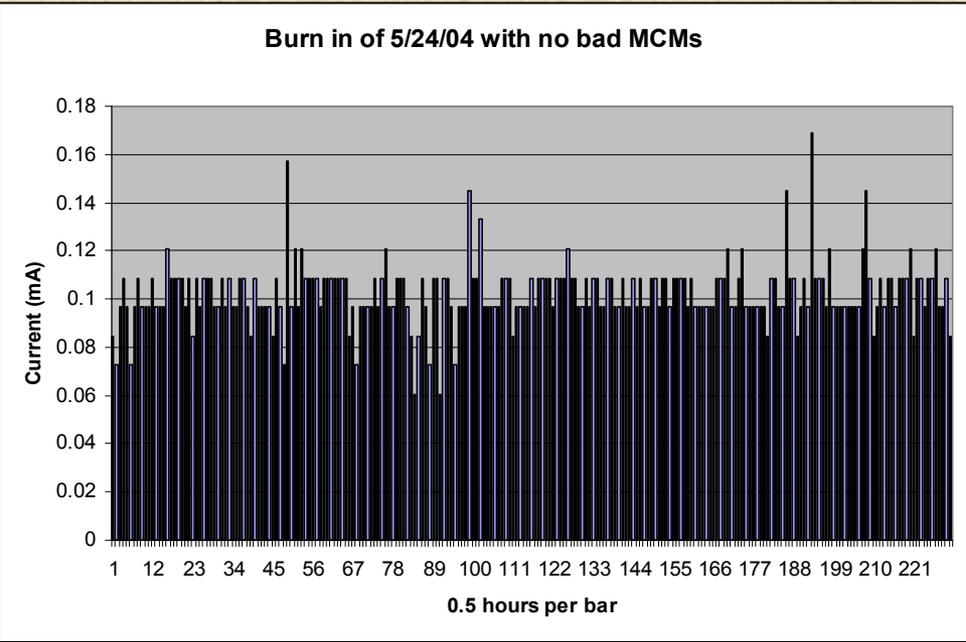
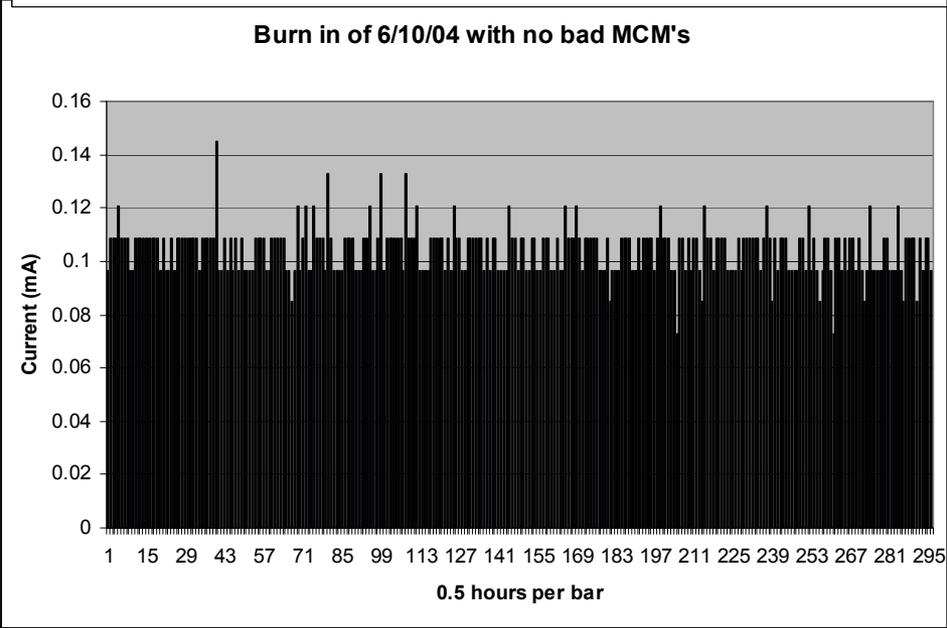
# Burn-in Currents – 270kΩ limits I to 0.4 mA

- ✦ The burn-in is done for 7 days at 85° C with 120 V between layers 7 and 8.
- ✦ 36 boards are done in parallel. The total bias current of the 36 boards is recorded.
- ✦ Batches with failed board(s) show a current increase after 2, 3.5, 4, 6, 10, 20, and 75 hours of the 168 hour burn-in.

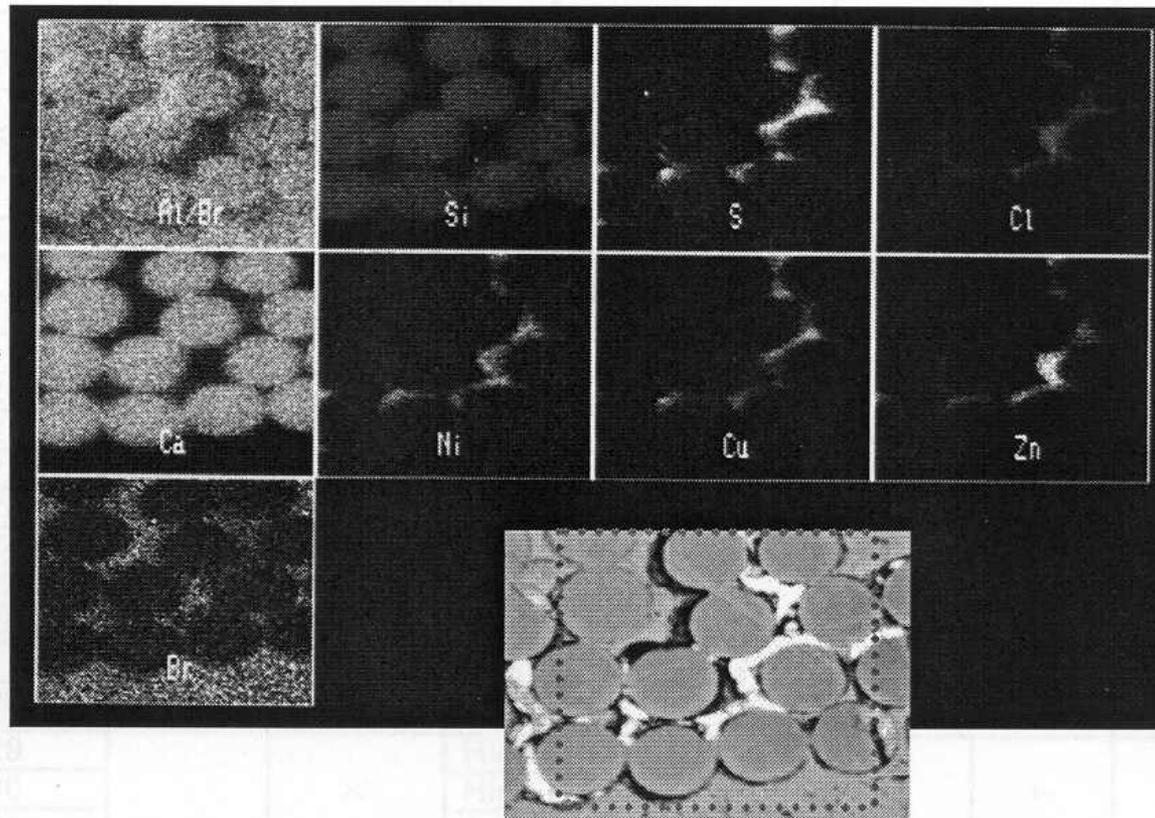
# Picture of CAF from NPL report MATC(A)155

Figure 14. Optical and EDAX images of microsection showing presence of many elements associated with the CAF

Could it be Conductive Anodic Filamentation (CAF)?

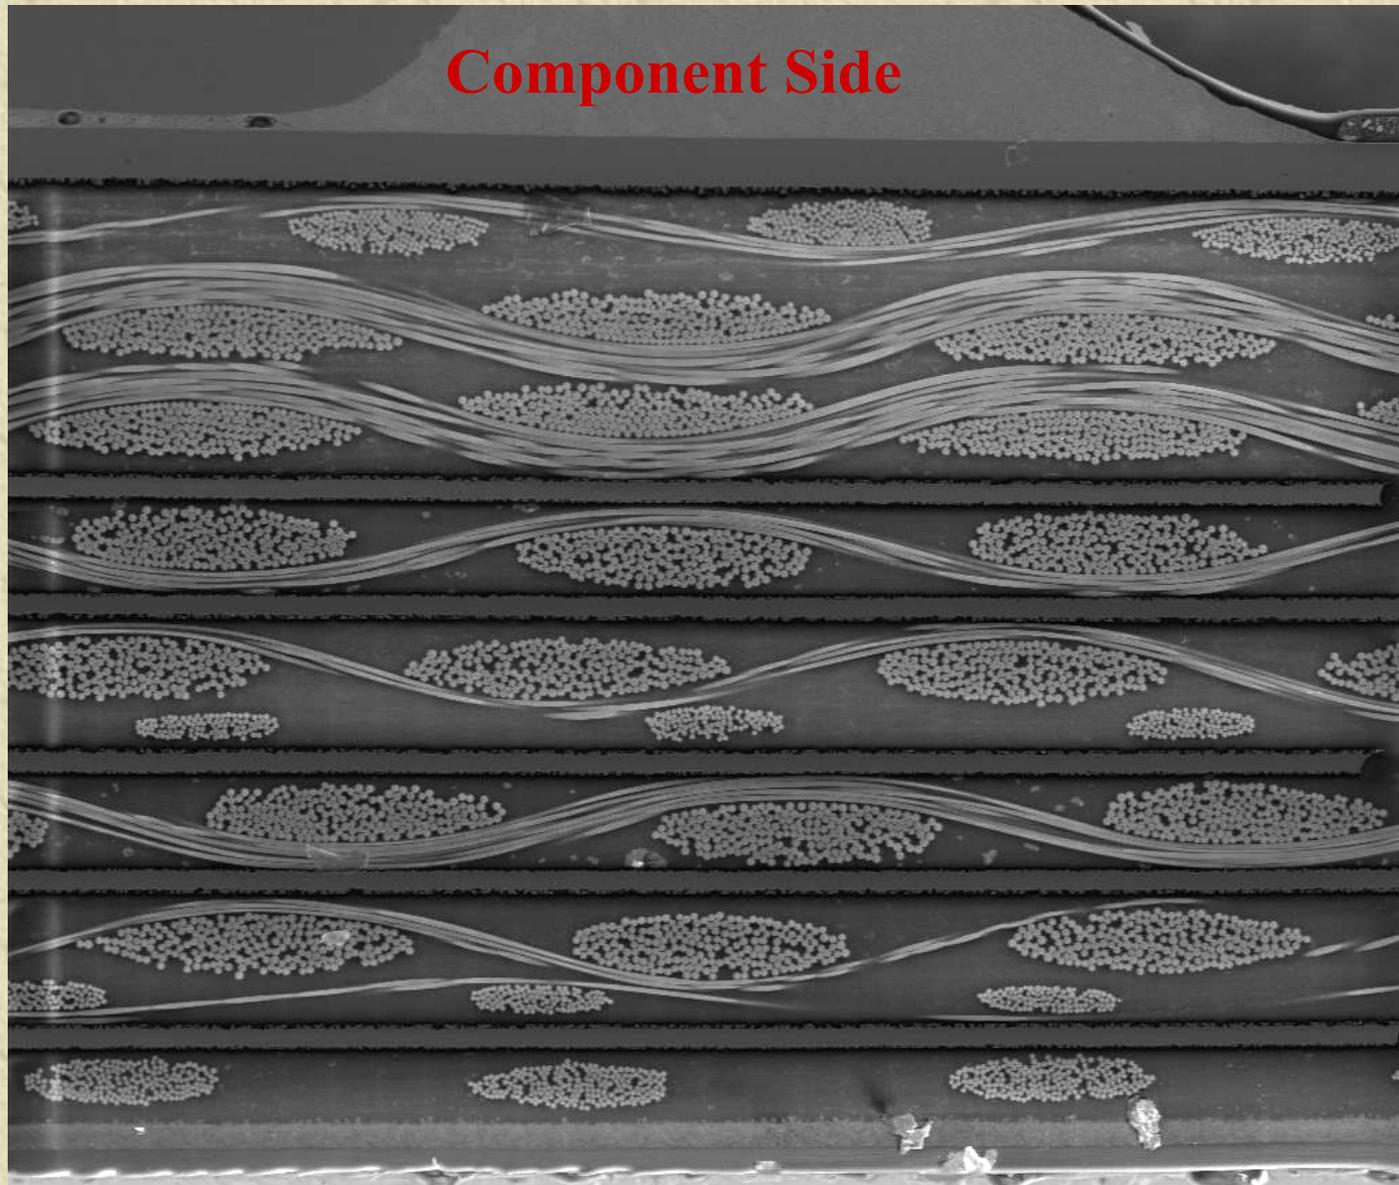
# E-SEM Cross-sectional Photo – 3 2-ply and 4 1-ply

Based on what I saw during the cross-sections and my previous experience, I believe that there are some rather large particles embedded in the resin. EDS analysis of these particles indicate that they are some form of silica. Optical photos show that some of these particles are just as large as the vertical distance between the planes. It is very likely that some of these particles are actually larger than the gap between the planes and during the lamination process, the pressing of the laminates together can squeeze and crack these particles which bridge the vertical gap between the planes. Once a crack is formed, moisture can accumulate and allow the copper on the positive plane to ionize and go into solution, moving towards the negatively biased plane where the soluble copper ions change back to solid copper particles after passing through a pH gradient (from low at the positive side to high at the negative side). This copper migration through these cracks can cause the short circuits experienced. **Note: silica is often used in prepreg to match the CTE. It is NOT used in the Arlan 35N of the MCM.**

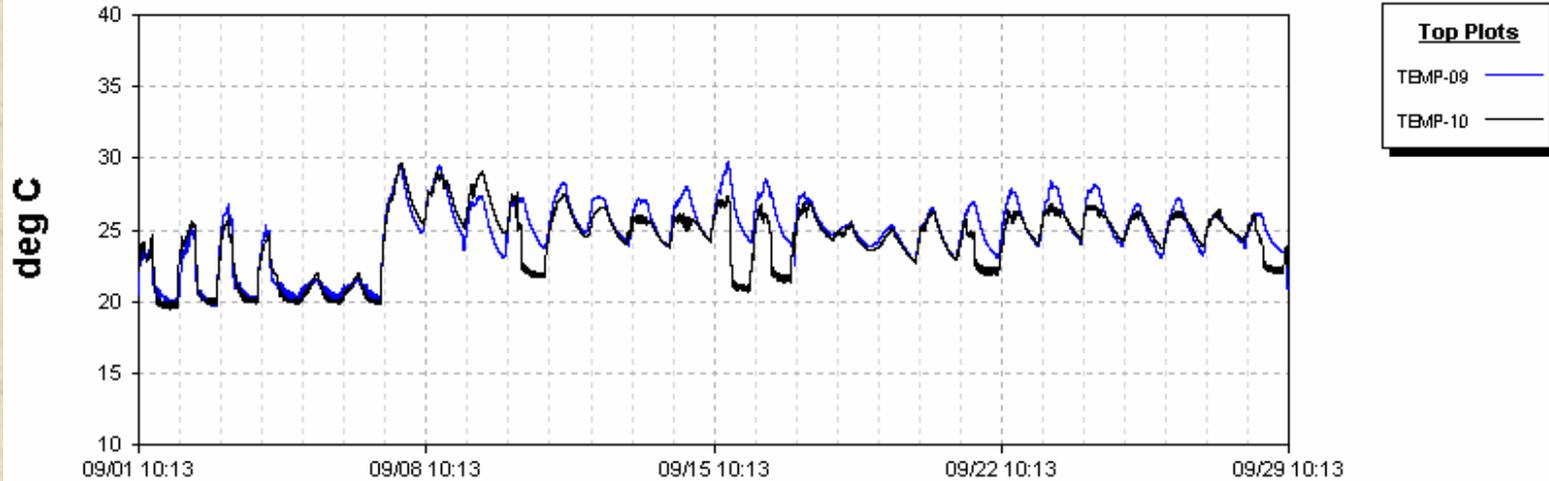
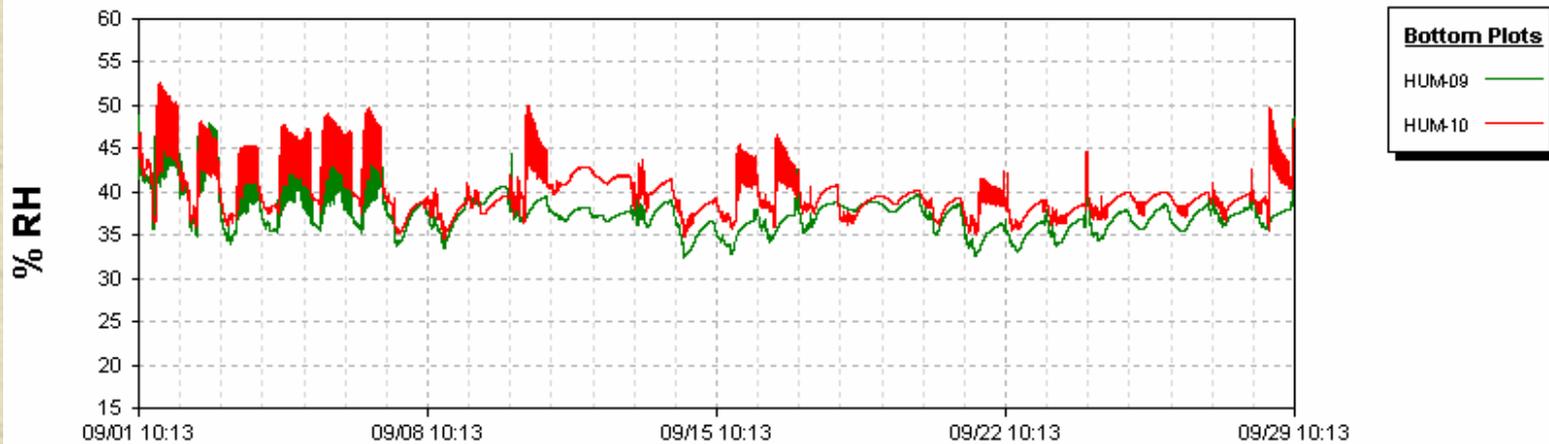
# Humidity of bldg where bare boards are stored at SLAC

- ✦ They are exposed to ~40% humidity.
- ✦ One expert said not enough.
- ✦ Almost all experience is with FR4
- ✦ Polyimide is more hygroscopic
- ✦ One expert said >0.2% by weight was bad.
- ✦ Our boards have 0.4% moisture content
- ✦ Conclusion: YES

A 4 hour bake at 250°F is long enough to remove moisture
