# **GLAST Large Area Telescope: Cost/Schedule Review February 25, 2004 AntiCoincidence Detector (ACD) Subsystem WBS: 4.1.6**

**David J. Thompson  
Thomas E. Johnson  
NASA Goddard Space Flight Center  
Subsystem Manager/Instrument Manager**

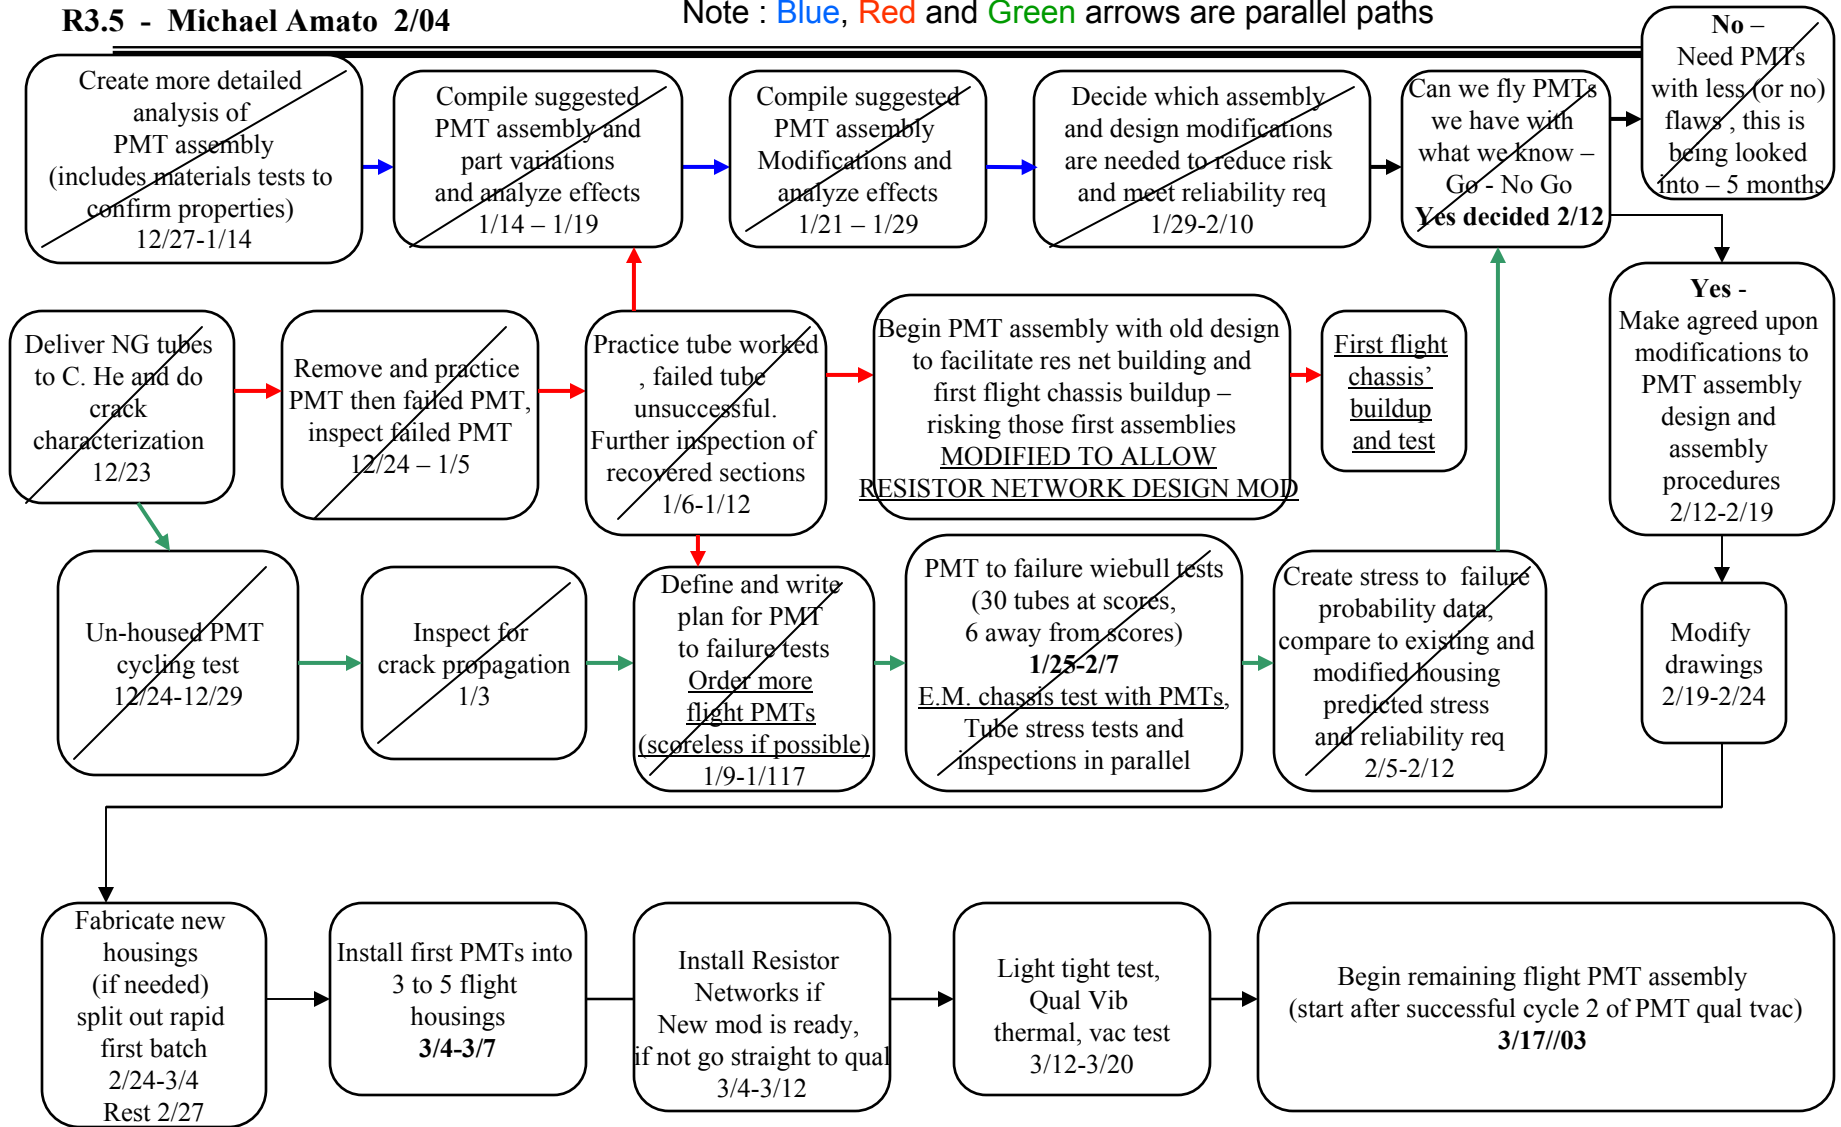
# PMT Anomaly Resolution Flow

Note : Blue, Red and Green arrows are parallel paths

**Four phototubes in housings cracked at -30 C in Thermal Vac tests. A team has been analyzing these failures.**

- **Glass strength as tested is about half the book values, discovered scores also reduce strength**
- **Overlap in magnetic shielding causes excess stress. It also adds handling risk and unwanted variability to design.**
- **Uralane potting material is not as compliant at at low temperatures as first thought.**

- **Much more detailed stress analysis and strength testing - complete, some test post processing almost complete.**
- **Removal and inspection of newer 3 breaks going on this week to look for more direct cause correlation.**
- **Preliminary solution –**
  - **Replace magnetic shielding with nickel plating of housings ( tried successfully )**
  - **Replace uralane with softer silicone ( trials ongoing )**
