GLAST Large Area Telescope

Systems Engineering

Test Status, NCRs and Verification Status

Stanford Linear Accelerator Center

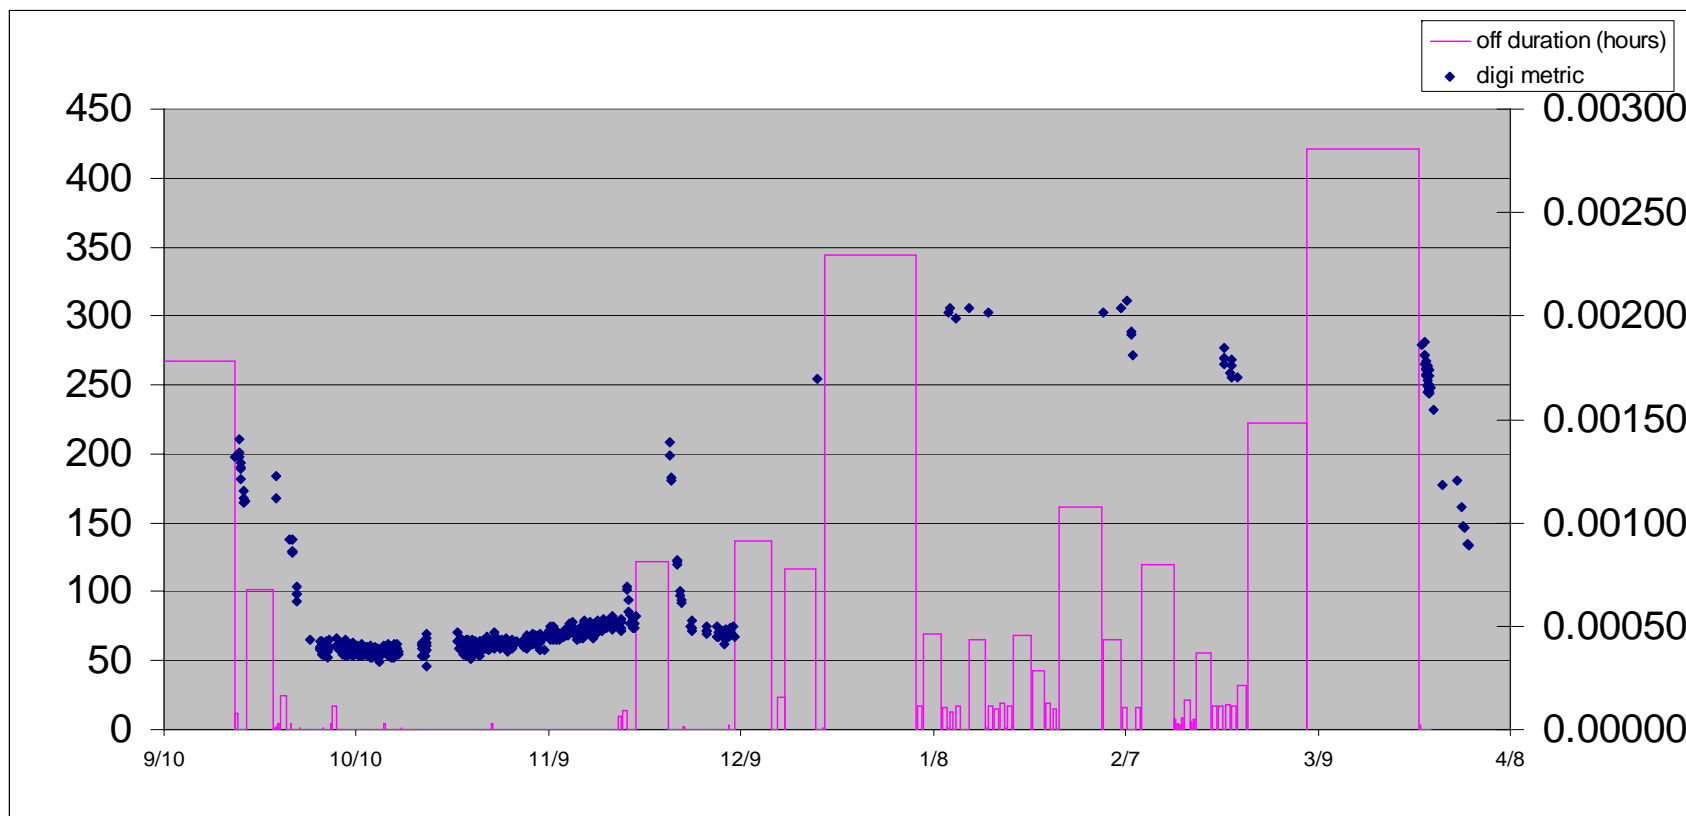
History at GD

- We have observed what appeared to be a step change in tracker efficiency after the LAT was integrated to the spacecraft
 - Efficiency numbers were down to 99% against a spec of 98%
 - Efficiency numbers are rising toward the normal level
- Review of historical data shows that this metric drops whenever the LAT has been unpowered for a length of time
 - LAT has had the longest unpowered intervals after the final stand-alone testing
 - Did not drop when unpowered during TV after initial bakeout
- Tracker team is fully involved to see if they can understand the phenomenon
- Following plots illustrate the history of the phenomenon
 - The metric is from the digi files and is related to 1-efficiency
 - Magenta line shows the times when the LAT was off
 - B side LAT CPT continued the expected downward trend
