Inside the Van de Graaff – 4/24/03

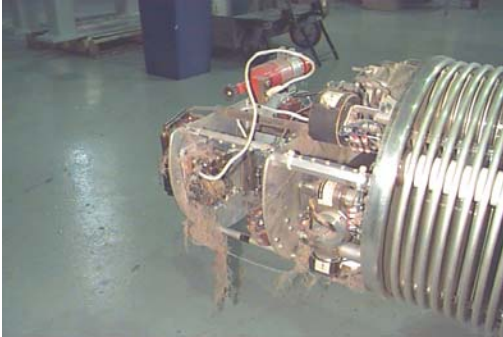
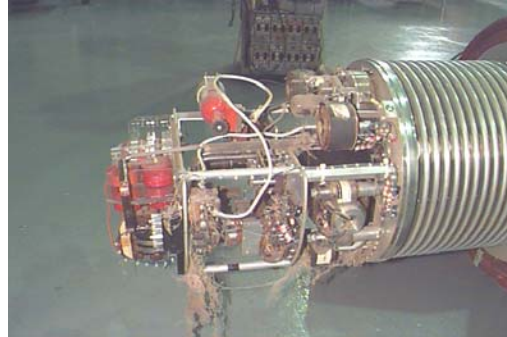
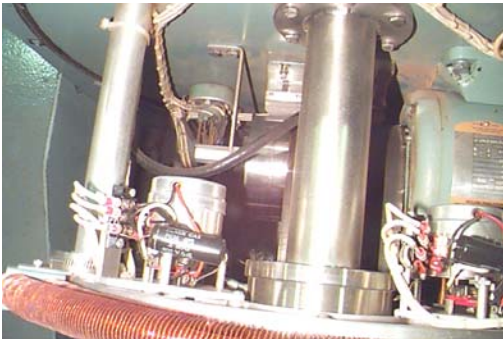
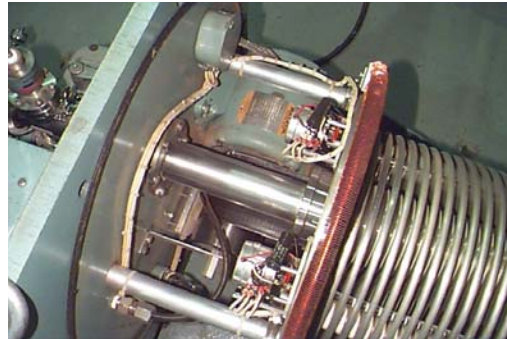
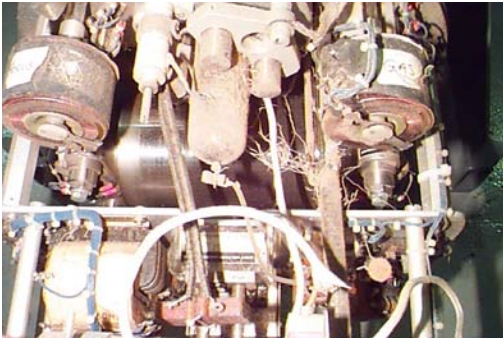
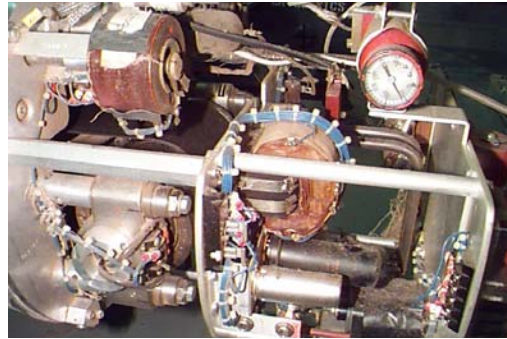
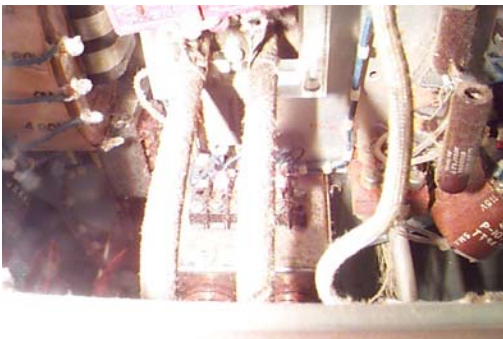
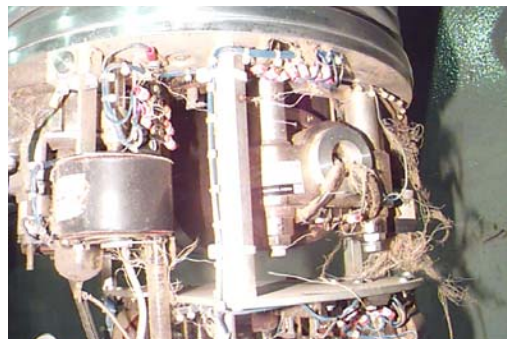
For the past couple of weeks the VG has been making 50-60 μA of column current but zero beam current...so we opened up the VG tank. Notice that the belt has gone off center and self destructed.
